EPL 283 2021 - 2022 Monitoring Report

Reporting Period: 24th November 2021 – 24th November 2022

Submitter Details: Kane Taylor, Paspaley Pearling Company Pty Ltd

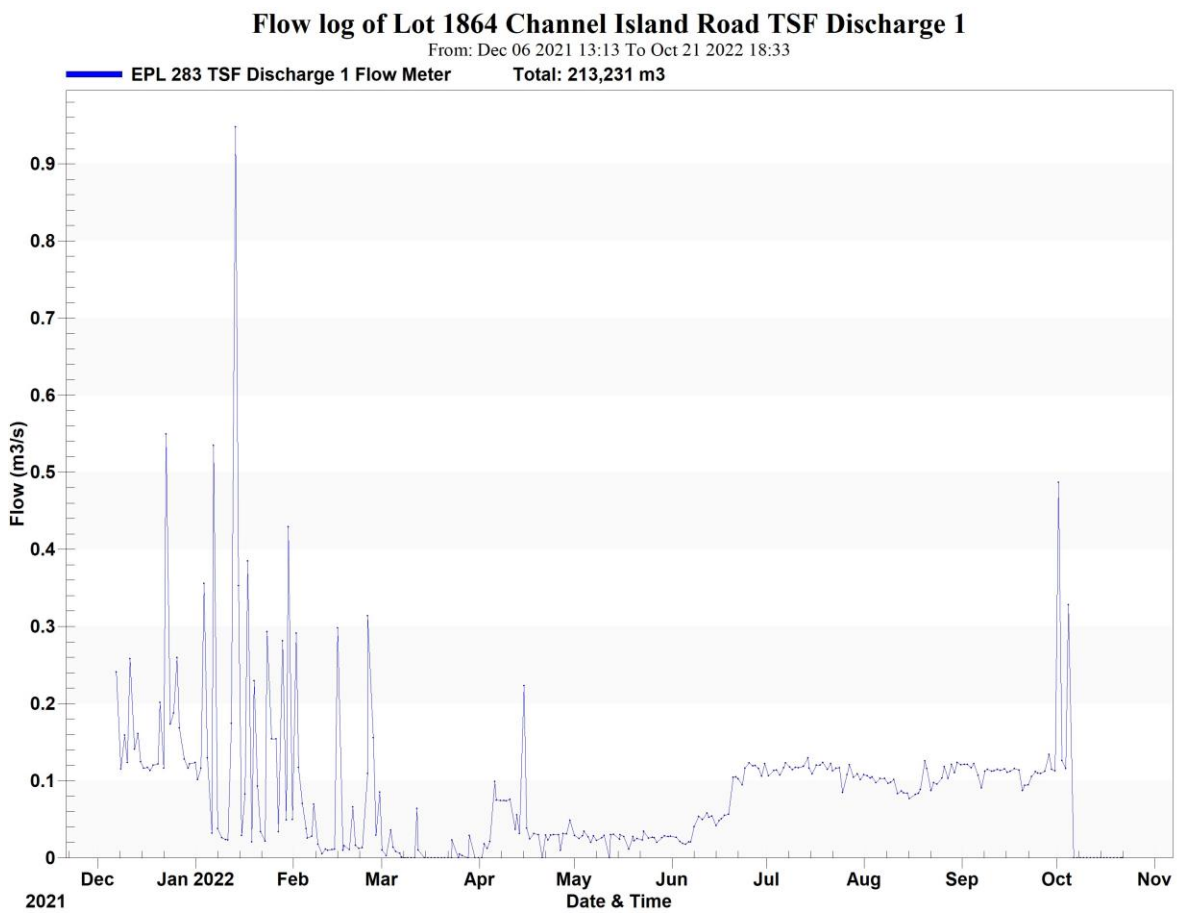
The graph below details the water discharged from the site TSF Discharge 1 as recorded by the water flow meter.

The graph shows a few high peaks during the annual wet seasons from rainfall events.

The rest of the year shows steady increase in discharge as more ponds are used in production. The flow rate from July until October is believed to be near maximum for the site as all ponds and tanks were being used at this time.

In early October we had a mechanical issue with the pump and the waterflow from the ponds then stopped. Unfortunately, the flow meter battery appears to have run out on Oct 21 however as with the previous few weeks only minimal water was discharged

The total discharge for this time is 213231m³.
