SECTION 14 INCIDENT REPORT (*Waste Management and Pollution Control Act*)

Date and Time of Notification:	Saturday 29/03/2025 15:00hrs
Person / Company:	Power and Water Corporation
Incident:	Overflow of diluted raw sewage effluent from Pine Creek sewage pump station

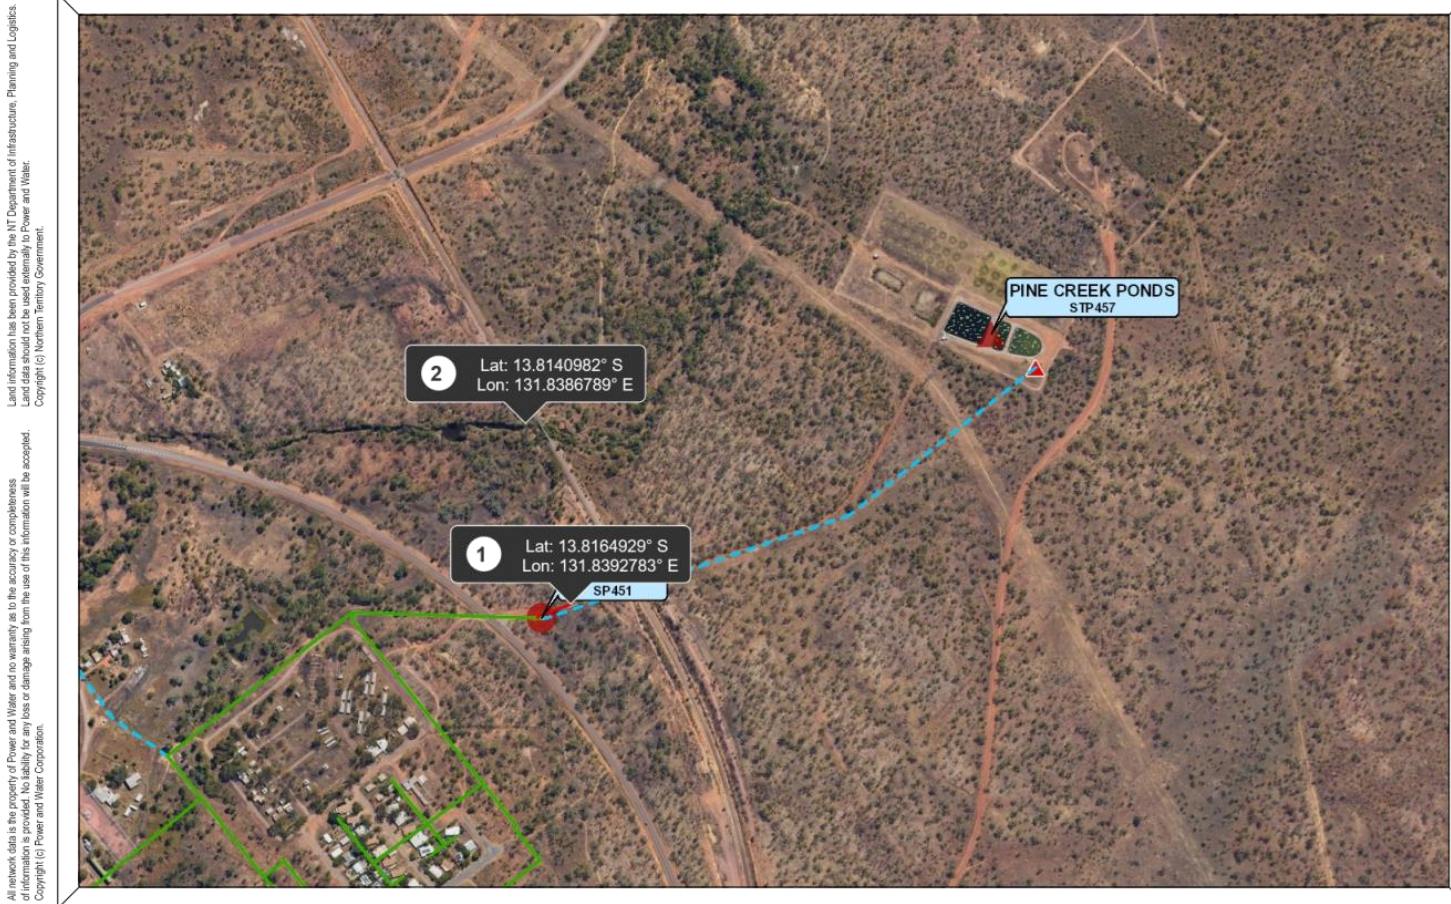
**Pine Creek Sewage Pump Station Overflow Initial and Final
Discharge Points**

0 187.5 375.0 Meters
Scale 1: 7,500

(b) the place where the incident occurred	<p><i>i. Description of the Power & Water asset from which the discharge occurred.</i> Pine Creek sewage pumping station.</p> <p><i>ii. GPS coordinates of the discharge point from the Power & Water asset, and the final coordinates of the final discharge point.</i> Discharge Point: 131.8392783 E, 13.8164929 S (emergency discharge pipe outlet) Final discharge point: 131.8386789 E, 13.8140982 S (Copperfield Creek)</p> <p><i>iii. Indicate any locations nearby to the discharge point where public can gain ready access, such as public open spaces through which the discharge moves.</i> Discharge is to Copperfield Creek, which is ordinarily accessible to the public, however the area is currently inundated with stormwater and hence it is inaccessible.</p>
