## Gove Operations

# WDL Annual Monitoring Report

For the reporting period of 1 April 2020 to 31 March 2021.

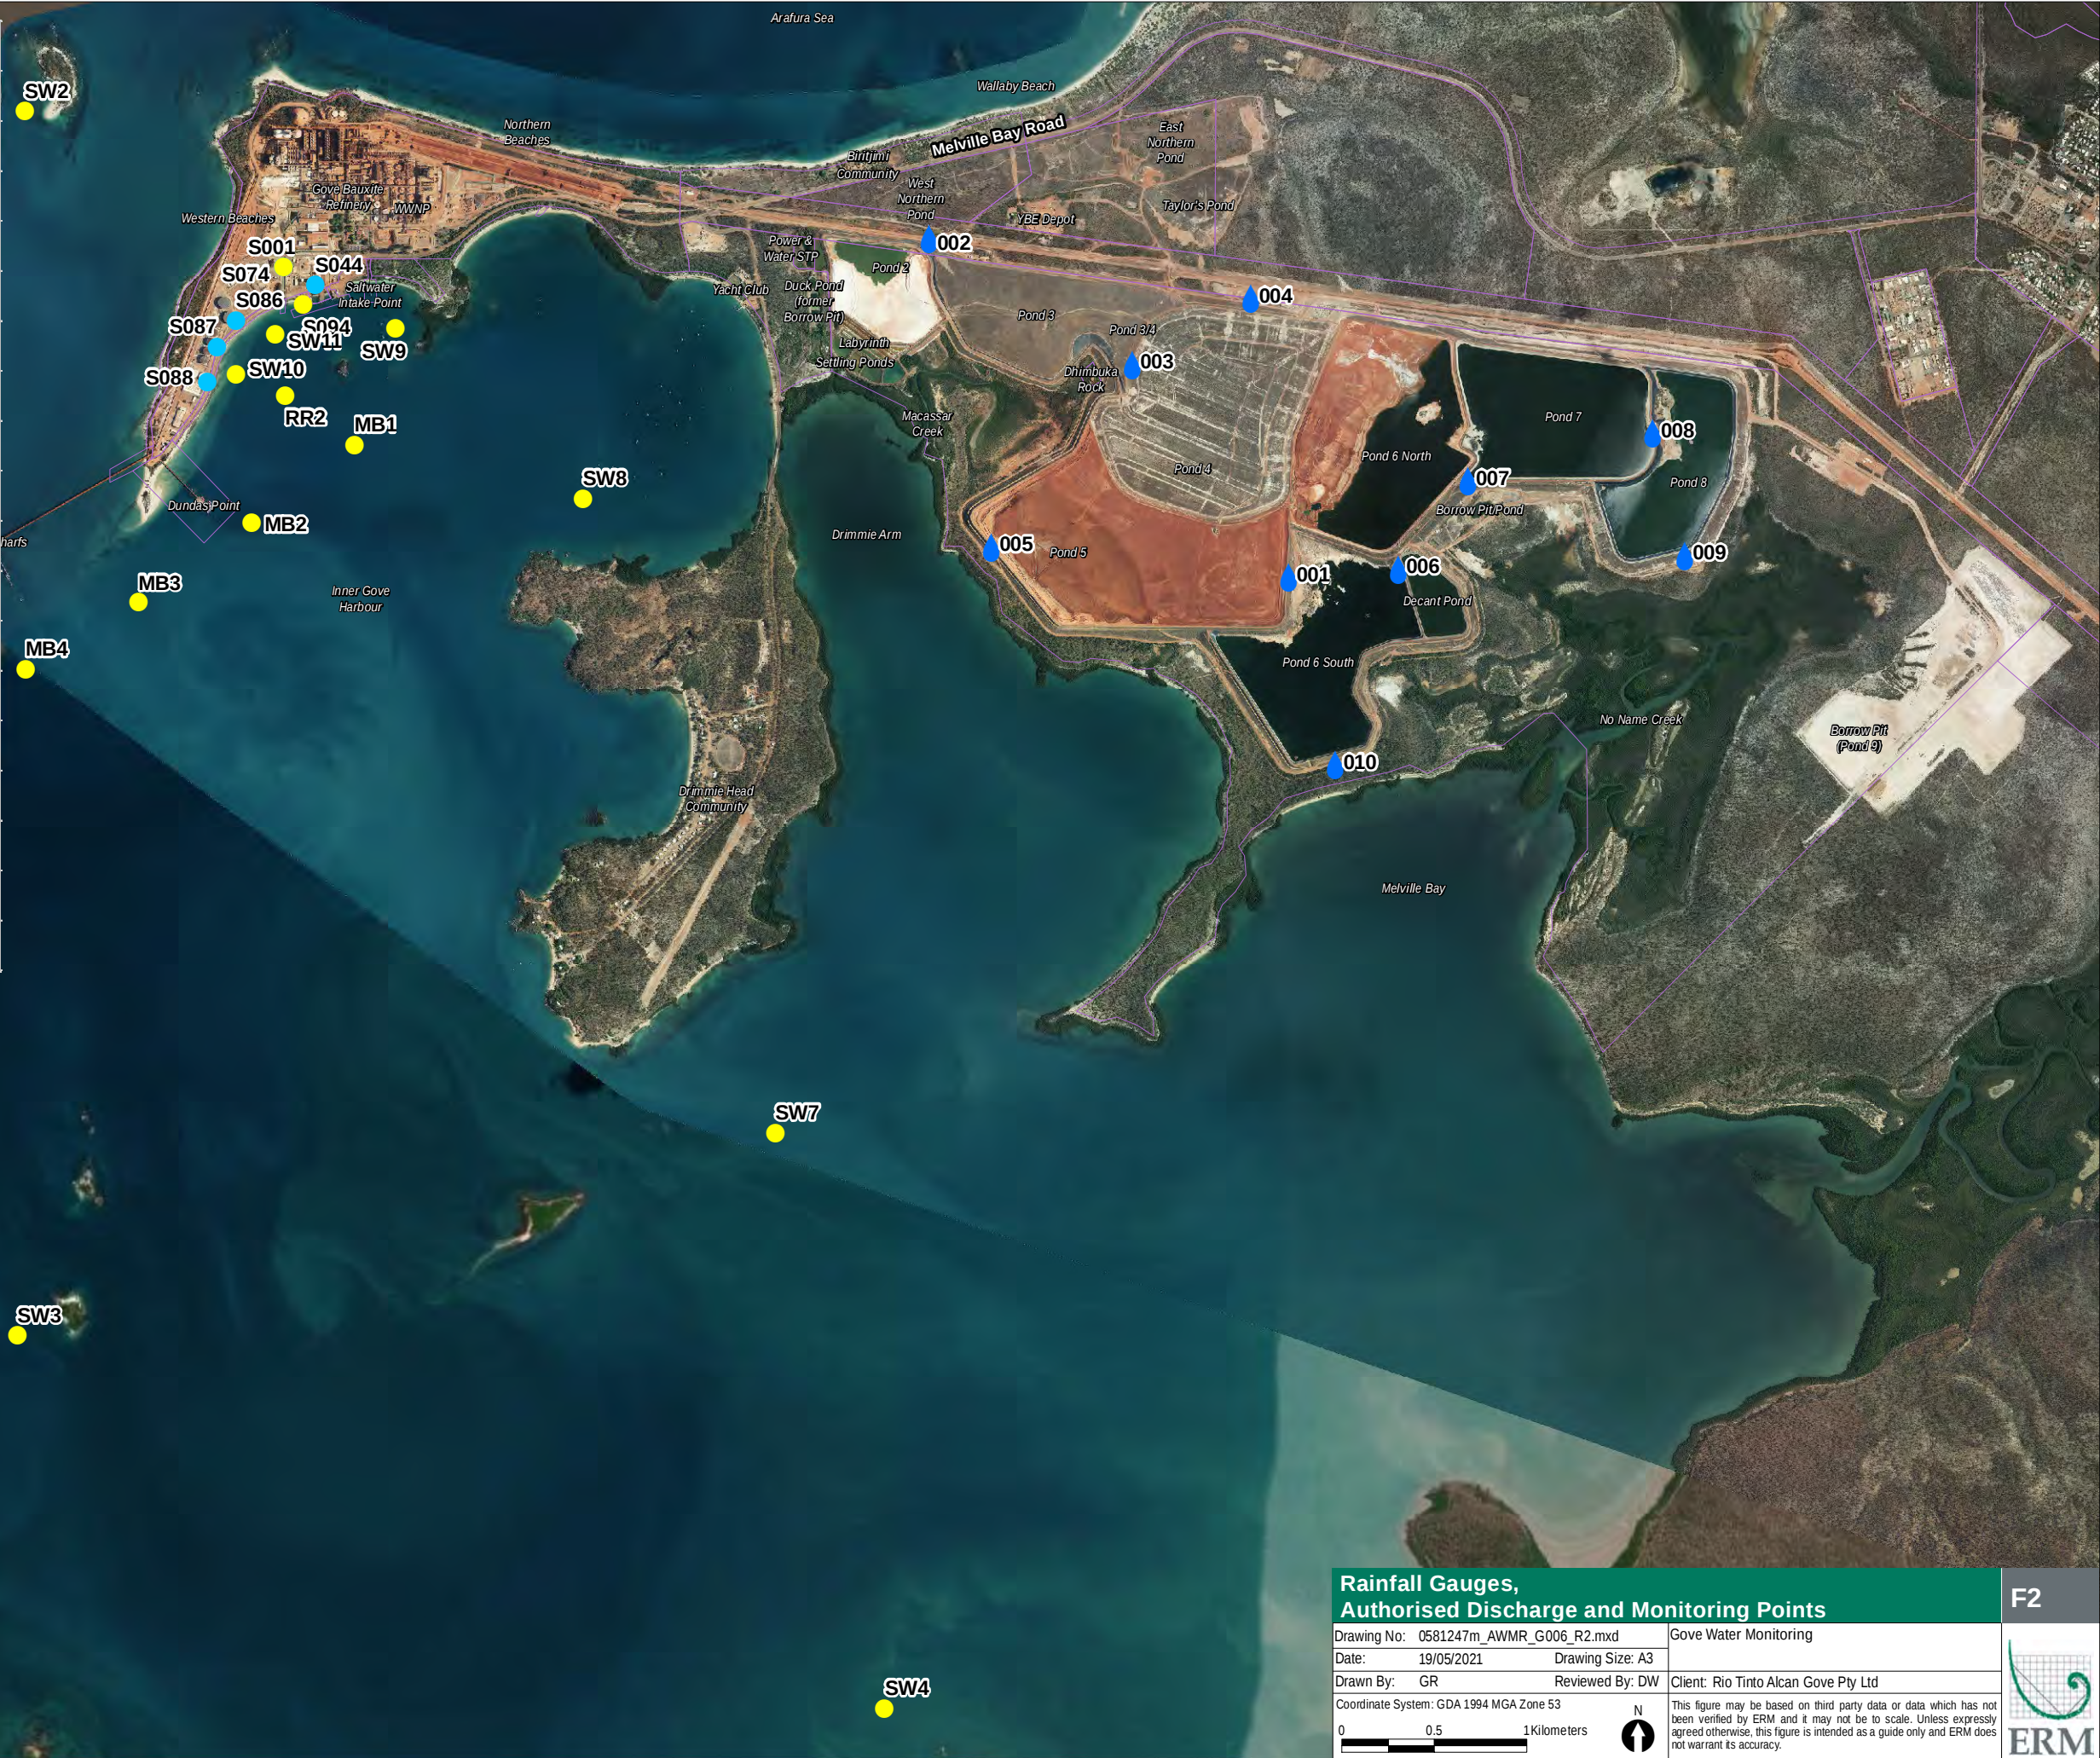
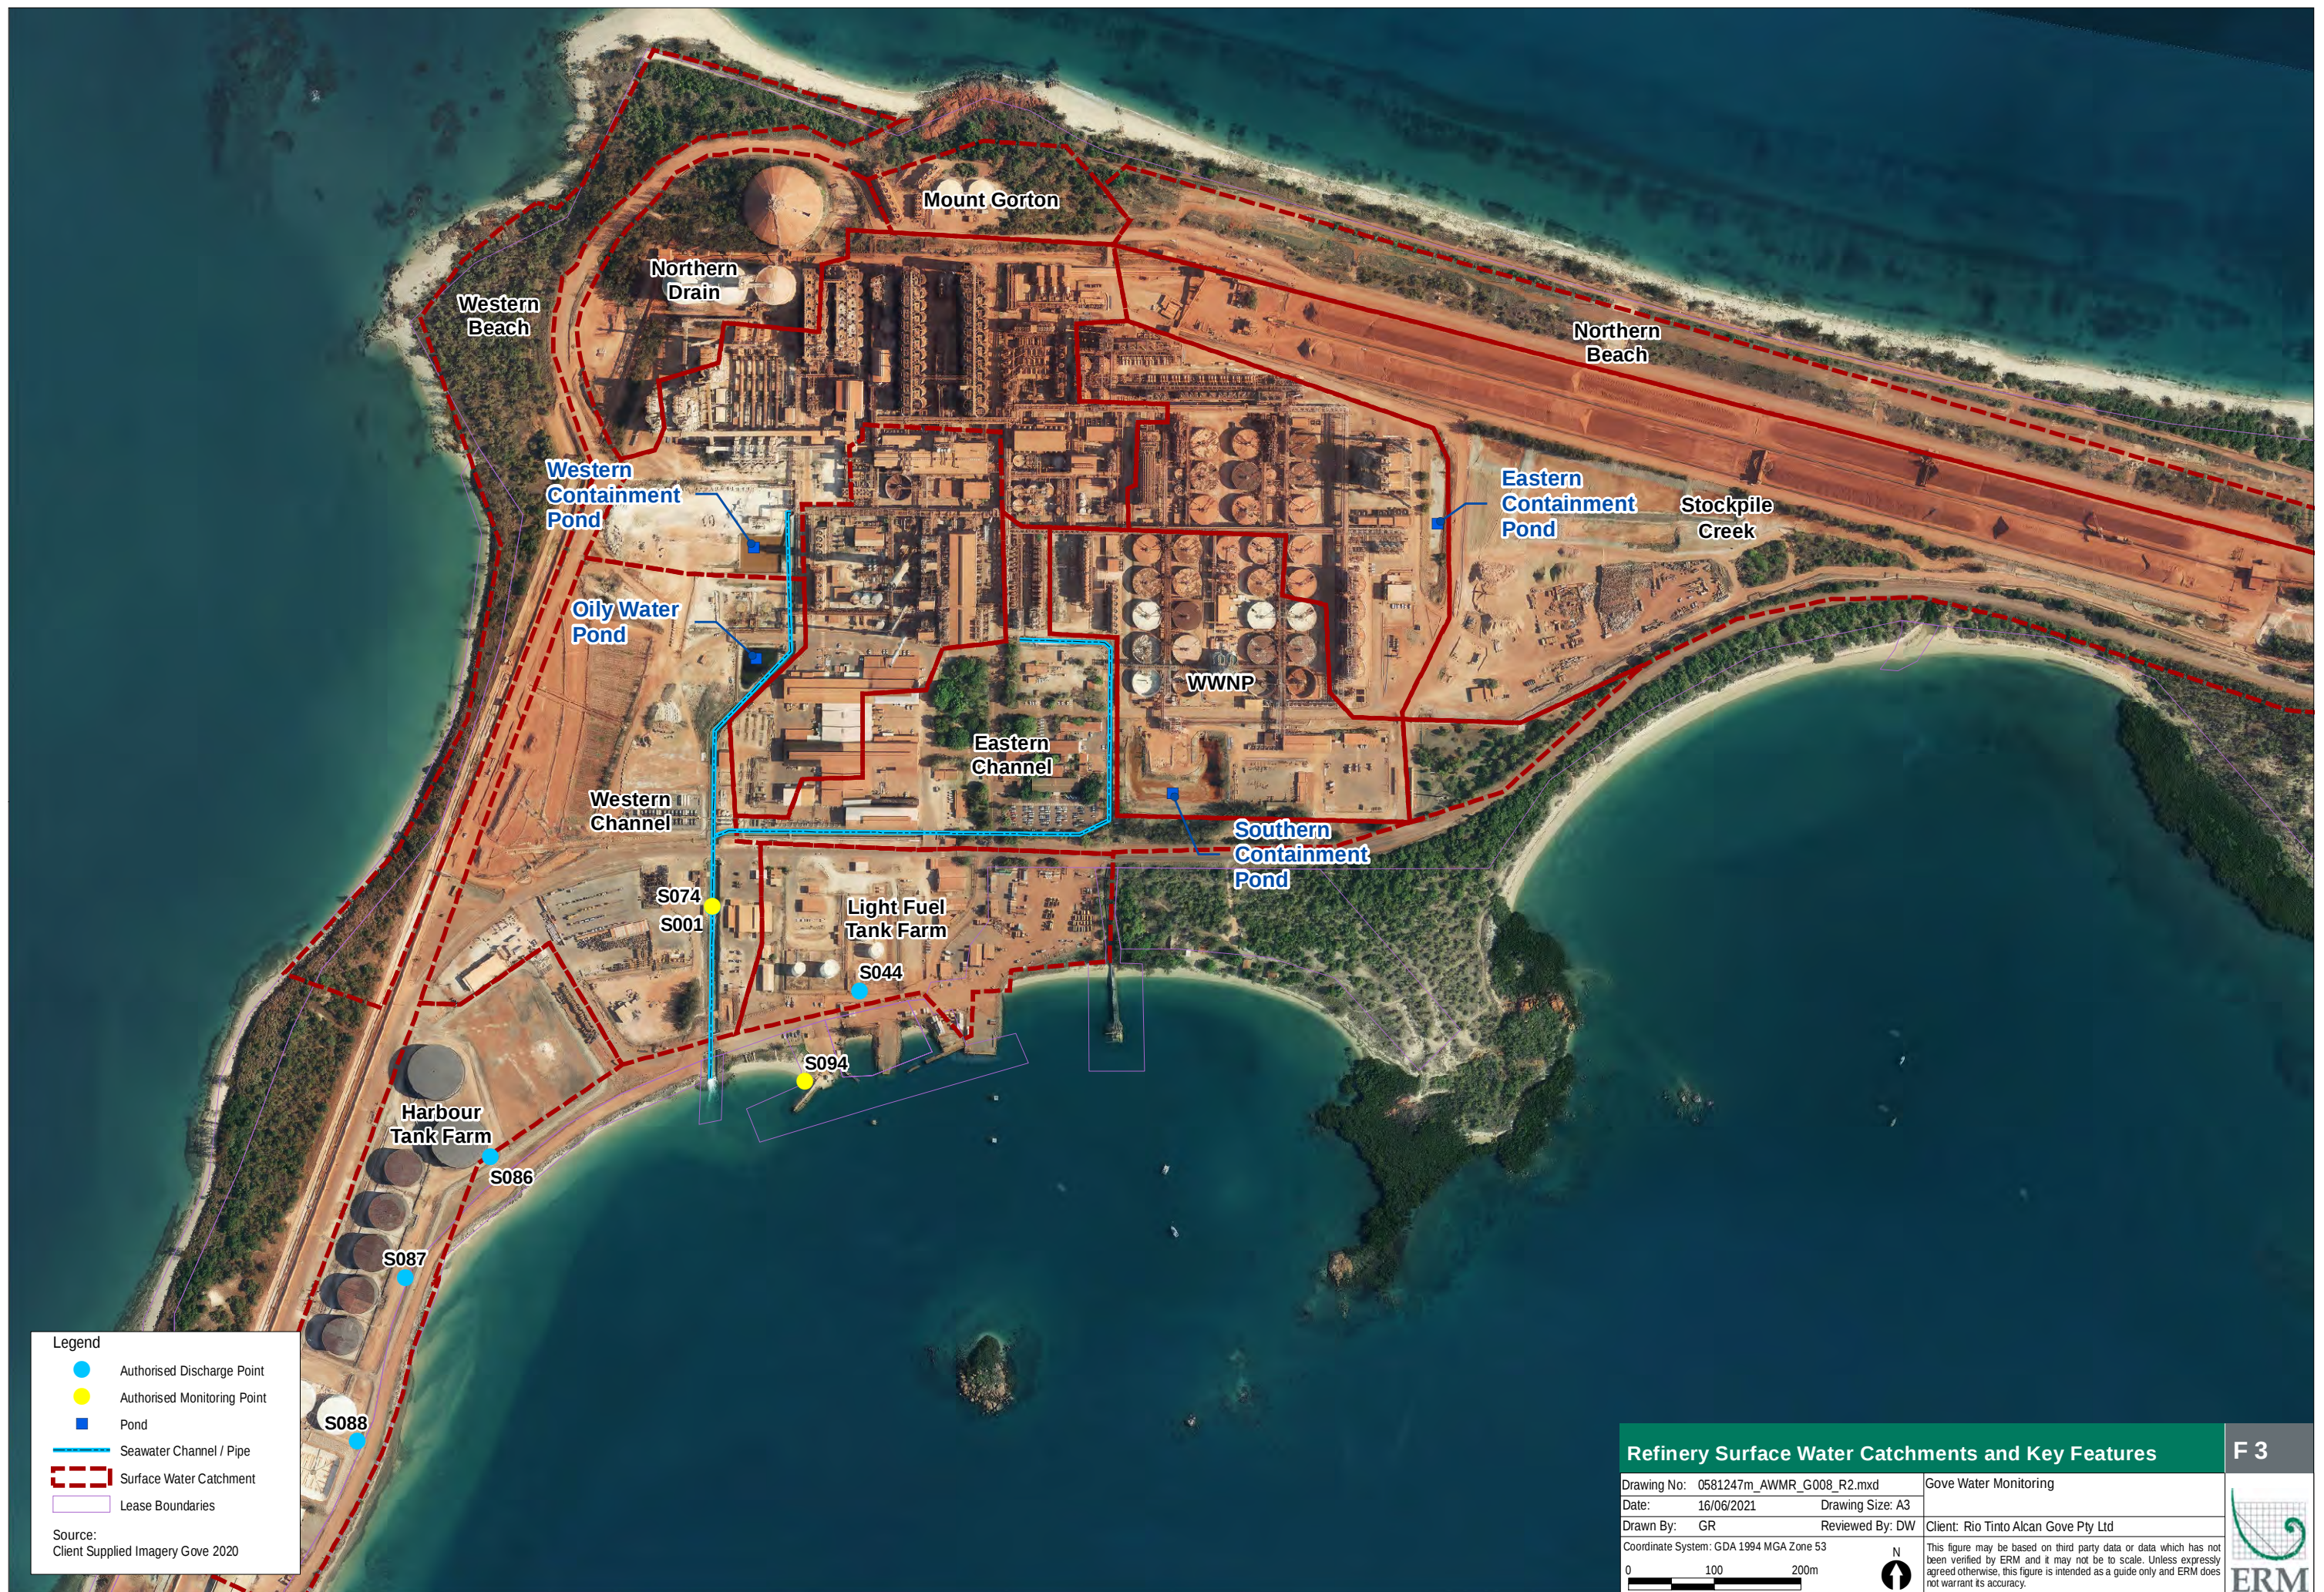
**Figure 1 – Overview of the Site**

**Figure 2 – Rainfall Gauges, Authorised Discharge and Monitoring Points**

**Figure 3 – Refinery Surface Water Catchments and Key Features**

The location of the Authorised Discharge Points and Authorised Monitoring Points / Compliance Points is shown on Figure 2, Appendix B.

Gove Operations operates ten rainfall gauges around the RDA (known as Gauge 001 – Gauge 010); the location of these are presented on Figure 2, Appendix B. These gauges collect rainfall at six-hourly intervals and are accessible via an online system for real time interrogation. Rainfall data from all gauges collected over the reporting period was downloaded and assessed for this report.

The Refinery has a total of 14 surface water sub-catchments which drain to the Eastern, Western and Southern Containment Ponds located within the Refinery (refer Figure 3, Appendix B). These ponds are designed to collect and retain surface water runoff, including any operational release of liquids, for subsequent re-processing and/or treatment. During storm events, the Containment Ponds also provide a runoff surge capacity and, if required, allow contaminated surface water to be recycled to the RDA, and then treated via the WWNP, prior to discharge (under the Licence) via the Seawater Outfall Channel (Soo1).

The Western Containment Pond, Oily Water Pond and the WWNP (Figure 3, Appendix B) all have the potential to discharge into the seawater circuit, and thereby potentially discharge to the marine environment via the Seawater Outfall Channel.

The Seawater Outfall Channel is located between the Light Fuel Tank Farm (east) and the Harbour Tank Farm (west), down-gradient of the convergence of the seawater circuit channels (Eastern Channel and Western Channel) (Figure 3, Appendix B). The Western Containment Pond, Oily Water Pond, the sewage treatment plant and the WWNP all have the potential to discharge into the seawater circuit, and subsequently, discharge via the Seawater Outfall Channel.

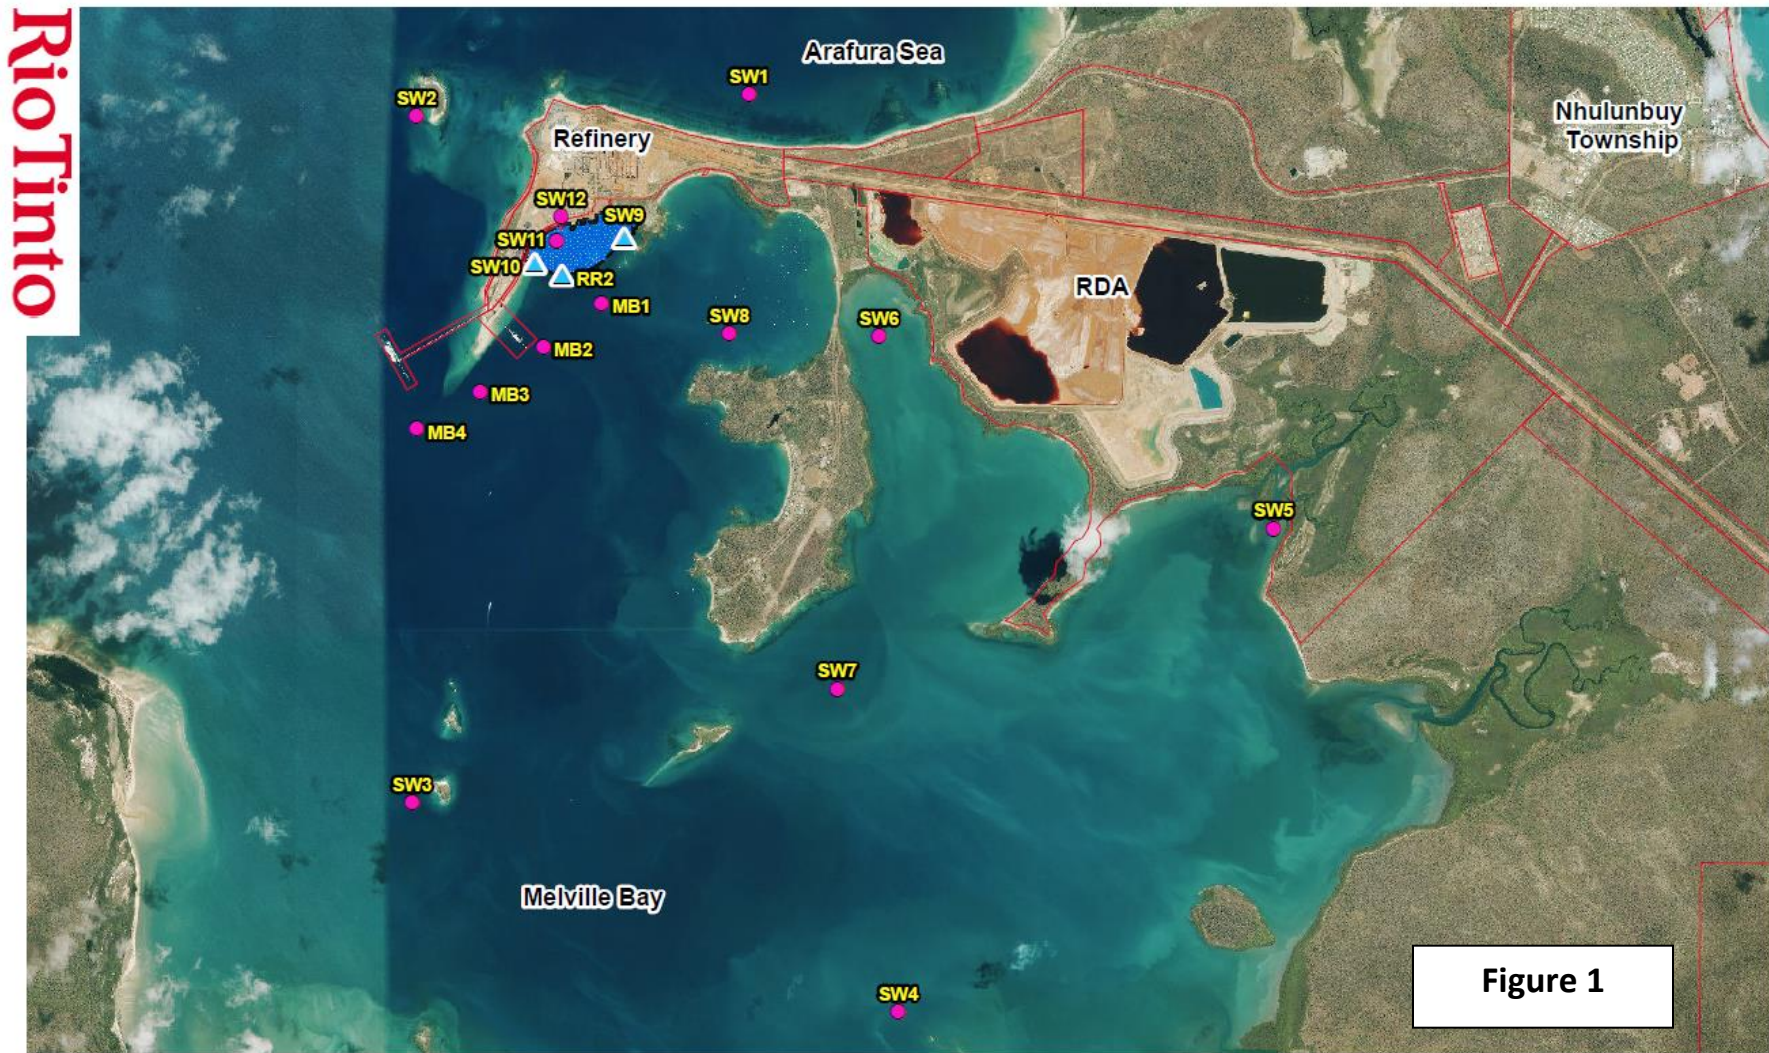
Figure 1. Southern Melville Bay MHMP seawater sampling sites.

Within the sampling area **Inner Gove Harbour**, **Crawford's Creek** and **Drimmie Arm** are the main areas of potential impact from the RTG operation, mainly via the **Refinery Seawater Channel Outfall** and **Residue Disposal Area (RDA)** discharge and seepage (Figures 1 and 2). Table 1 shows the monthly, half-yearly and yearly sampling and analytical programs as of March 2021. Sampling sites are shown in Figures 1 and 2, with the location coordinates in Appendix 1.

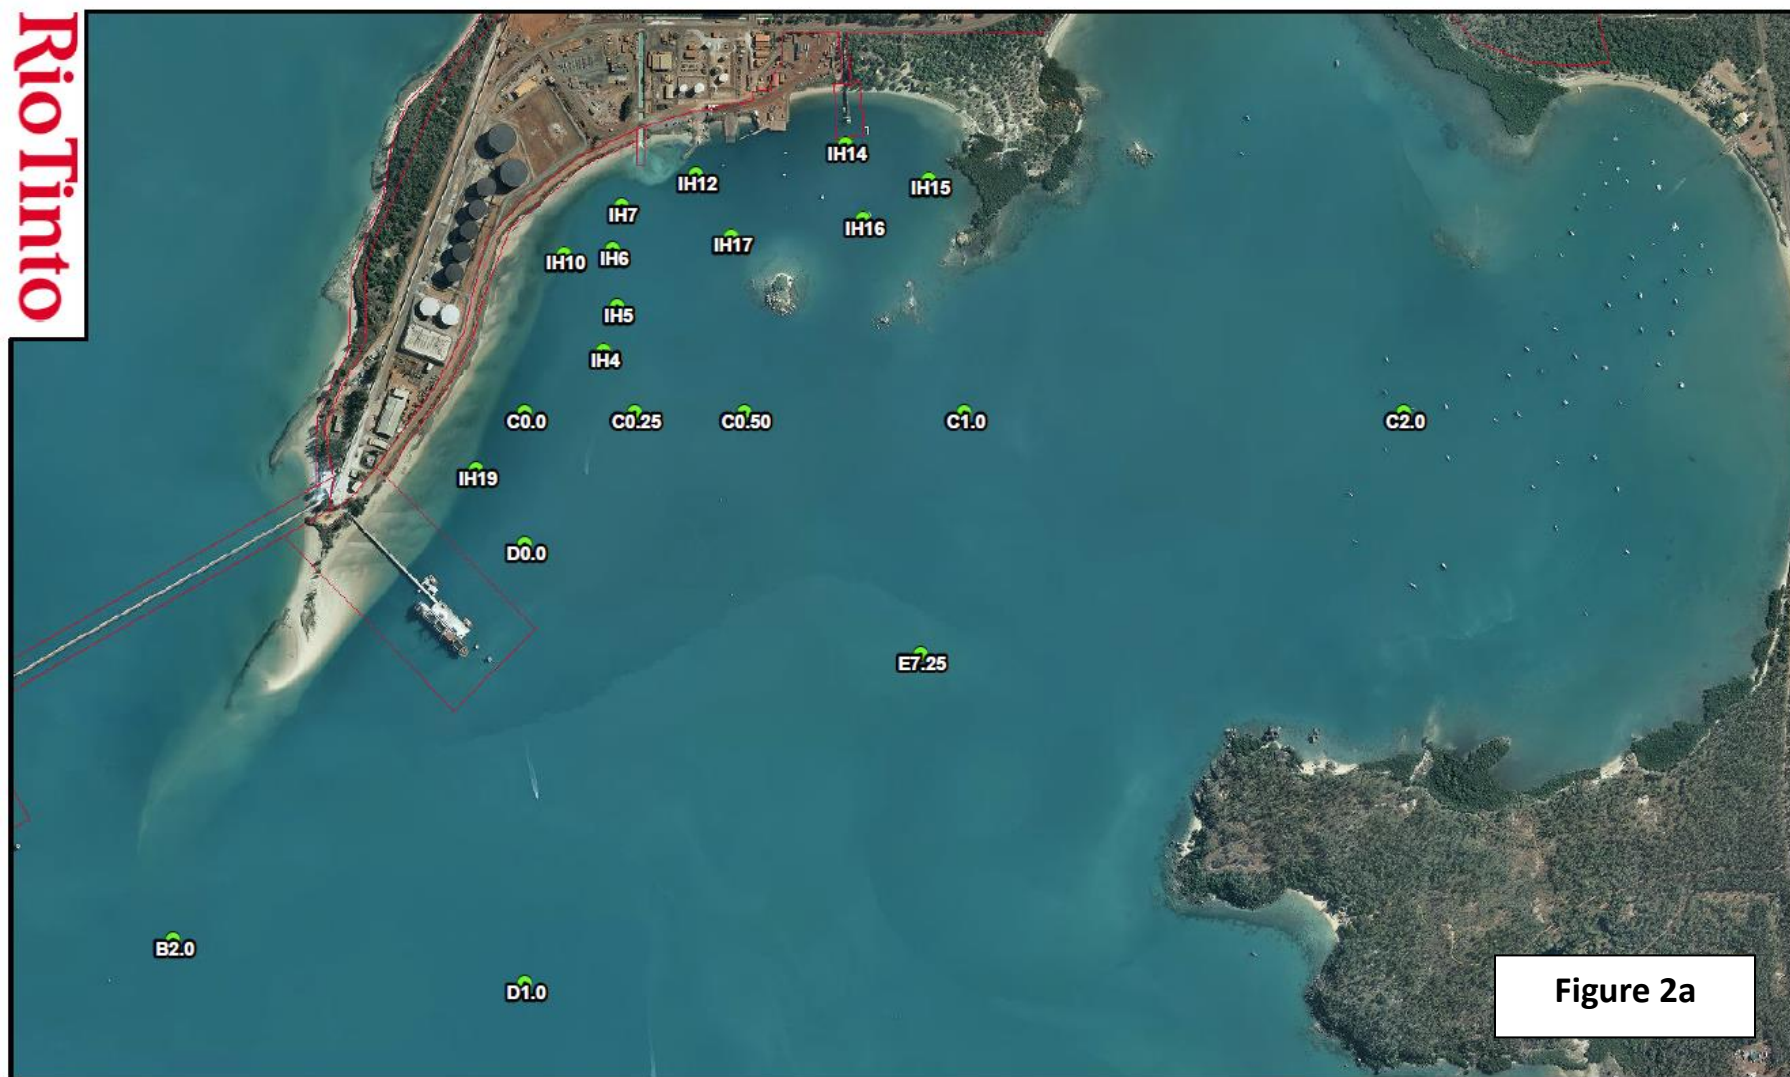
Figure 2a

| LEGEND | | SCALE 1:10,000 | | PROJECTION GDA 1994 MGA Zone 53 | | | GOVE INNER HARBOUR<br>SEDIMENT SITES | | | A3 |

Figure 2 a, b, c. Southern Melville Bay MHMP sediment and oyster sampling sites.

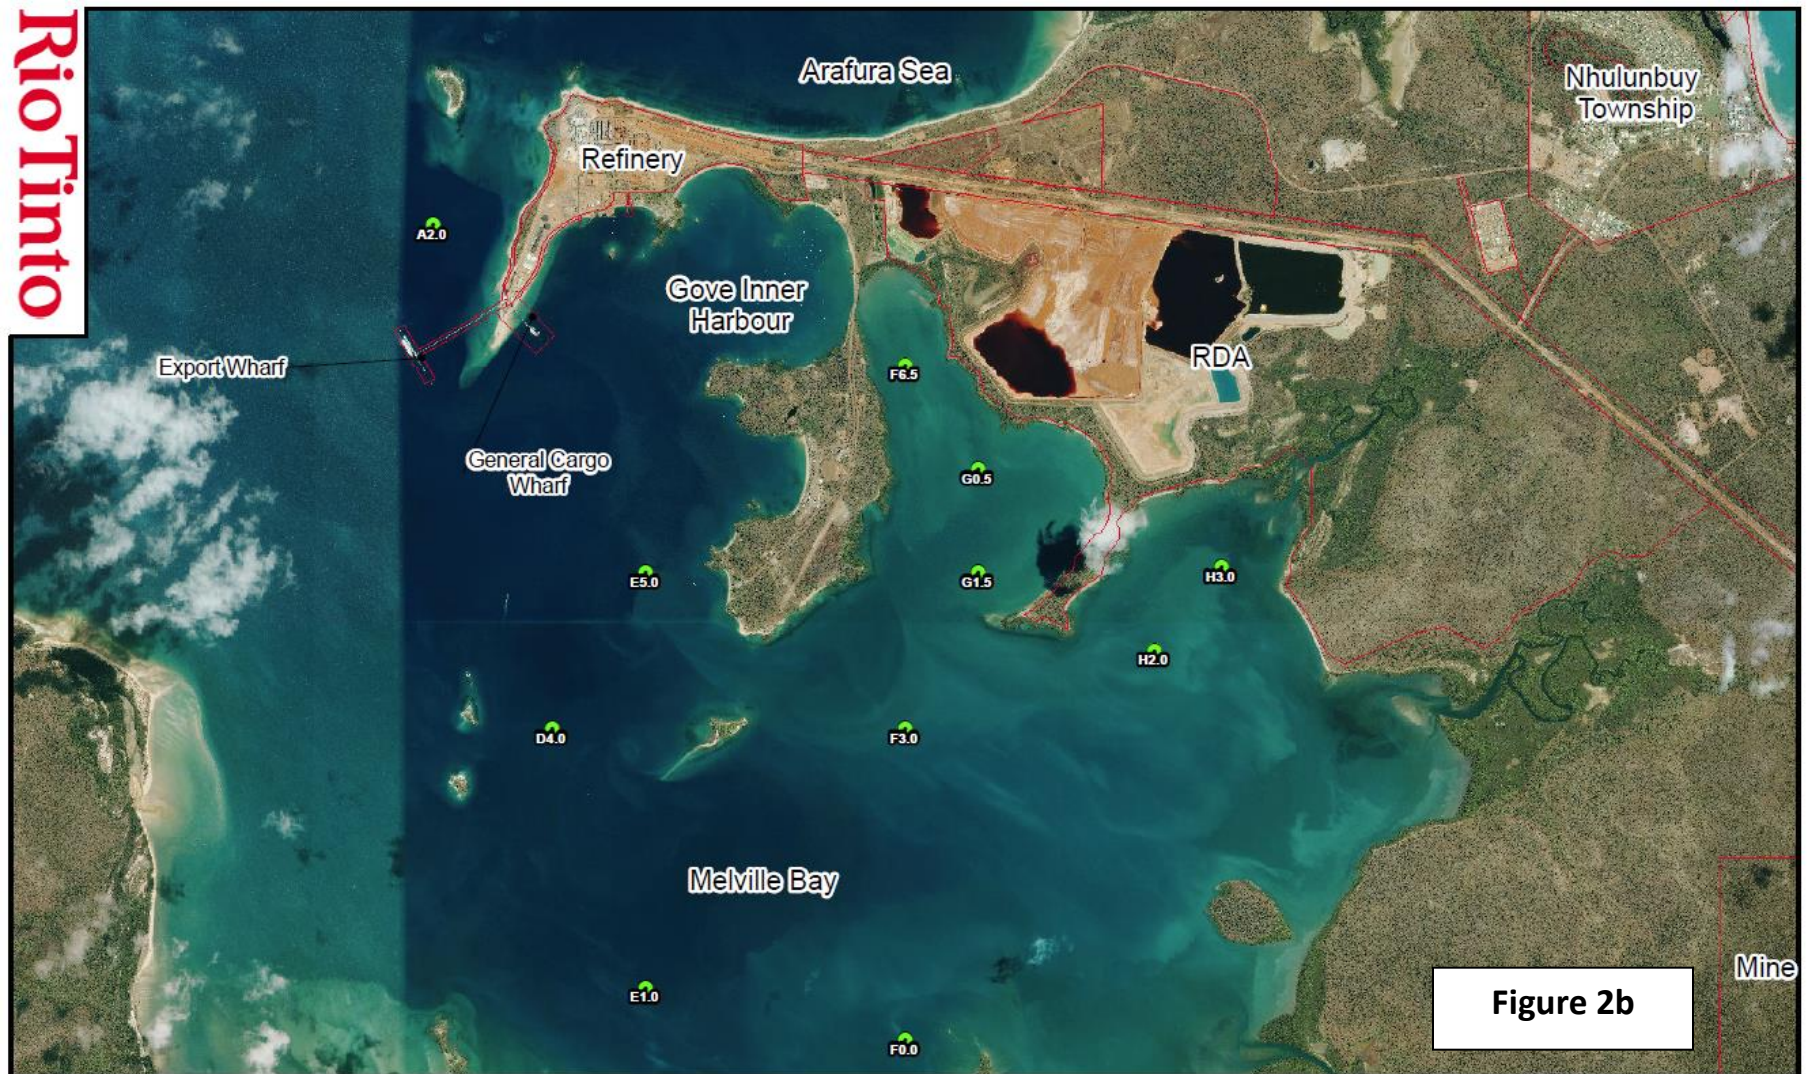
Figure 2b

| LEGEND | | SCALE | 1:42,000 | PROJECTION | GDA 1994 MGA Zone 53 | | GOVE OUTER HARBOUR<br>SEDIMENT SITES | |
