## Gove Operations

# WDL Annual Monitoring Report

For the reporting period of 1 April 2021 to 31 March 2022.

Prepared in accordance with the requirements of the Northern Territory Government Waste Discharge Licence (WDL171-11, 15 February 2022) and Northern Territory Environment Protection Authority "Guideline for Reporting on Environmental Monitoring (Version 1.0, May 2016)."

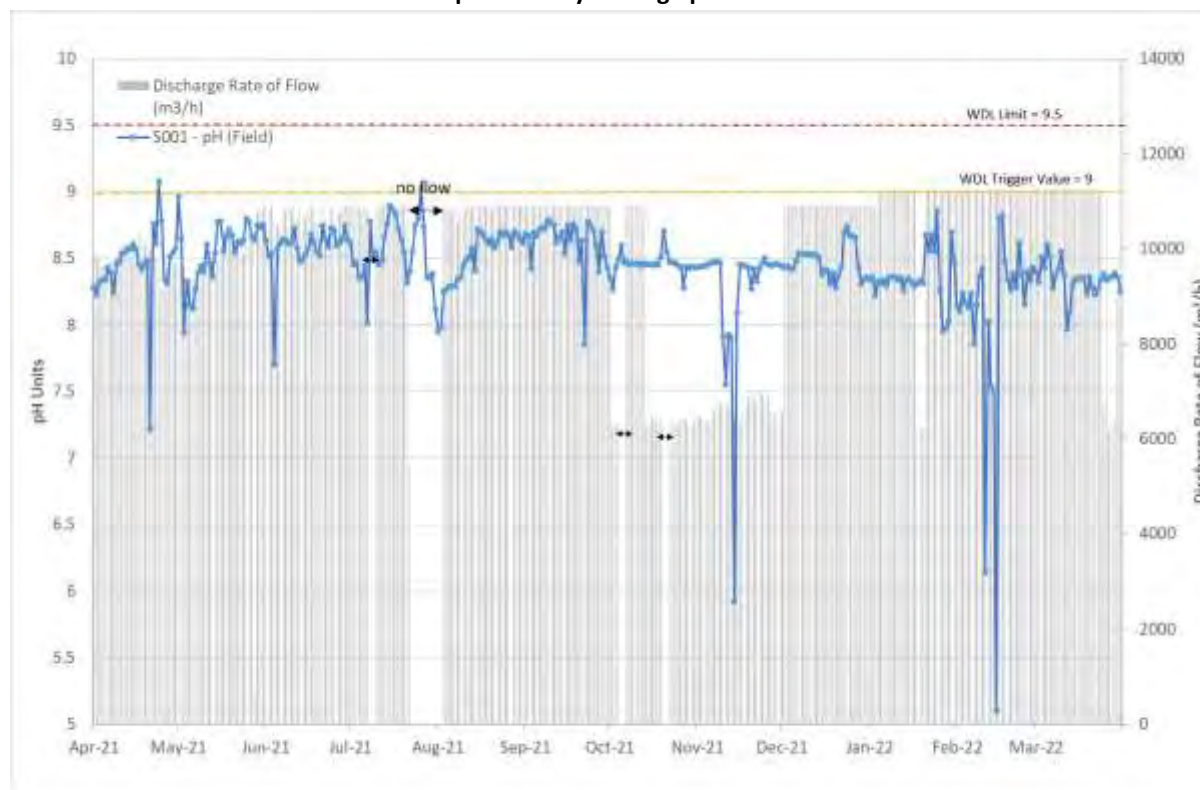
**Graph 5-2 Daily Average pH at S001**

between readings was one hour. The events (recorded under **1000578371**, **1000608476** and **1000608477**) were reported to the Northern Territory Government (refer Appendix F).

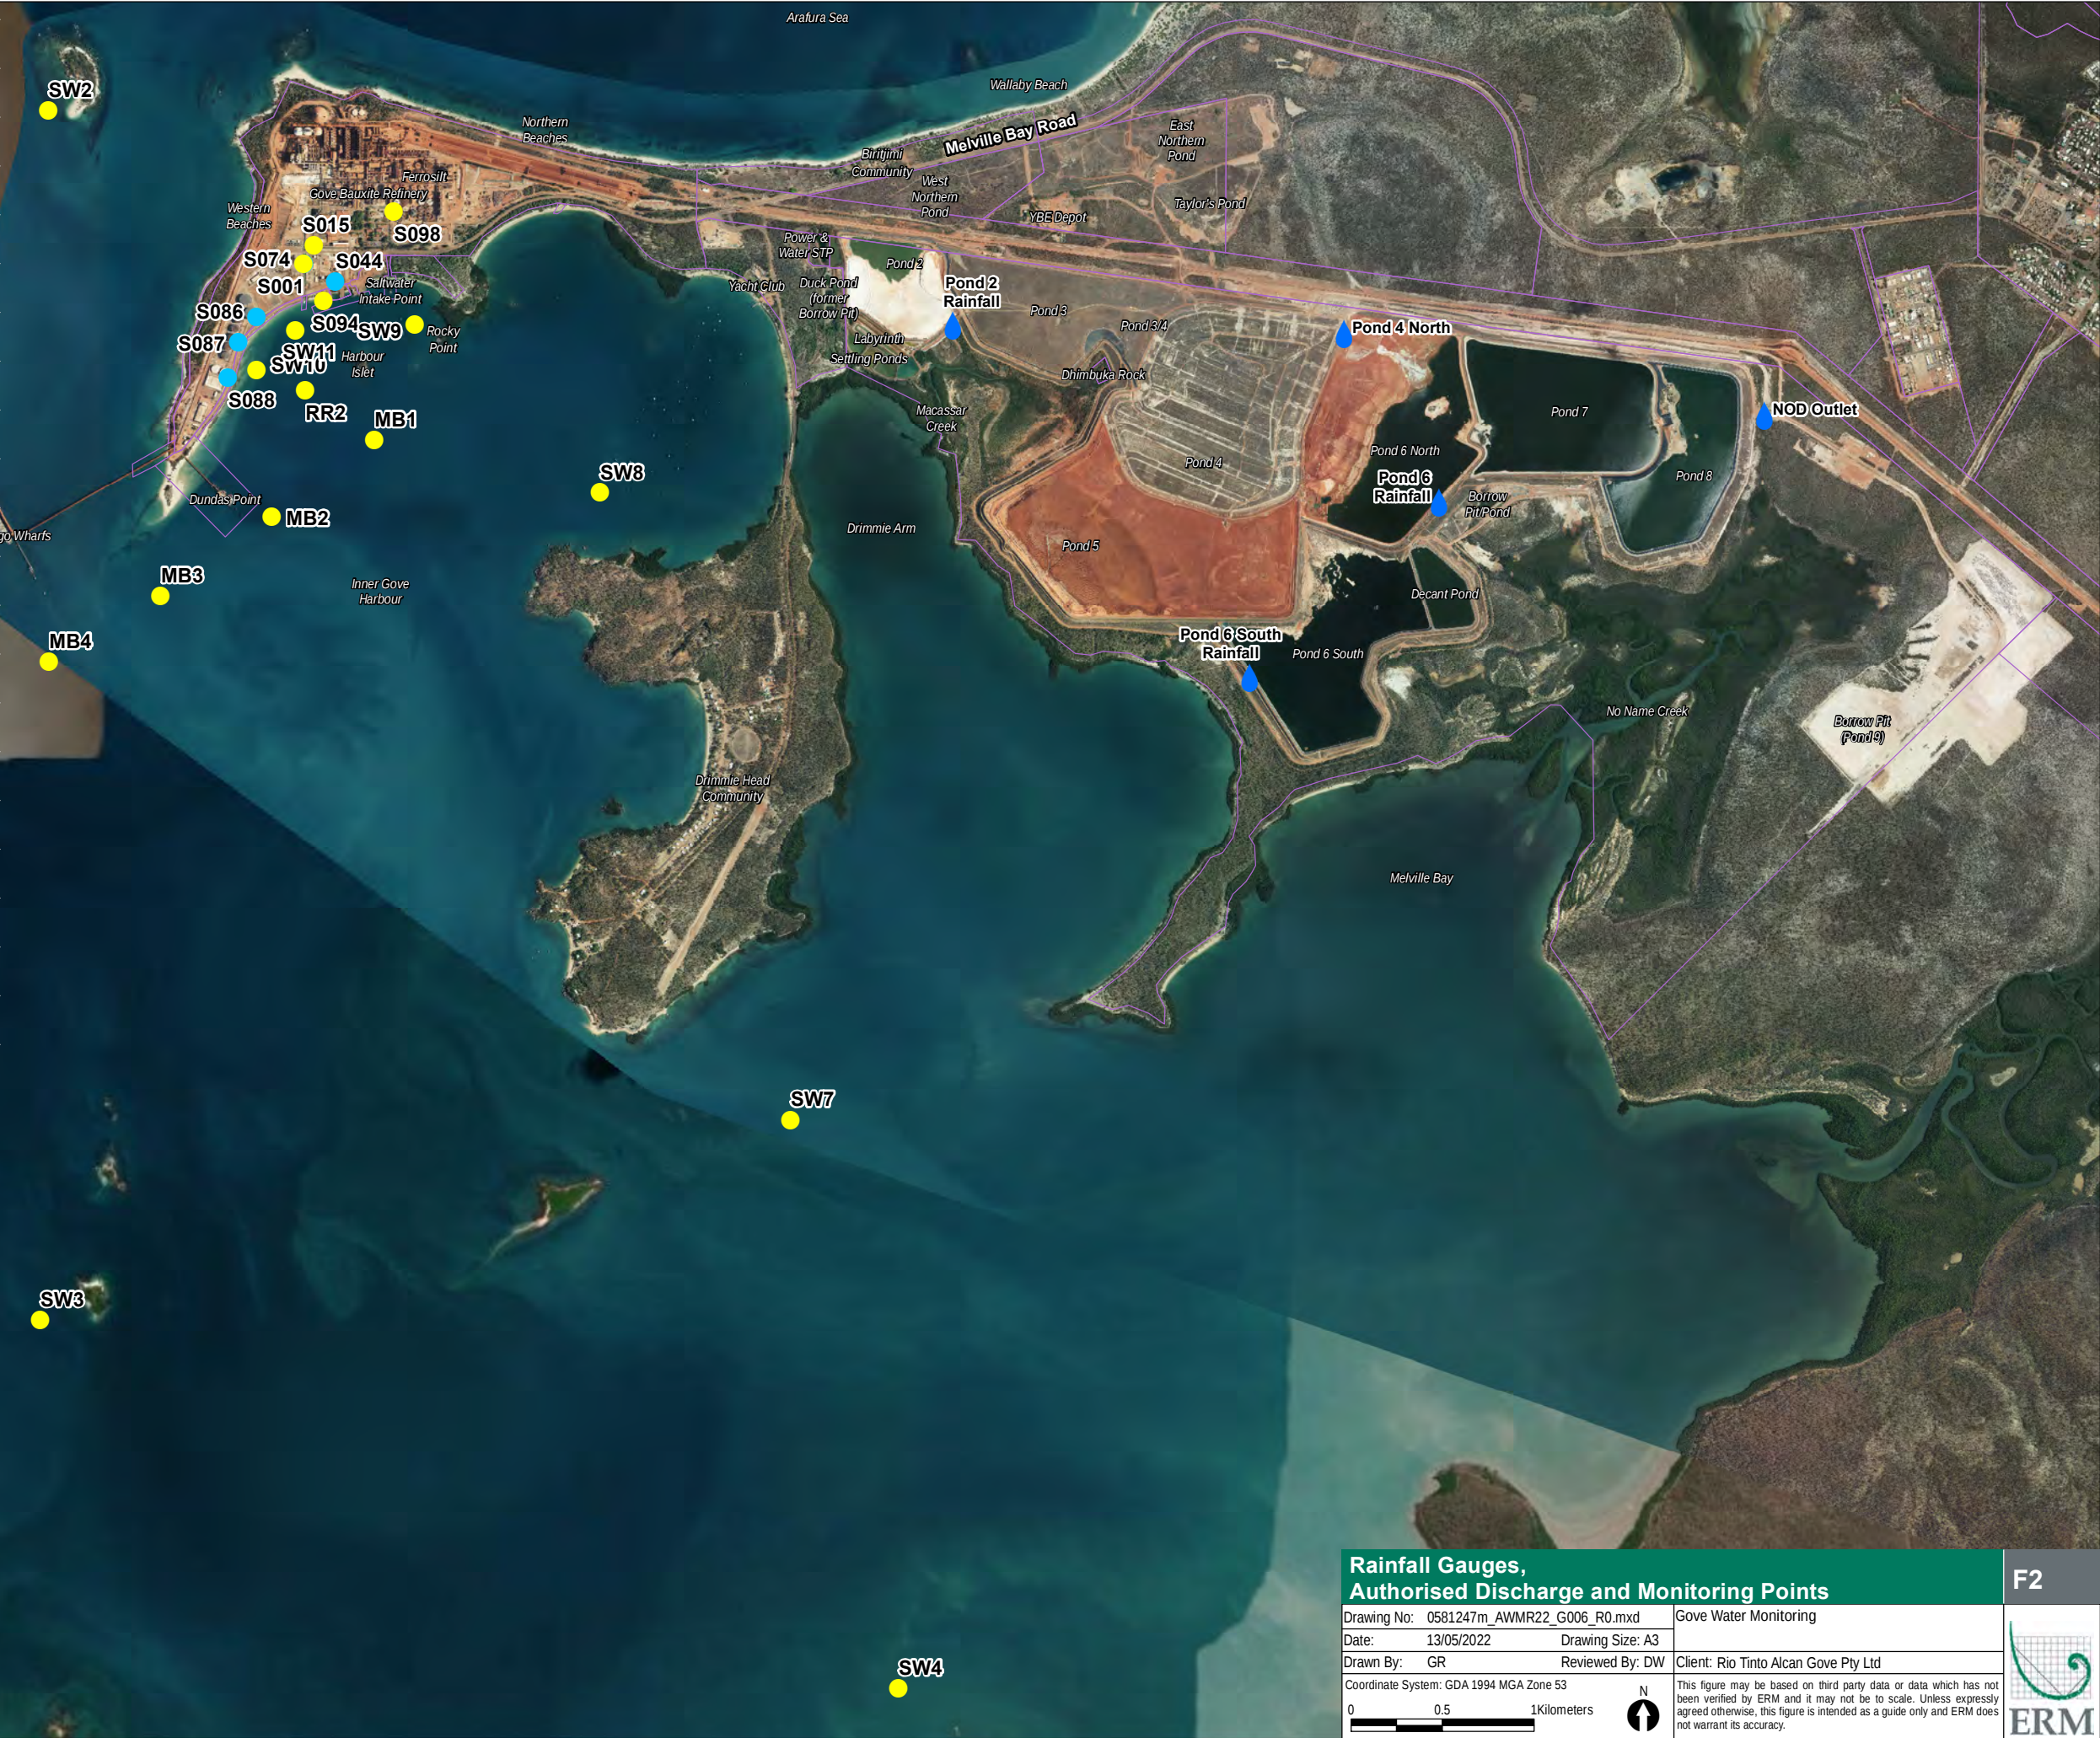
**Figure 2 – Rainfall Gauges, Authorised Discharge and Monitoring Points**

- Legend
- Rainfall Gauges
  - Authorised Discharge Point
  - Authorised Monitoring Point
  - Lease Boundaries

The locations of the Authorised Discharge Points and Authorised Monitoring Points / Compliance Points are shown on Figure 2, Appendix B.

Gove Operations currently operates five rainfall gauges around the RDA; the location of these are presented on Figure 2, Appendix B. These gauges collect rainfall at five minute intervals and are accessible via an online system for real time interrogation. Rainfall data from all gauges collected over the reporting period were downloaded and assessed for this report as average daily rainfall.

Locations of the Authorised Discharge Points and Authorised Monitoring Points are shown on Figure 2, Appendix B.
