NOTICE OF INTENT
for the NT EPA
for the
REHABILITATION OF THE FORMER RUM JUNGLE MINE
SITE
29 June 2016 v1.3

PREPARED AND SUBMITTED BY:
DEPARTMENT OF MINES AND ENERGY
NORTHERN TERRITORY GOVERNMENT

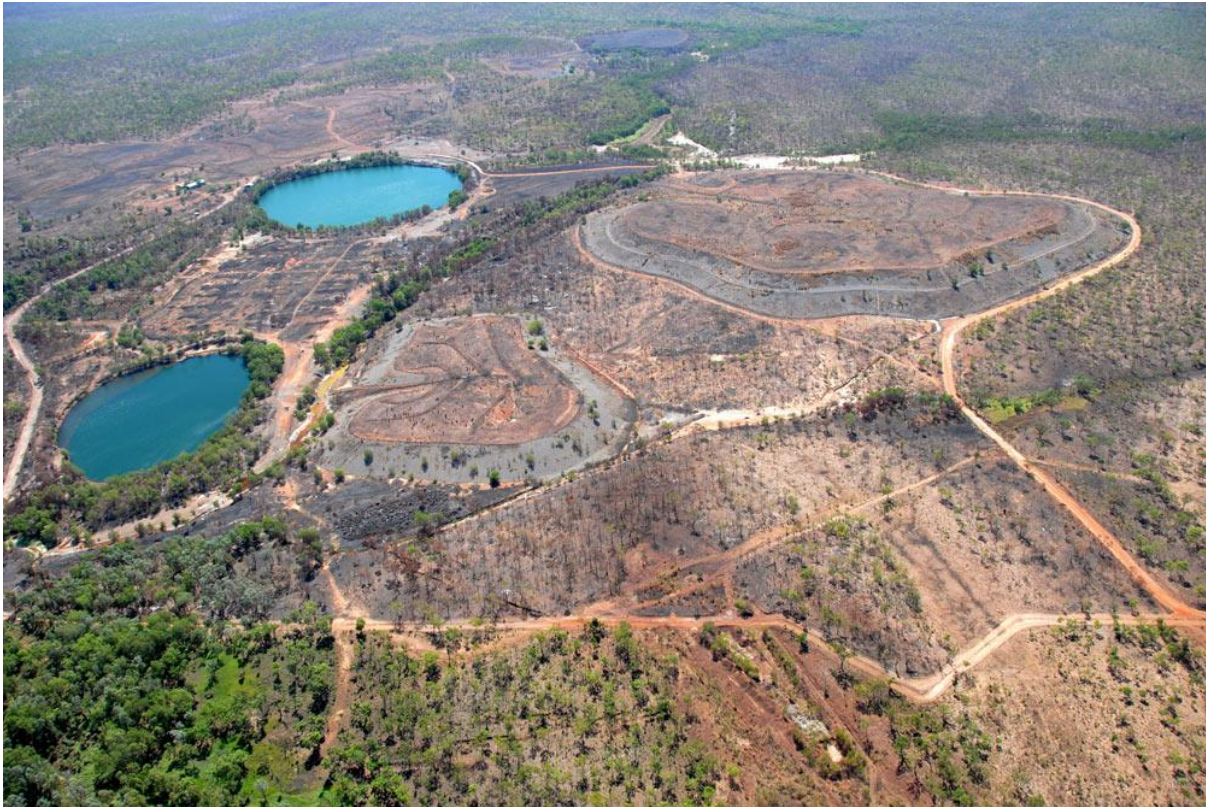
Plate 1 Aerial oblique view of Intermediate (foreground) and Main waste rock dumps, Intermediate (left foreground) and Main water filled pits

Plate 1, Plate 2, Plate 3 and **Plate 4** show current site landforms and visual evidence of impacted water and land.

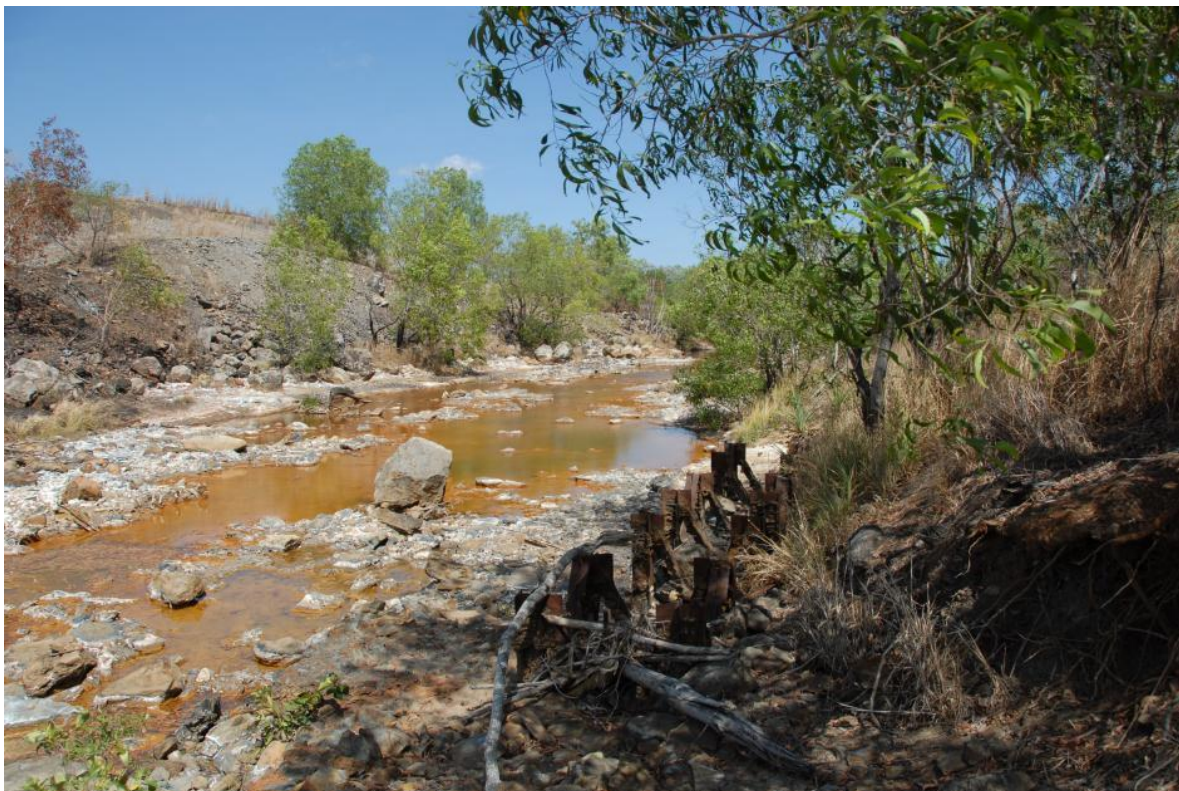
Plate 2 Salt efflorescence and seepage in the diversion channel at the toe of Intermediate waste rock dump, Rum Jungle (NT DME)

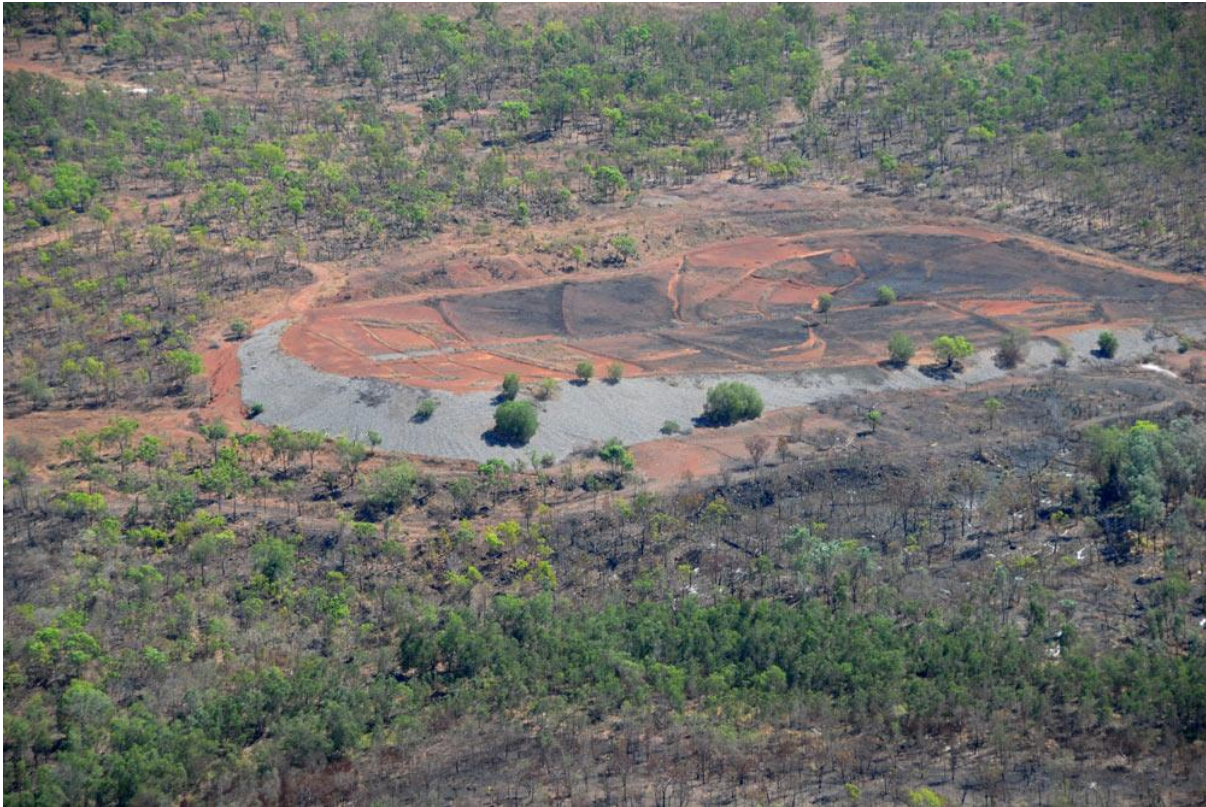
Plate 3 Aerial oblique view of Dysons backfilled pit, Rum Jungle (NT DME)

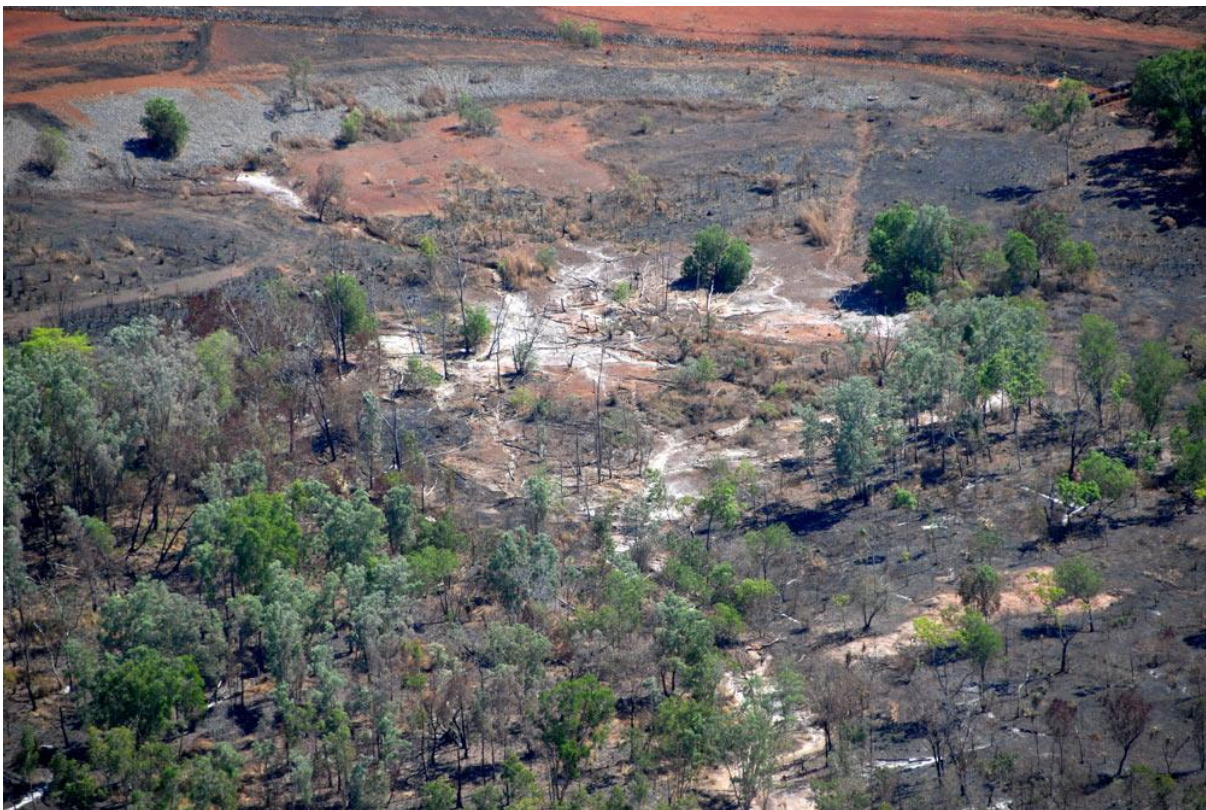
Plate 4 Salt efflorescence from seepage downslope of Dysons backfilled pit, Rum Jungle (NT DME)

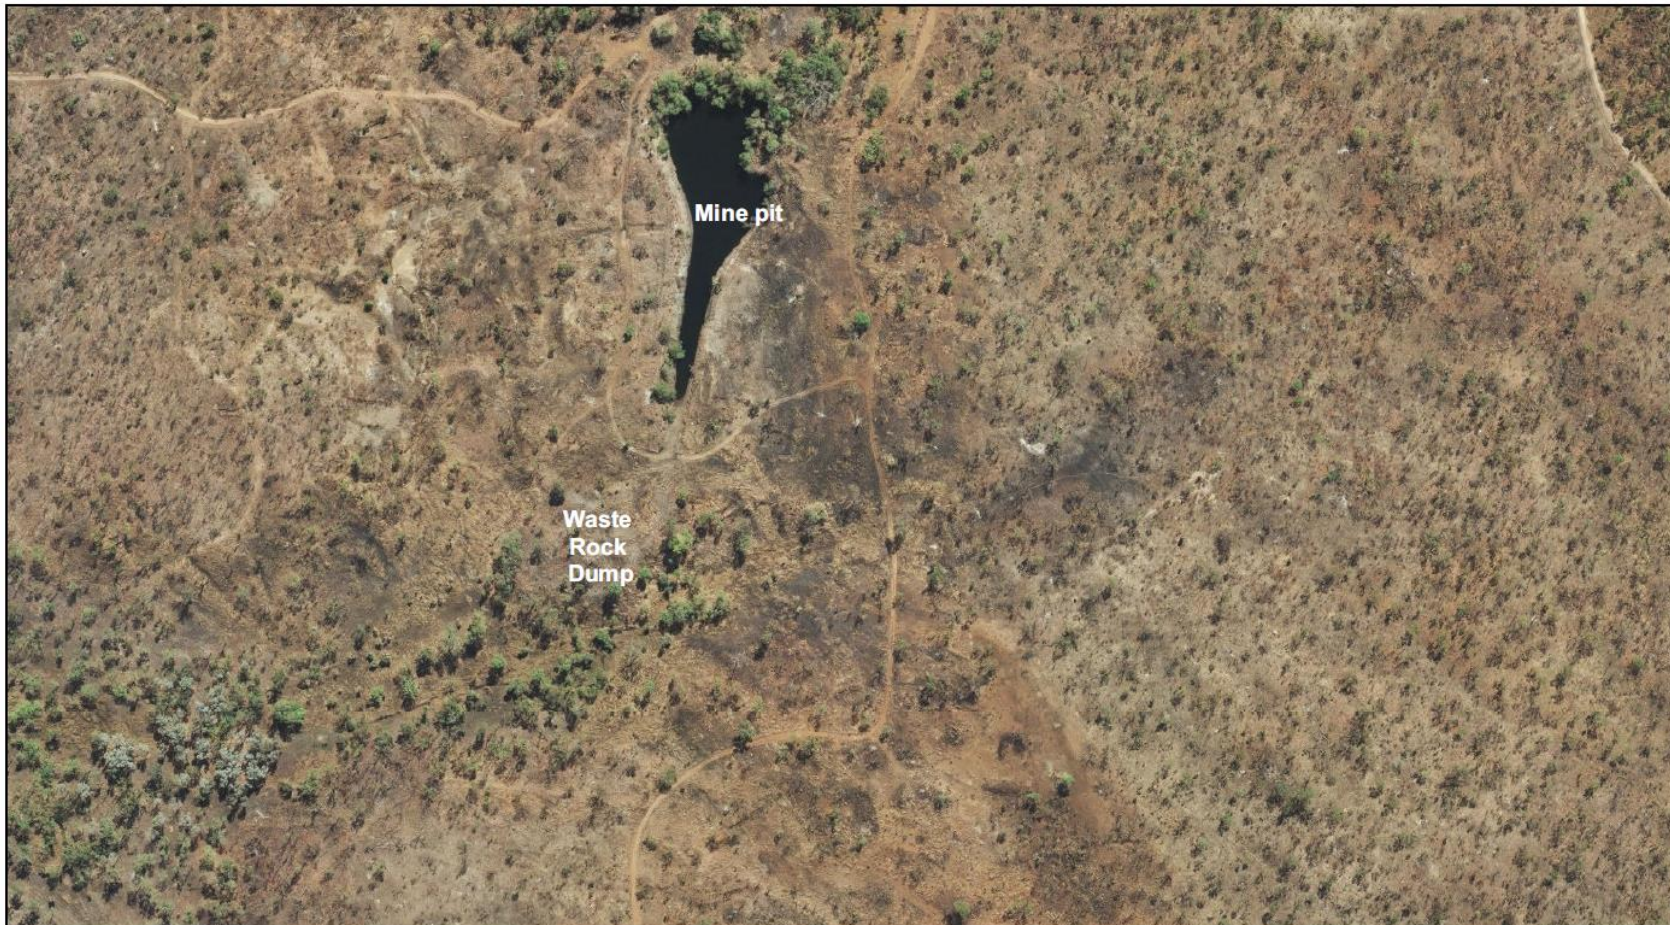
Figure 5 - Mount Fitch

The Mount Fitch site is approximately 3.5 kilometres northwest of Mount Burton mine on a low rise east of the Finniss River. In 1966, exploration drilling was carried out to a depth of 130 metres and a small open pit was excavated for process evaluation. However, the ore was not recovered and was left in the pit (Davy, 1975). A small overburden heap, covering 0.7 Ha is located directly south of the pit (see Figure 5). The pit itself was allowed to fill with water following completion of activities in 1969. Presently, the land on which Mount Fitch is situated is held by the Northern Territory as a form of Crown Lease. There has been no post-mining remediation of this site.
