# Visual Amenity 14

# 14 VISUAL AMENITY

EASTERN LEASES PROJECT

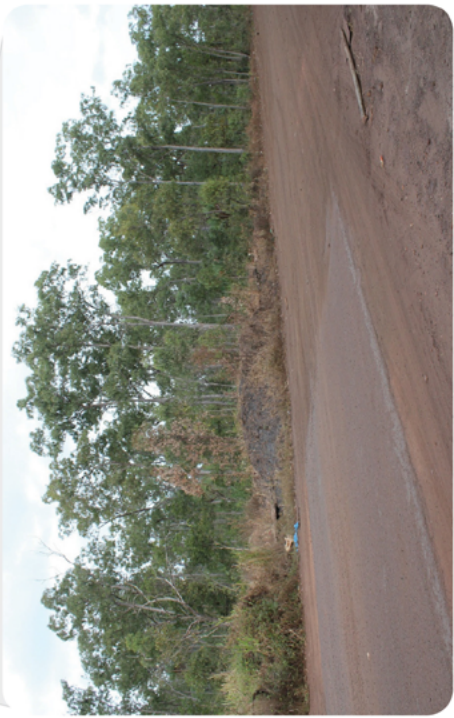
FIGURE 14-2

Line of Sight from R1 (Angurugu) to Project Site

View from Angurugu facing South-east towards Project Site

View from R1 (Angurugu) to the Project Site

- There is intervening topography (i.e. rocky outcrops and ridges), that would prevent any views of project elements from R1 (Angurugu) (Figure 14-2).
- There is intervening topography that would prevent any views of project elements from R2 (Yedikba) (Figure 14-3).
- There is intervening topography (i.e. rocky outcrops and ridges), that would prevent any views of project elements from R3 (Wurrumenbumanja) (Figure 14-4).

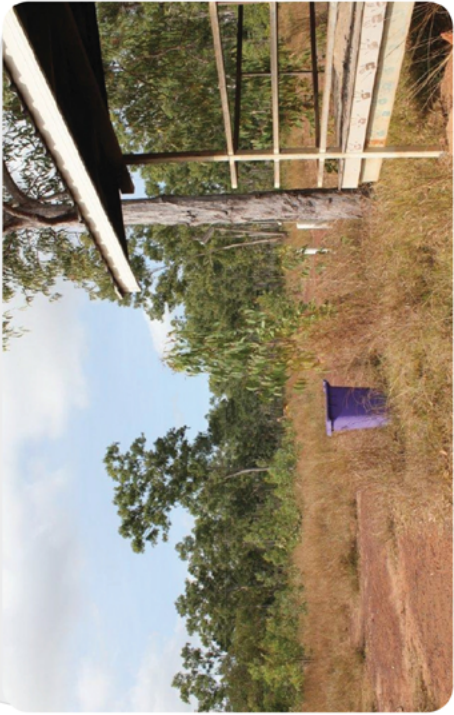
FIGURE 14-3

Line of Sight from R2 (Yedikba) to Project Site

View from Yedikba facing East towards Project Site

View from R2 (Yedikba) to the Project Site

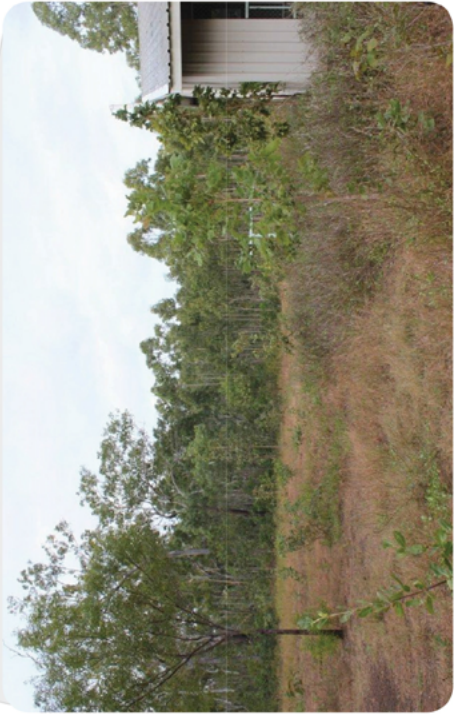
FIGURE 14-4

Line of Sight from R3 (Wurrumenbumanja) to Project Site

View from Wurrumenbumanja facing North-east towards Project Site

View from R3 (Wurrumenbumanja) to the Project Site

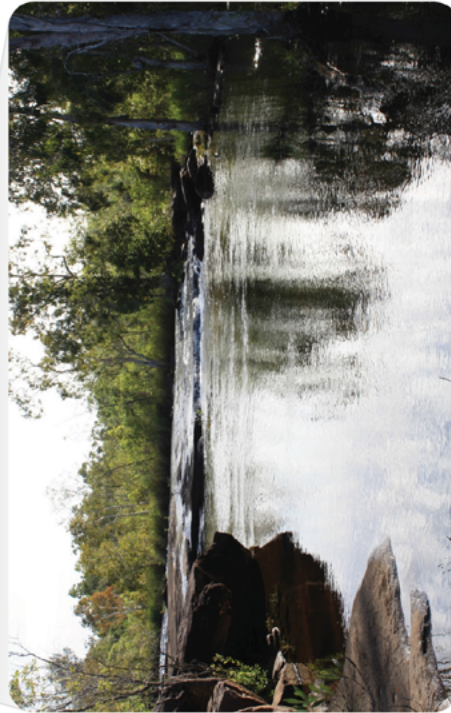
**FIGURE 14-5**

Line of Sight from R4 (Leske Pools Swimming Hole) to Project Site

View from Leske Pools Swimming Hole facing North towards Project Site

View from R4 (Leske Pools Swimming Hole) to the Project Site

- There is dense vegetation surrounding R4 (Leske Pools Swimming Hole), which would block views towards project elements (Figure 14-5).
- There is intervening topography (i.e. rocky outcrops and ridges), that would prevent any views from the lookout at the Wurruwarrkbadenumanja cave paintings (Figure 14-6).

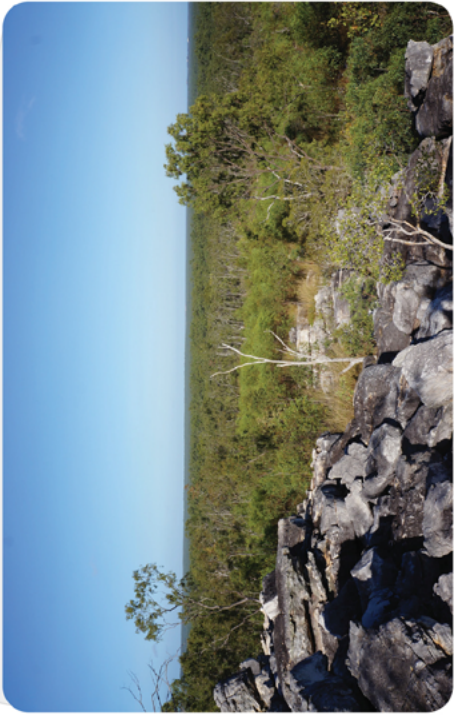
Line of Sight from Lookout at Cave Paintings to Project Site

General View from Lookout at Cave Paintings facing toward the Southern Side of Groote Eylandt

View from Lookout at Cave Paintings (Wurruwarrbadunumanja) to the Project Site
