**ARCHAEOLOGICAL SURVEYS FOR  
THE PROPOSED EAST POINT OUTFALL AUGMENTATION  
PROJECT DARWIN, NT**

**A Report for the Power and Water Corporation**

September 2009

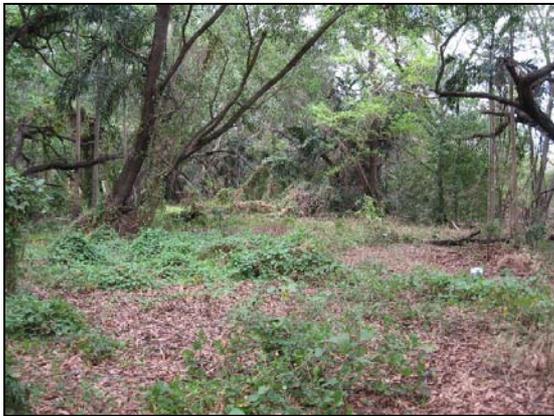
**Monsoon forest near creek**

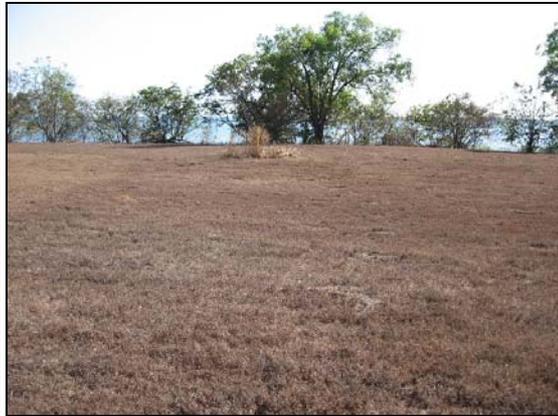
During construction the disturbed area will vary in width, with a minimum of 10-15 metres through existing vegetation and up to 20 metres in cleared areas. At the end of East Point, next the shoreline will be the lay-down area for equipment, pipes etc and the disturbance area there is expected to be approximately 100 x 100 metres.

**Proposed laydown area**

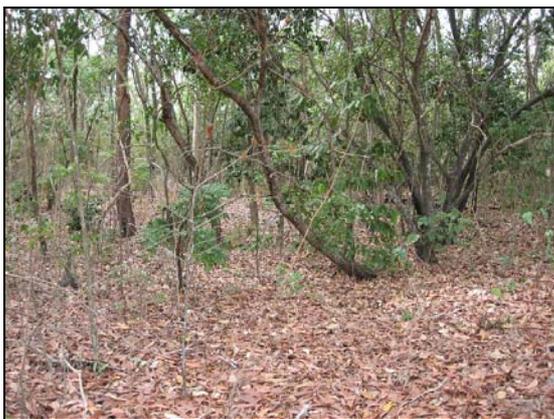
**Edge of vine forest**

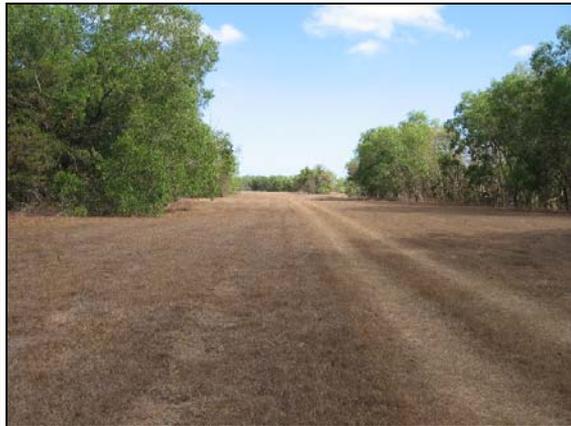
The surface along the entire length of the proposed rising main has been previously disturbed. The northern section of the proposed rising main corridor runs across areas of cleared corridors through vine forests that are now mown areas. There were several isolated small pockets of vine forests within the cleared areas surrounding large trees. Surface visibility on the grass areas was less than 5% as was the surrounding vine forests. There were only a few locations where the 20m wide corridor may infringe upon the vine forests. These were examined in greater detail and it appears that these areas had also been disturbed in the past

**Cleared corridors through vine forest**

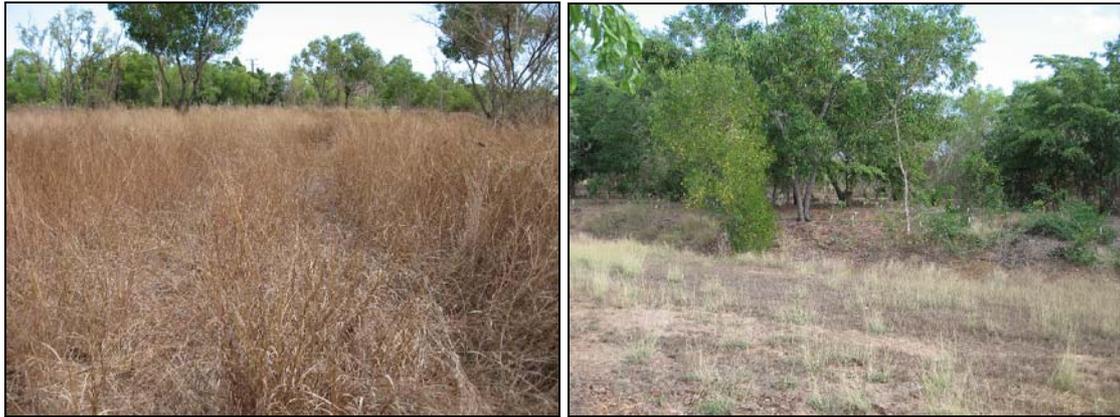
with signs of grading. Behind the picnic area the surface has been either disturbed by trenches, clearing activities or by recent revegetation in the vicinity of the mangrove board walk. Surface visibility was 30-40% in these areas except for surfaces covered in Mission Grass. The area south of the Lake Alexandria has either been completely cleared by grading or is covered in dense grass over silty soils. This area appears to have been used as a dumping ground in the past, as has another area of vine forests behind the house blocks and the old oval. The route next to the pumping station has also been highly disturbed with sections near a small freshwater creek covered in monsoon forests and surface visibility was again very poor.

**Grass covered area**

**Disturbed and re-vegetated area**

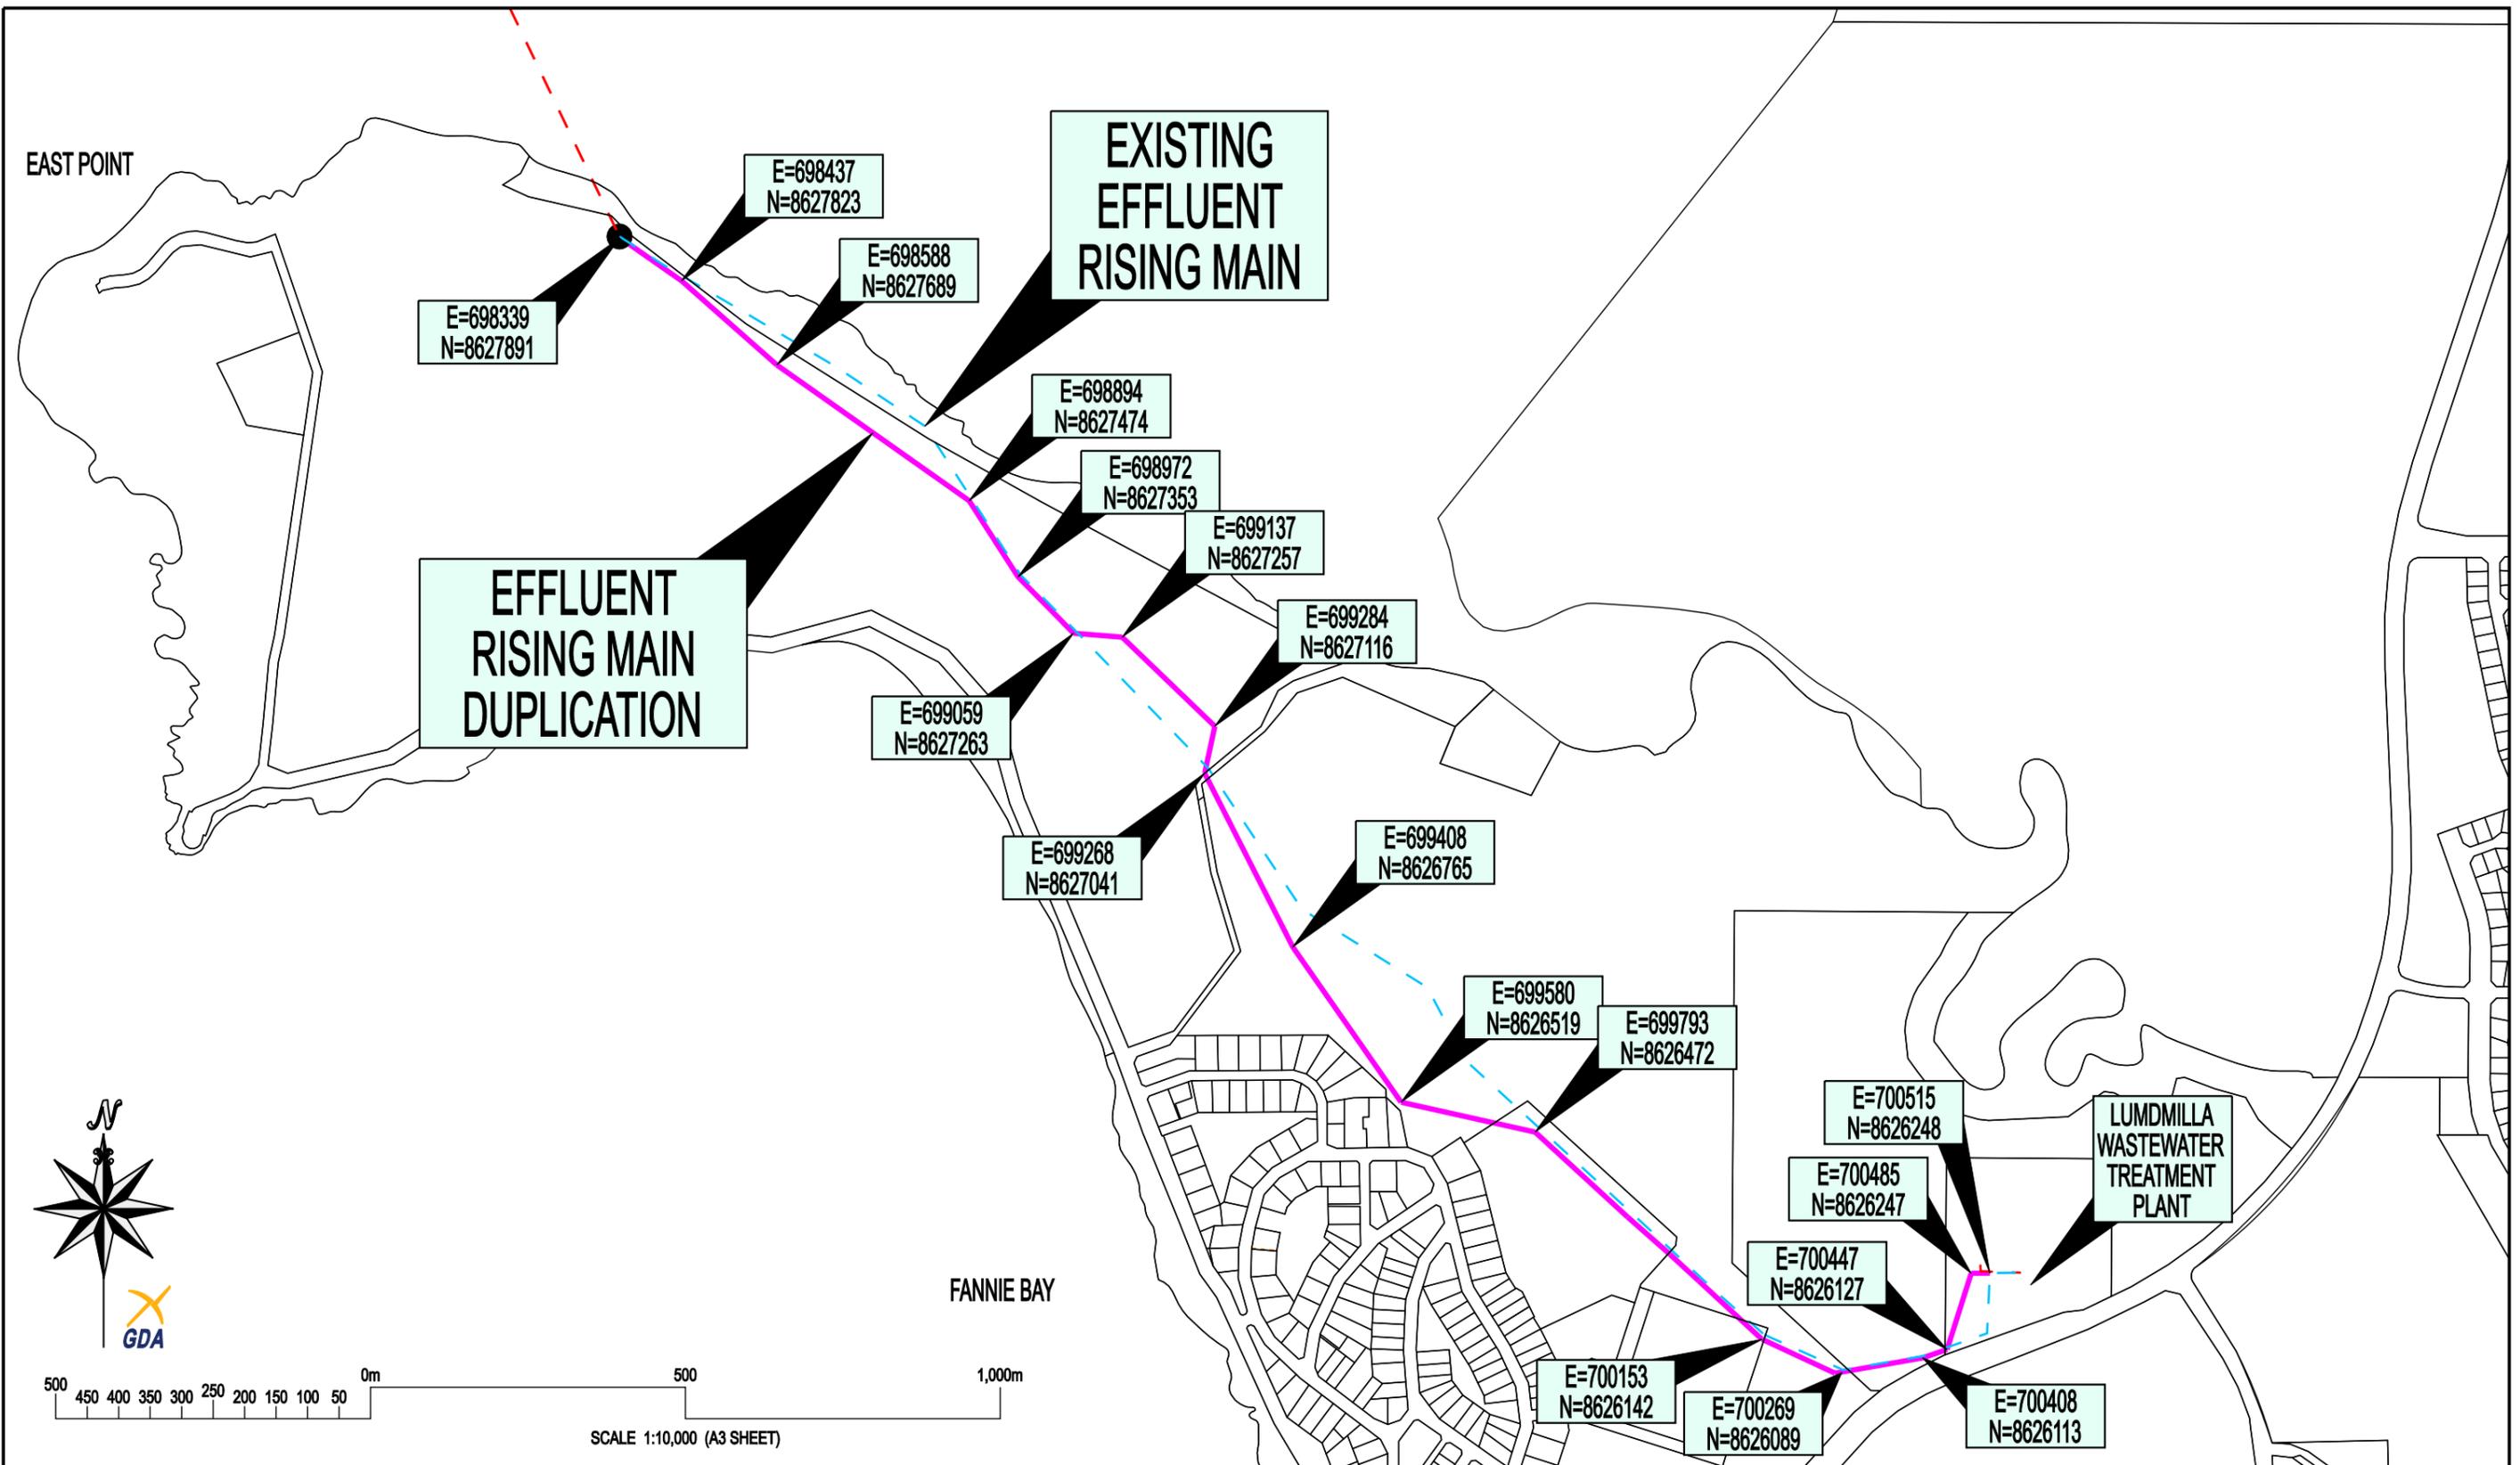
**DARWIN SEWERAGE SYSTEM  
EAST POINT RISING MAIN DUPLICATION  
LOCATION DIAGRAM**

The proposed corridor is approximately three kilometres over land and 3 kilometres under water. The approximate alignment is shown in Figures 1 and 2. Some sections of the proposed corridor is over the existing rising main. The exact location of the new infrastructure is dependent, in part, on the results of this investigation.
