REVIEW OF THE McARTHUR RIVER MINE OPEN CUT PROJECT PUBLIC ENVIRONMENTAL REPORT

By
Professor Wayne D. Erskine
Centre for Sustainable Use of Coasts and Catchments
School of Environmental and Life Sciences
University of Newcastle – Ourimbah Campus
PO Box 127
Ourimbah NSW 2258

July 2006

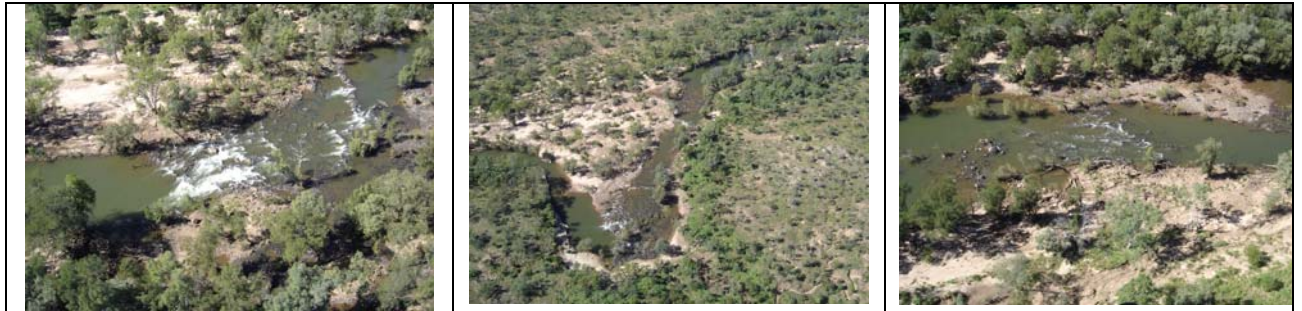
Figure 1. Bedrock exposed in the bed of the main channel in the upstream anabranching reach. (W.D Erskine photographs).

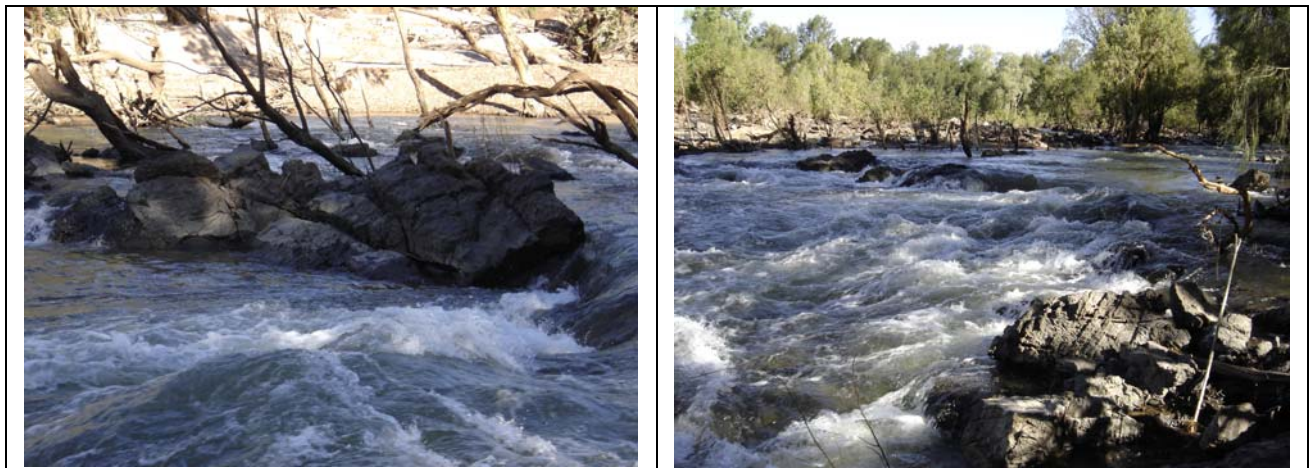
Erskine (2006) expressed concern at the magnitude of the specific stream power/shear stress on the McArthur River under natural and diverted conditions. Erskine (1999) found that when specific stream power exceeds 35 W/m^2 , sand-bed channels usually erode. On the McArthur River, specific stream power often exceeds 80 W/m^2 and hence the channel should be either a very active sand-bed stream with many pockets of rapid bank erosion or contain long sections of channel protected by extensive bedrock bars exposed in the channel boundary. URS (2006) point out that the high specific stream powers calculated under natural conditions occurred where bedrock was exposed in the channel or where some large-scale flow restriction was present. I agree with this assessment following the aerial and on-site inspections of the McArthur River. Figure 1 shows some of the many bedrock bars that are present in the upstream anabranching reach. Figure 2 shows the extensive, steep bedrock rapids at the downstream end of Djurinmini Waterhole. Many trees have had their trunks snapped by the high shear stresses experienced on these rapids and most trees have a marked downstream lean.

Figure 2. Steep bedrock rapids downstream of Djirinmini Waterhole showing downstream leaning trees and snapped tree trunks. (W.D Erskine photographs).

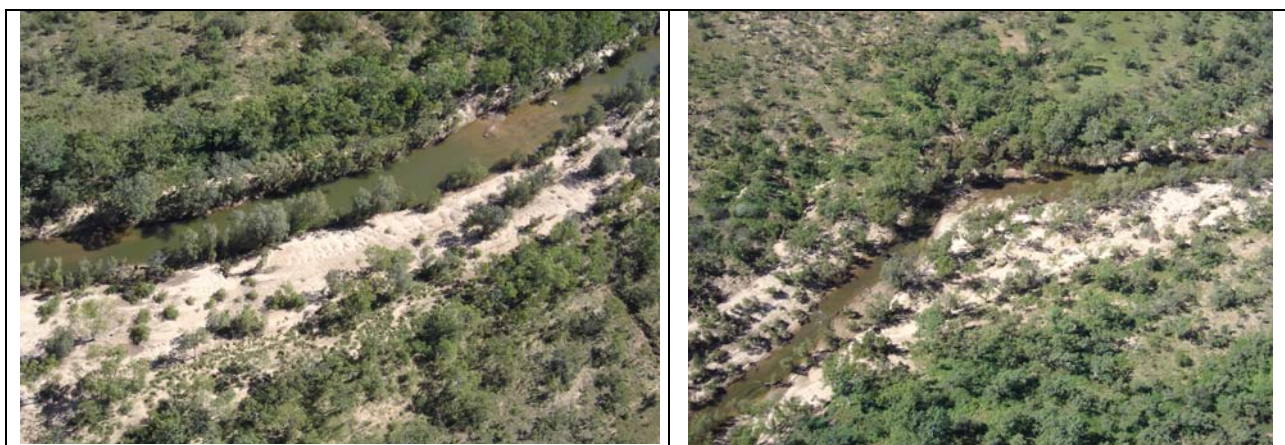
Figure 3. Sand deposits in the channel of the upstream anabranching reach of the McArthur River. (W.D. Erskine photographs).

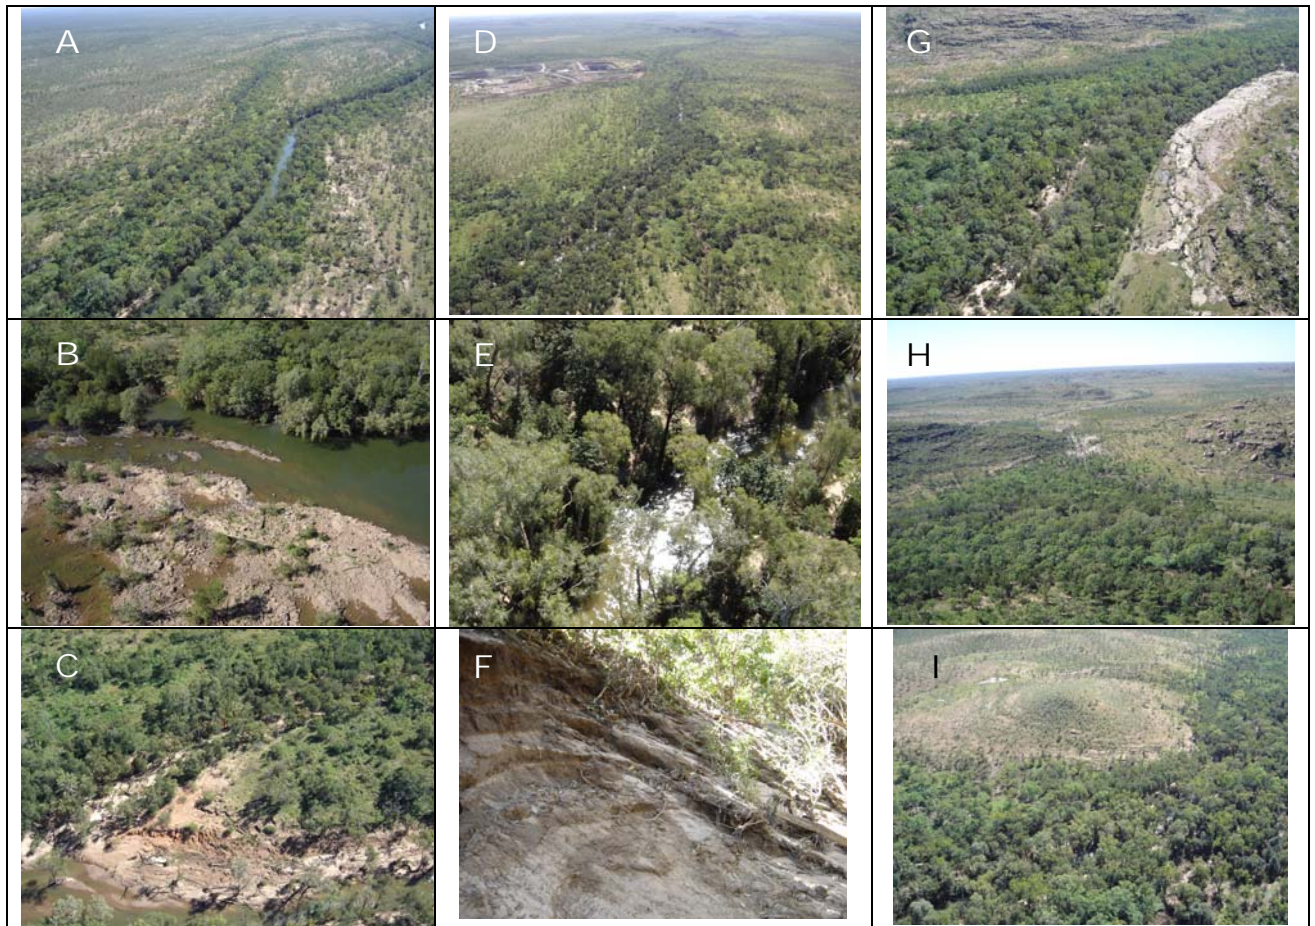
Figure 4. (A) Upstream anabranching reach showing the deep main channel and shallower anabranches on the wide floodplain. (B) One of the numerous bedrock bars in the river bed of the main channel of the anabranching reach, which were not mentioned in the Draft EIS (URS, 2005a). (C) One of the occasional examples of bank erosion present in the anabranching reach, which were not mentioned by URS (2006). (D) The low sinuosity mine reach next to the test pit. (E) Run which is the dominant channel unit in the low sinuosity mine reach. (F) Steeply channel-dipping, intercalated mud and sand units which have been obliquely accreted on the channel banks of the low sinuosity mine reach. (G) Well-vegetated Bukalara bedrock-confined reach downstream of the mine. (H) Another example of a well-vegetated section of the Bukalara bedrock-confined reach (I) Bedrock mound beside the channel in the Bukalara bedrock-confined reach. Such mounds also occur on the floodplain in the upstream anabranching reach (All photographs by W.D. Erskine).

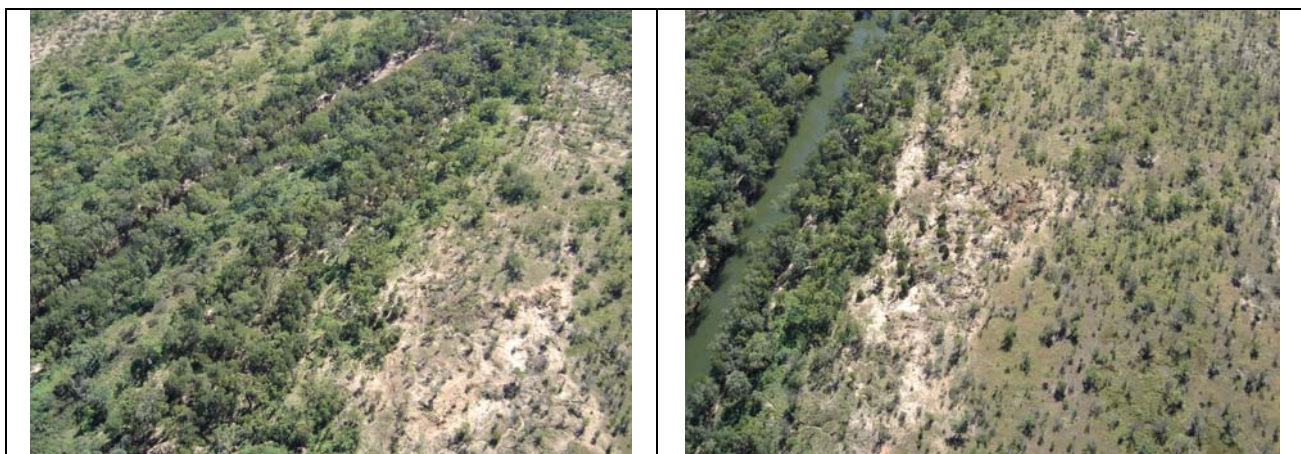
justify calling the existing channel near the mine as stable (see URS, 2005a, Appendix K, p. K-24). The representativeness of a single piece of site specific data is always a concern. By itself, it is not helpful. As noted in URS (2006), aerial inspection of the upstream anabranching reach revealed numerous bedrock bars in the bed of the main channel and occasional sections of bank erosion (Figure 4C). Furthermore, high parts of the floodplain were also eroded by rilling and gullying and appeared to be associated with overgrazing of dispersible/slakeable soils (Figure 5).

Figure 5. Natural levees in the upstream anabranching reach eroded by rilling and gullying of dispersible/slakeable soils (W.D. Erskine photographs).

The time needed for plant establishment will be relatively long in this strongly seasonal climate. Dispersible sediment may also cause major erosion problems. Therefore, it is essential that annual inspections of the diversion channel are conducted at least until riparian vegetation is well established.

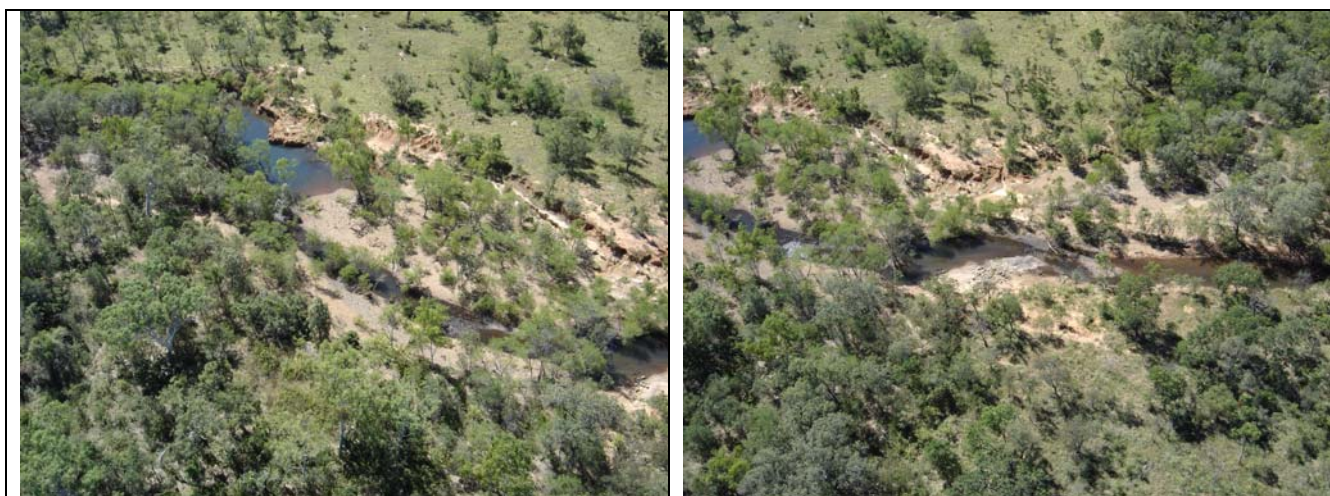
The design of the Barney Creek diversion channel has been modified since the Draft EIS and its Supplement (URS, 2005a; 2005b). The fluvial geomorphology and aquatic habitats of Barney and Surprise creeks are discussed in Sections 5.3 and 5.4, respectively of the Public Environmental Report (URS, 2006). Significantly, field inspections have established that the lower section of Barney Creek is often backwater-affected by the McArthur River, as evidenced by its channel morphology and the perched nature of the channel bed of Barney Creek above the main stream. Furthermore, there are many bedrock outcrops in the channel and gravel lag deposits. Nevertheless, there are extensive areas of bank erosion, pool scour and flood chute development on Surprise Creek (Figure 6). These indicate that Surprise Creek is not as stable as Barney Creek and responds to floods.

Figure 6. Bank erosion, pool scour and flood chute development on Surprise Creek. (W.D. Erskine photographs).

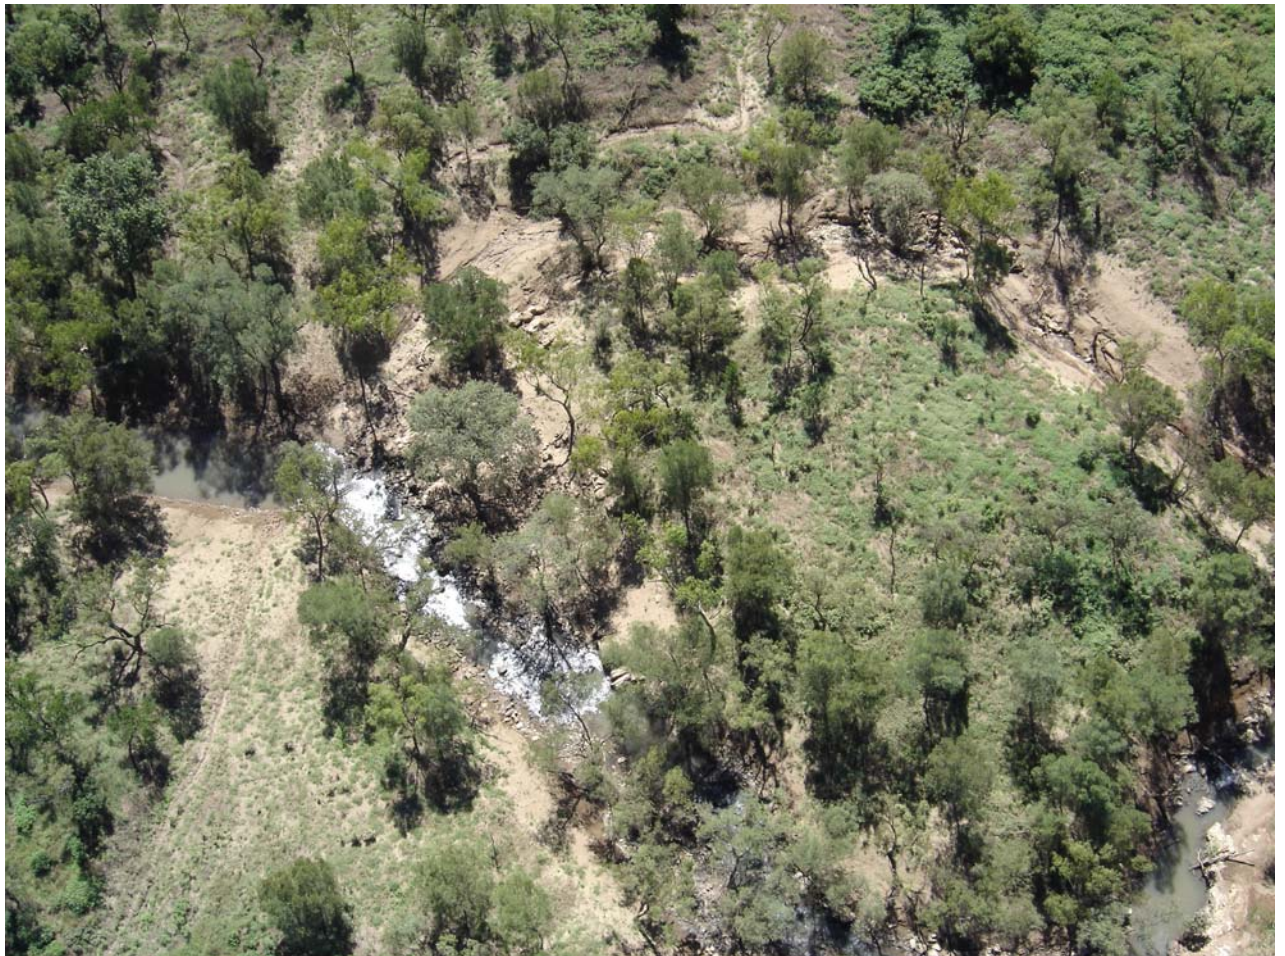
Figure 7. Flood chute and low flow channel on lower Barney Creek downstream of the Surprise Creek junction. (W.D. Erskine photograph).

The Public Environmental Report (URS, 2006) has largely addressed all of the issues that I raised in my earlier report (Erskine, 2006). To ensure that the Barney Creek diversion channel functions as designed, it is essential that annual inspections of the diversion channel are undertaken until riparian vegetation has been re-established. This will take at least 10 years. The frequency of inspections can be reduced thereafter.
