Site Audit Statement

Site audit statement no. **ALC_1**

Title **Site Audit Report ALC_1 by Dr Ian Swane, Remediation of Asbestos Contamination at the former Bartalumba Bay Homestead Site, Groote Eylandt, Northern Territory 0822**

LONG-TERM ENVIRONMENTAL MANAGEMENT PLAN FOR CONTAMINATION RISKS AT THE FORMER BARTALUMBA BAY HOMESTEAD SITE

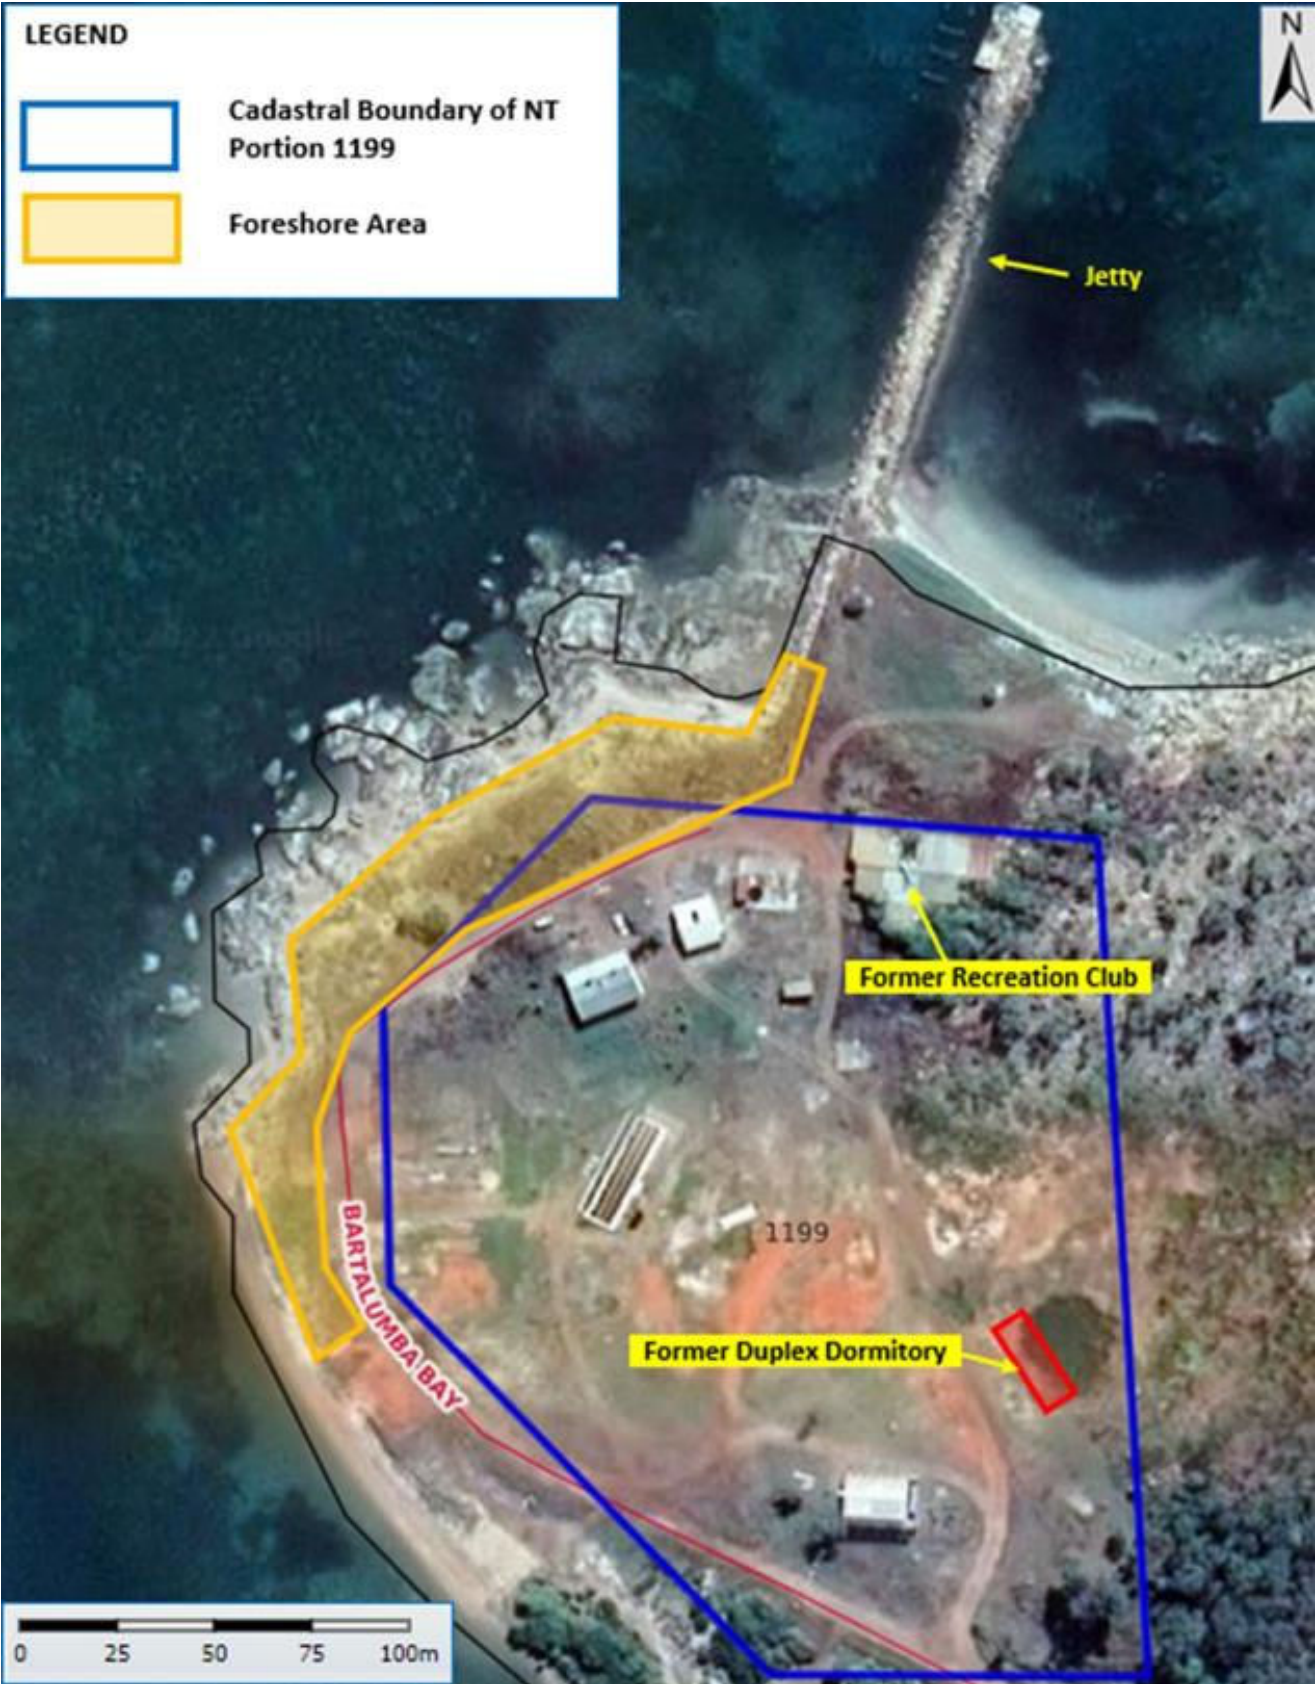
Figure 2 2022 Site Layout

- a) The purpose of this long-term environmental management plan (**LTEMP**) is to provide protocols for managing presently unknown asbestos or other types of contamination that may remain at the former Bartalumba Bay Homestead site (**Homestead Site**), Bartalumba Bay Road, Groote Eylandt, covering 31.11ha of land legally defined as NT Portion 01199 plan(s) B 000517. A location plan for the Homestead Site is provided in **Figure 1**, with layout plans for 2022 and 2023 provided in **Figures 2** and **3**, respectively.
