Environmental Audit Report

Yelcherr Gas Plant, Northern Territory

13 October 2023

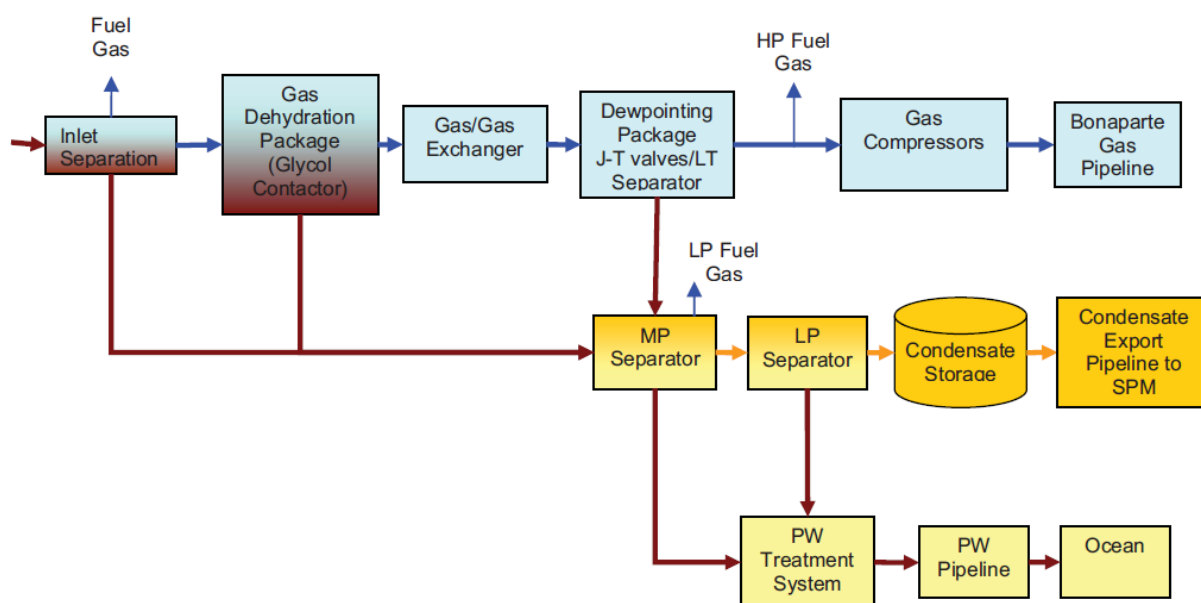
1. An onshore gas processing plant consisting of separation, gas dehydration, compression, condensate storage, ground flare, produced water treatment facilities and subsequent wastewater discharges;
2. A wastewater irrigation field, storm water infrastructure and groundwater monitoring bores;
3. An 18" carbon steel, multi-phase pipeline utilised for importing produced fluids from the offshore gas field;
4. A condensate offtake line from the condensate storage facilities to the Single Point Mooring (SPM) location offshore; and
5. A processed gas export pipeline and custody transfer meter located at the premises boundary.

Figure 1: YGP Process Diagram
(from: Onshore Gas Plant Environmental Management Plan, 29 November 2010)
