## **Gove Peninsula Waste Management Facility**

### **Leachate, Surface Water, Groundwater and Landfill Gas Monitoring Report 2021**

| Report No.: | 115005_REO_007_REV A |

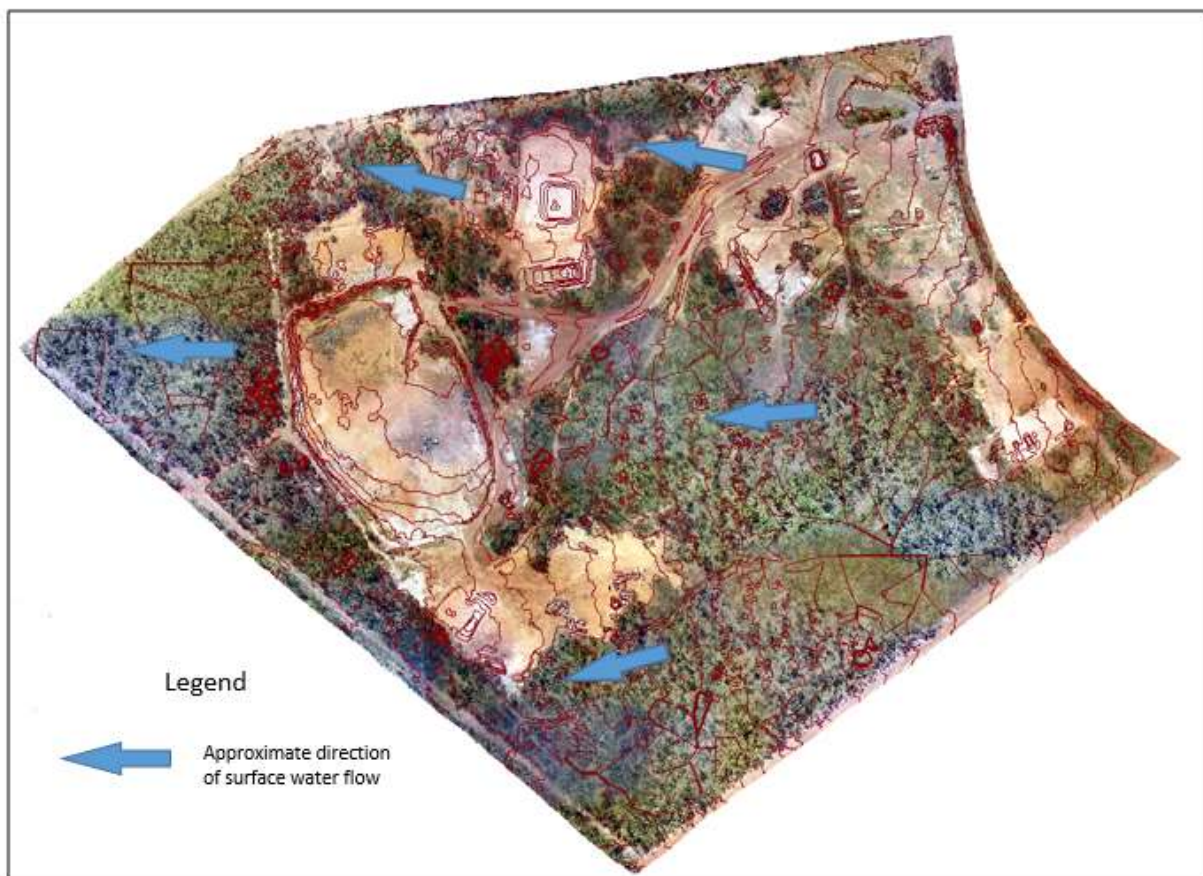
**Figure 2: Inferred direction of surface flows and DSM at Gove Peninsula Waste Management Facility**

Water flow is expected to occur during the wet season as either sheet flow or subsurface water flow, and due to the lack of erosional features or channels is expected to slow, with high percentage of infiltration. The surface water flow direction has been inferred using recent Digital Surface Mapping (DSM) undertaken during the drilling program and baseline groundwater sampling conducted in July 2016. The inferred surface water flow direction is expected to travel in an east to west direction as shown by the direction of surface flows and the DSM is shown in **Figure 2**.

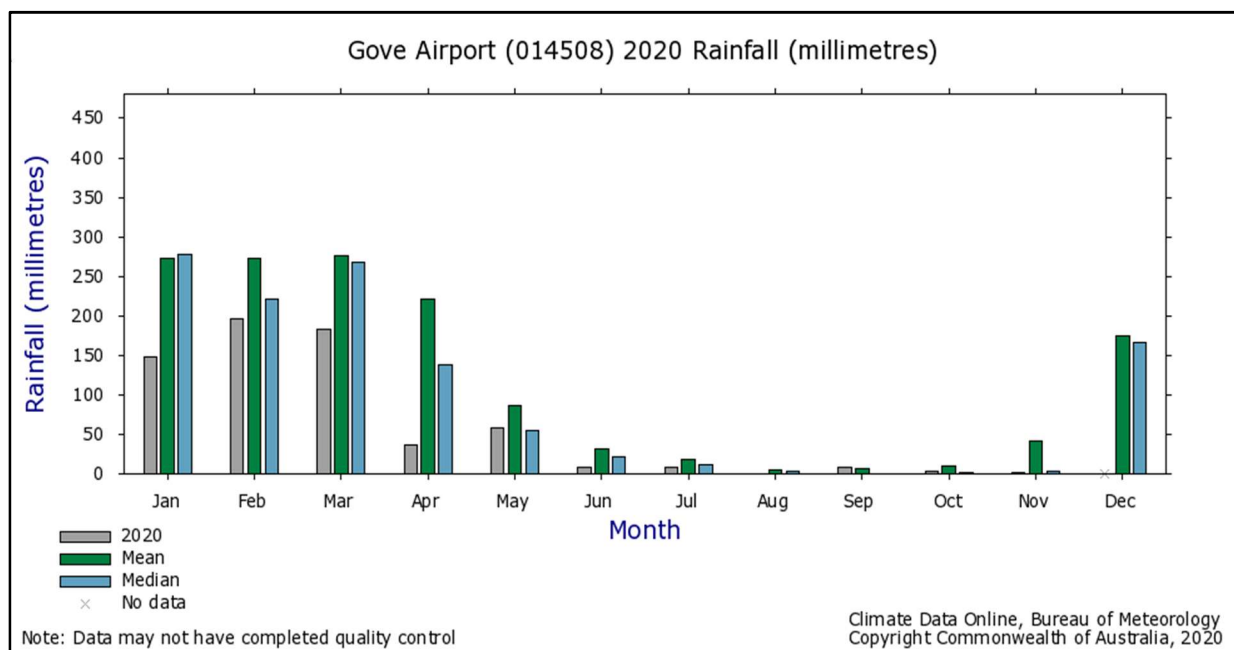
**Figure 3a: Rainfall Data 2020 at Gove Airport**

During 2020 the Northern Territory had a second season of below average rainfall, immediately following a dry 2018-19 wet season. Territory-wide, rainfall was 20% below the long-term average. Only a few parts of the eastern NT saw average or above average rainfall for the wet season. The north-western, the far north, and the south-western NT, had seasonal rainfall totals in the lowest 10% of historical records since 1900. The primary climate driver responsible for the low rainfall was the near-record strong positive Indian Ocean Dipole (IOD) which dominated Australia during the second half of 2019. The positive IOD contributed to the late monsoon onset of 18 January, 3 weeks later than average. Following this initial monsoon activity, two other relatively weak and short-lived monsoon bursts were observed, contributing to moderate widespread rainfall over the NT. Below average tropical low/cyclone activity during 2019-20 also contributed to the relatively dry conditions (BOM 2020).

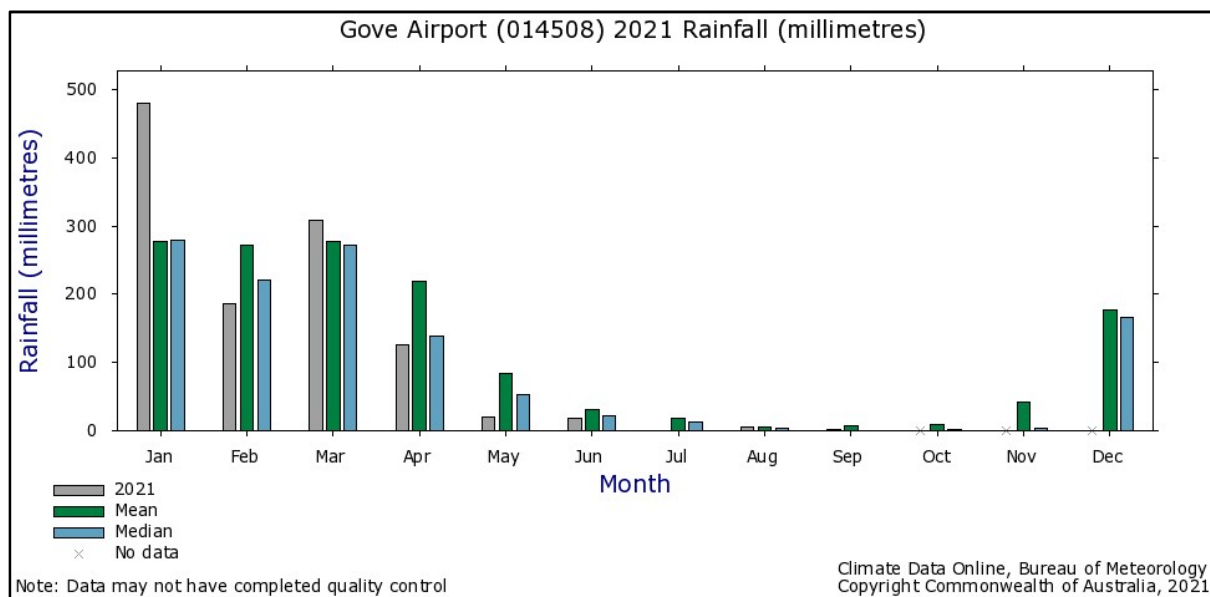
**Figure 3b: Rainfall Data 2021 at Gove Airport**

Rainfall totals during the wet season were generally above average; Territory-wide, rainfall was 21% above the long-term average, and the highest since the wet season of 2016-17. Four of the 7 months of the wet season saw above average rainfall across the Territory, starting with an unusually wet October (2020) as La Niña became established in the Pacific Ocean. A relatively dry start to January 2021 was followed by a monsoon burst late in the month, although rainfall was 20% below average overall for the month.

Monsoonal conditions continued into early February, leading to above average rainfall. While rainfall in the northern half of the Territory was below average during March, tropical low activity affected southern and western areas, leading to slightly above average rainfall for the month. The final month of the wet season saw mostly dry conditions during April, with no monsoonal activity affecting the Territory.

These results are consistent with the above average rainfall described by BOM during the 2020-2021 Monsoonal periods. Previous years were affected by both the Indian Ocean Dipole and neutral to slightly positive El nino weather patterns experienced at Gove however conditions returned to La nina influences across the NT. As the climate predictions are for a La Nina event the 2021-2022 monsoon is expected to provide a level of rainfall replenishing the groundwater reserves and potentially, depending upon the local rainfall recorded – returning groundwater levels to 2016 equivalences.

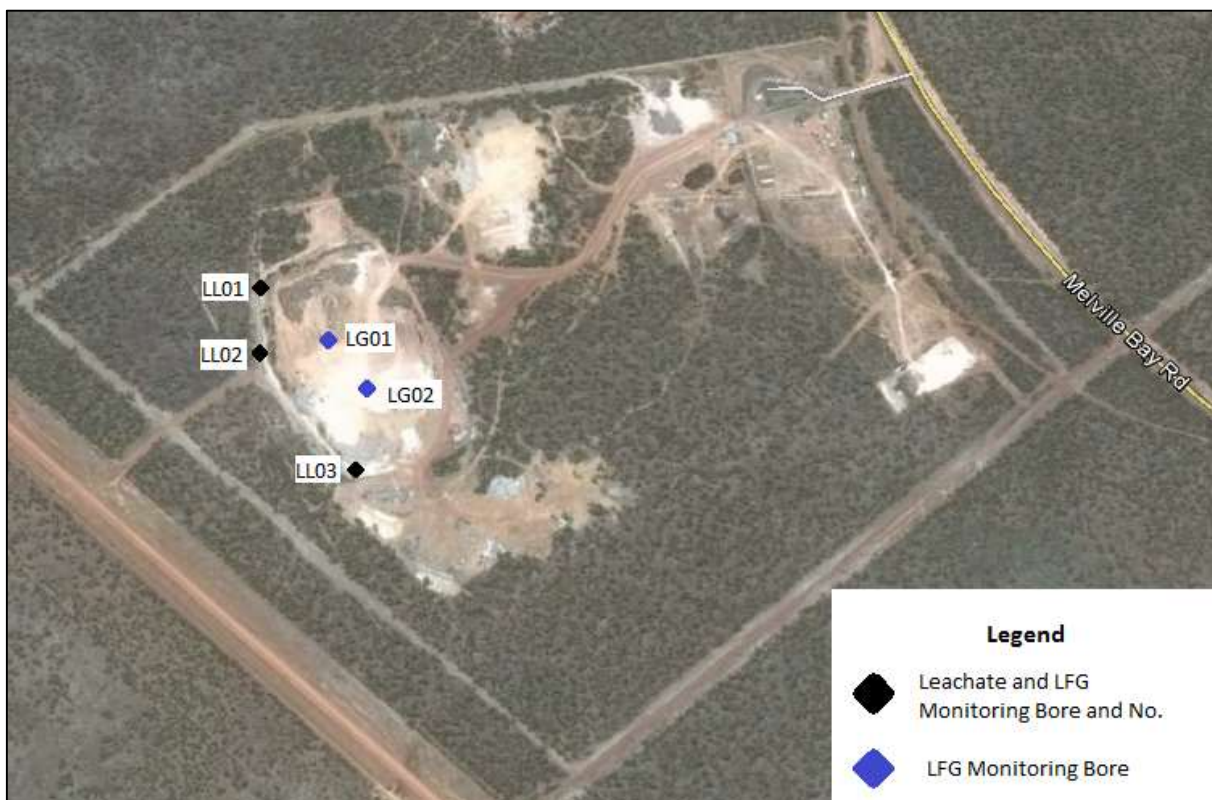
**Figure 4: Landfill Gas Monitoring Bores installed at Gove Peninsula Waste Management Facility.**

The dedicated Landfill Gas Monitoring was conducted at two wells was installed into the centre of each of the two capped landfill cells, to a depth of approximately 6m below ground surface within the waste mass and at 3 shallow Leachate wells to determine if any migration of Landfill gas was occurring.

All bores were fitted with an Ex Cap Vapour extraction 2" Locking Monitoring Well Expansion Plug, with Air Sampling Ports and the insitu gas composition was analysed at all five bores and the two ambient air sampling sites using the Landtec GA5000 Portable Landfill Gas Analyser. The details of each monitoring bore is shown in Table 1 and the location of each bore is provided on Figure 2.

Detailed gas composition sampling was undertaken at the two LFG bores (LFG 01 and LFG02) using soil gas canisters.

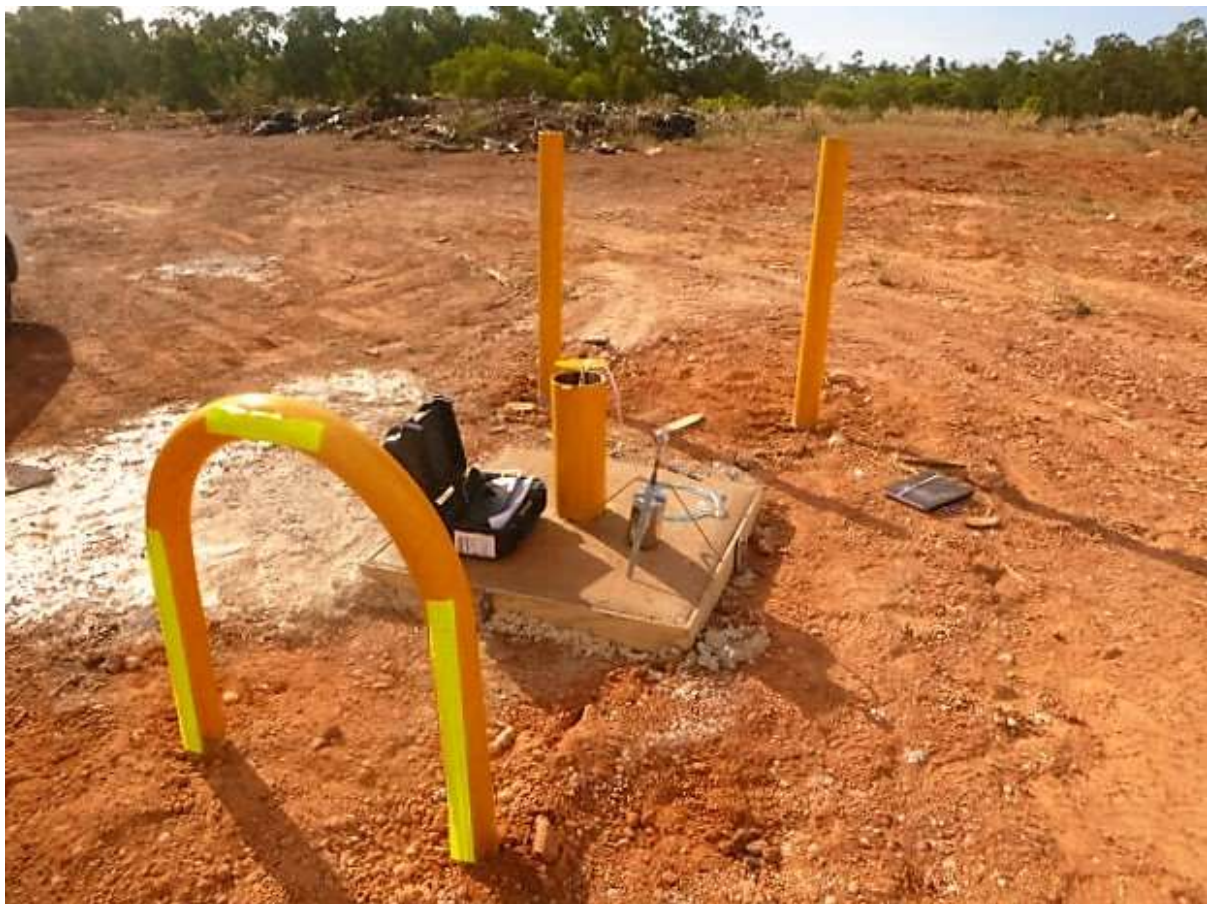
**Figure 5: Landfill Gas Monitoring - Gove Peninsula Waste Management Facility**

The results demonstrate that the landfill continues to generate significant percentages of Methane in the closed and capped landfill cells. The gas composition recorded in LG01 has observed an increase in Methane levels between 2016 and 2021 from 49.0% to 62.6%. The older of the two cells (LFG 02) shows methane concentrations of approximately 64.7% in 2016, and similar levels in 2021 to 64.5%.

The three Leachate/Landfill gas bores (LL01/LL02/LL03) situated on the edge of the landfill also recorded no Methane (0.0 -0.0%) and extremely low levels of Hydrogen Sulphide (1ppm). Neither of these correlate to typical Landfill gas concentrations.

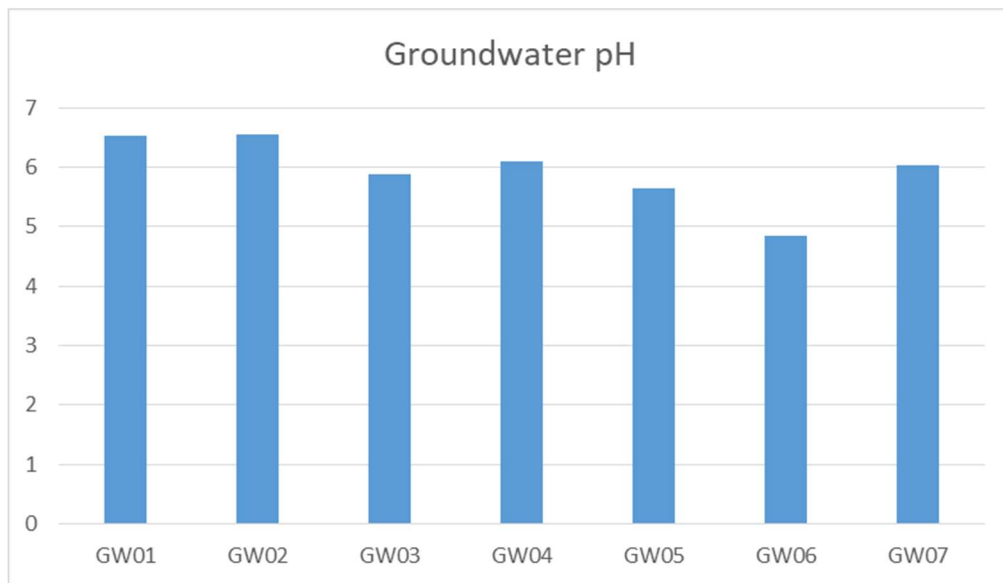
**Figure 7: Groundwater pH May 2021**

Groundwater pH was relatively consistent across all piezometers apart from GW01 which recorded a neutral pH level. All other piezometers recorded acidic water ranging from 4.85 to 6.55.

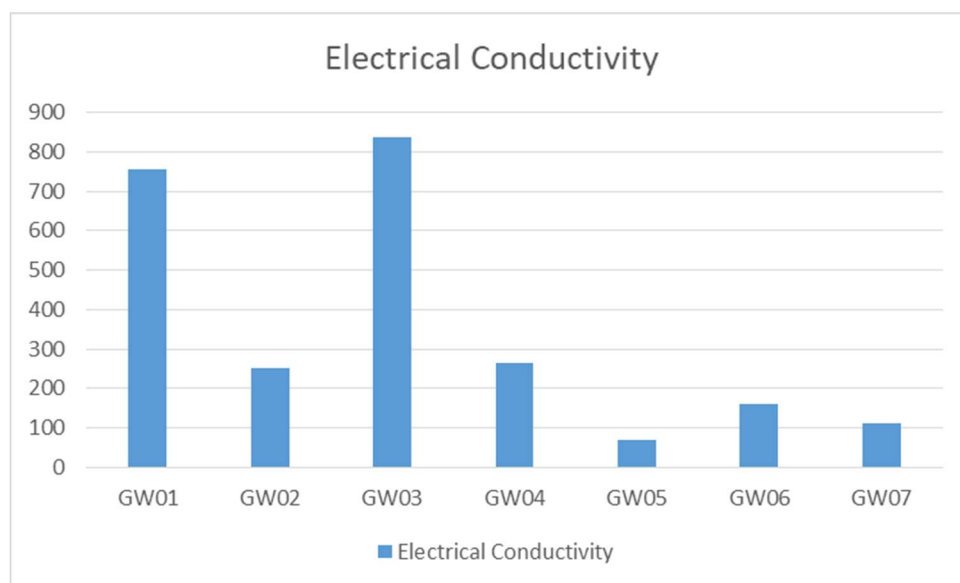
**Figure 8: Electrical Conductivity (µS/cm) May 2021**

The recorded Electrical Conductivity (EC) varied across piezometers however the piezometers with the highest EC was GW01 down gradient to the recent operational cells and at GW03 which is not located near any current or former landfill cell.

The EC was however consistently lower at the up gradient piezometers GW04, GW05, GW06 and GW07.

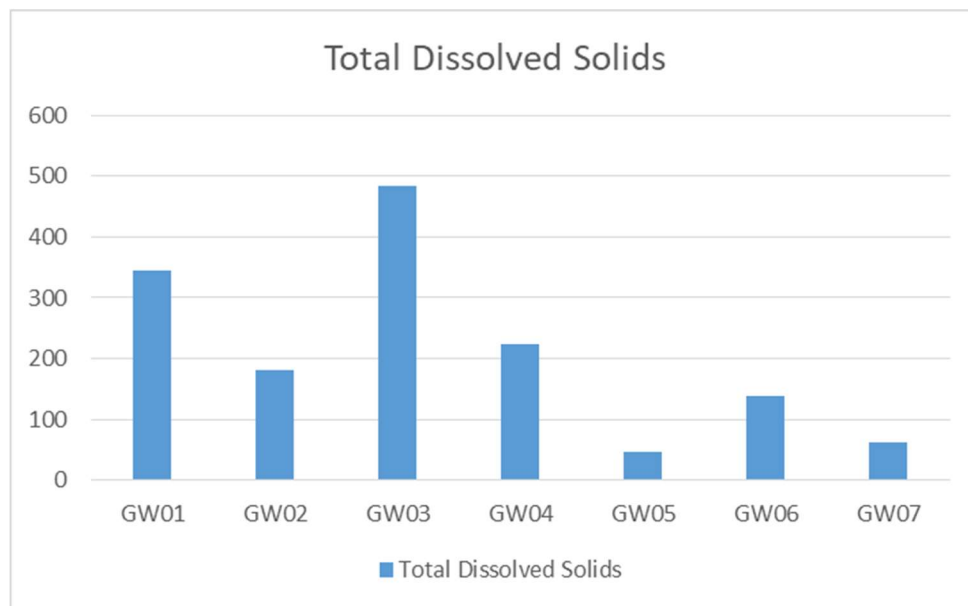
**Figure 9: Total Dissolved Solid (TDS) May 2021**

Similar to the recorded Electrical Conductivity (EC), TDS varied across piezometers however the piezometers with the greatest variability was GW01 down gradient to the recent operational cells and a GW03 which is not located near any current or former landfill cell.

The EC was however consistently lower at the up gradient piezometers GW04, GW05, GW06 and GW07.

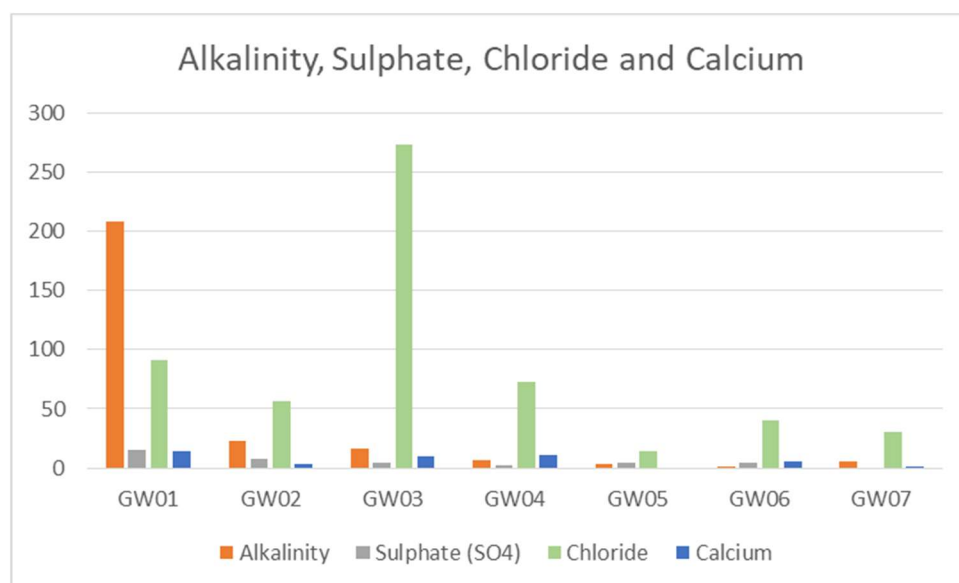
**Figure 10: Alkalinity, Sulphate, Chloride and Calcium May 2021**

The Alkalinity, Sulphate, Chloride and Calcium also followed the trends of the EC with again GW03 recording highest Chloride levels despite being a significant distance from any cell. GW01 down gradient to the recent operational cells also showed some elevation in Alkalinity, Sulphate, Chloride and Calcium.

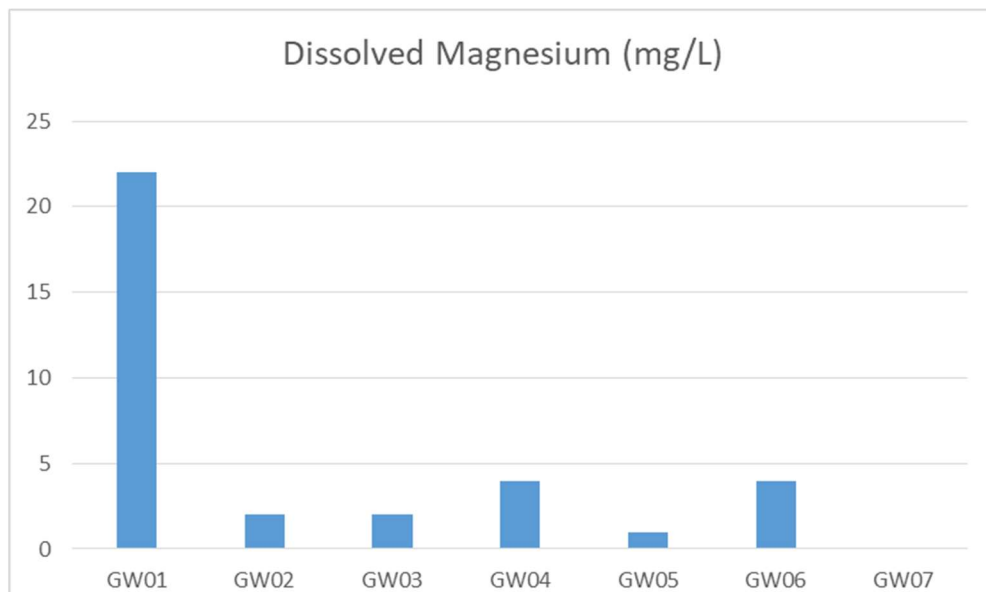
**Figure 11: Dissolved Magnesium May 2021**

The levels of Dissolved Magnesium were elevated at GW01 down gradient to the recent operational cells while all other piezometers recorded low concentrations.

Upon reviewing all data – it is clear that the down gradient piezometer GW01 has a water chemistry influenced by the Landfill as this is showing elevated results in some metals, however as this is extremely close (<10m) to the landfill it does not provide a good indication of contaminants moving off site. the other ‘close’ downgradient piezometer GW02 has not recorded similar elevated results. Also where an analyte is found to be elevated at GW02 the same analyte is elevated at up gradient or “control piezometers” therefore showing natural variation in water chemistry and not significant movement of soluble metaloids as a result of the landfill.

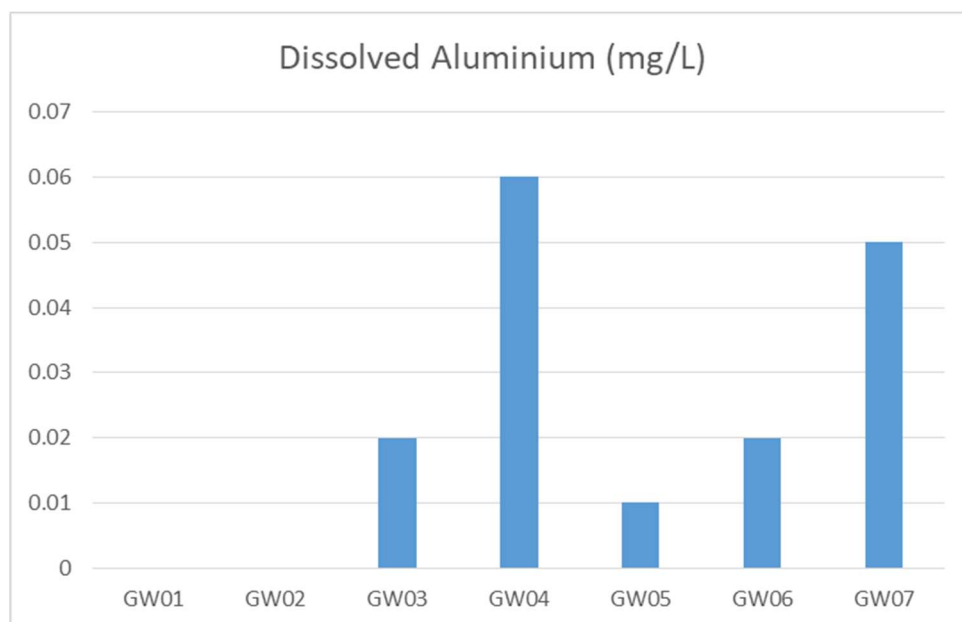
**Figure 12: Dissolved Aluminium May 2021**

The levels of Dissolved Aluminium were lowest at GW01 down gradient to the recent operational cells and GW05 a “control piezometer”, while all other piezometers recorded low concentrations.

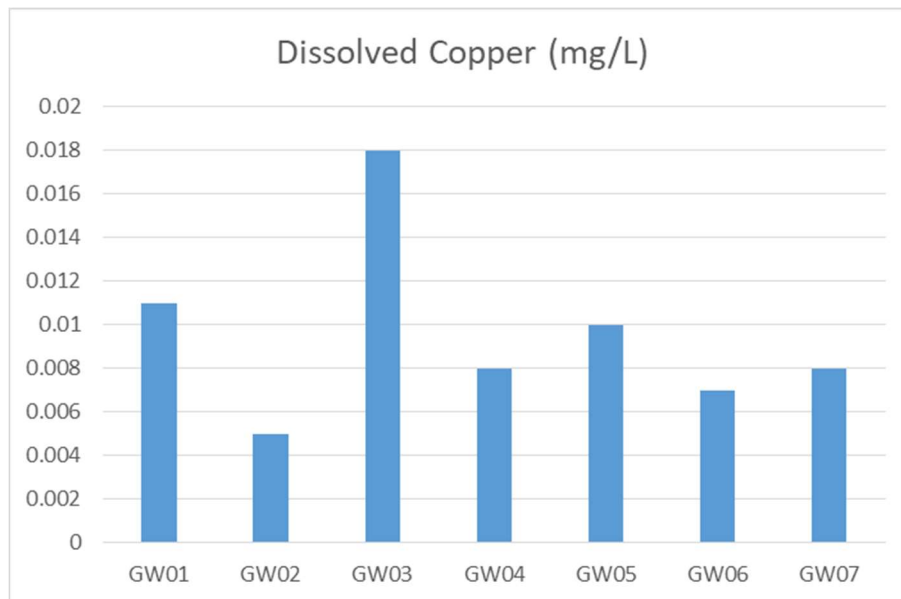
**Figure 13: Dissolved Copper May 2021**

The levels of Dissolved Copper were only elevated at GW03 which does not occur near operational cells, while all other piezometers recorded low concentrations.

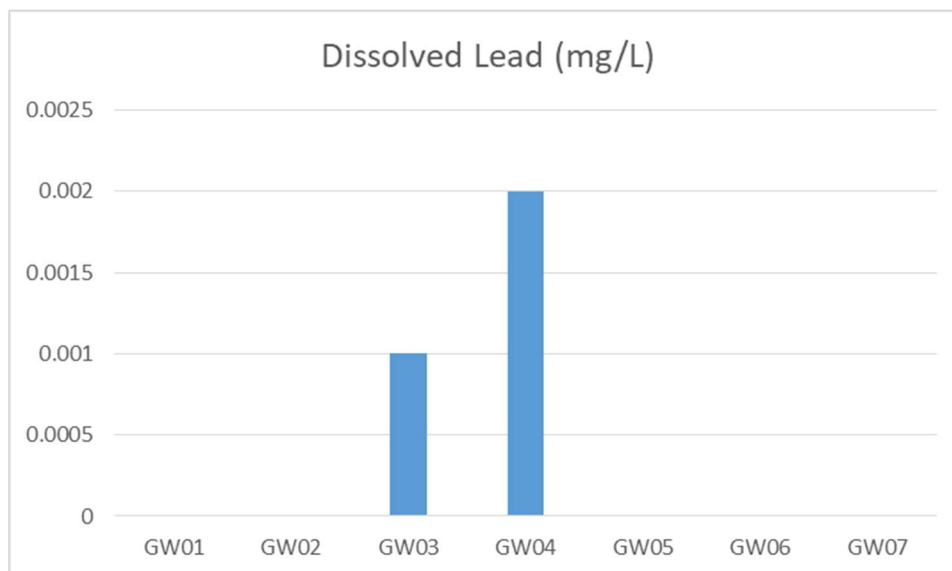
**Figure 14: Dissolved Lead May 2021**

The levels of Dissolved Lead were only elevated at GW03 and GW04, while all other piezometers recorded “below detect” concentrations.

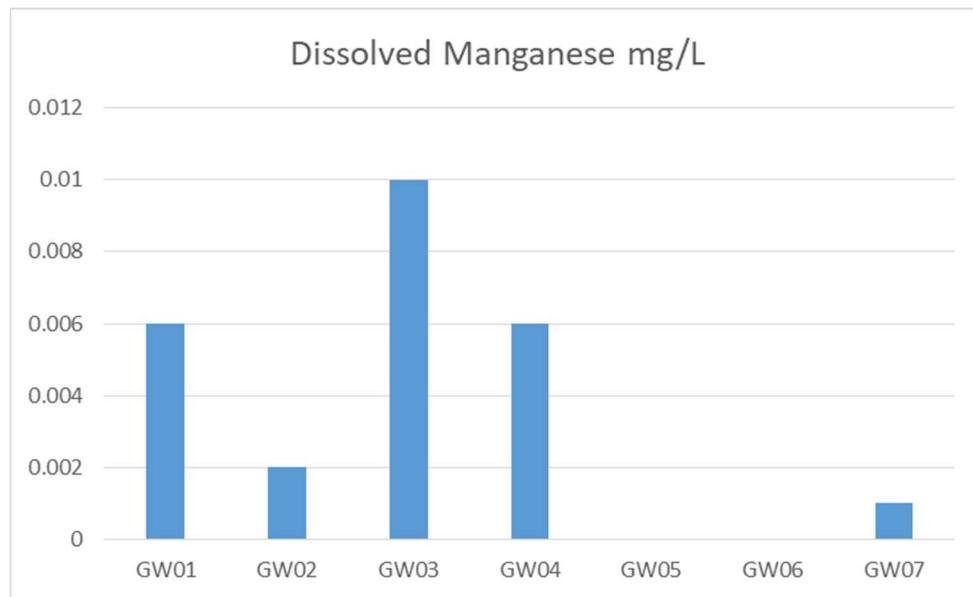
**Figure 15: Dissolved Manganese May 2021**

The levels of Dissolved Manganese were elevated at GW01 down gradient to the recent operational cells, and GW03 and GW04 up gradient of operations while all other piezometers recorded low concentrations.

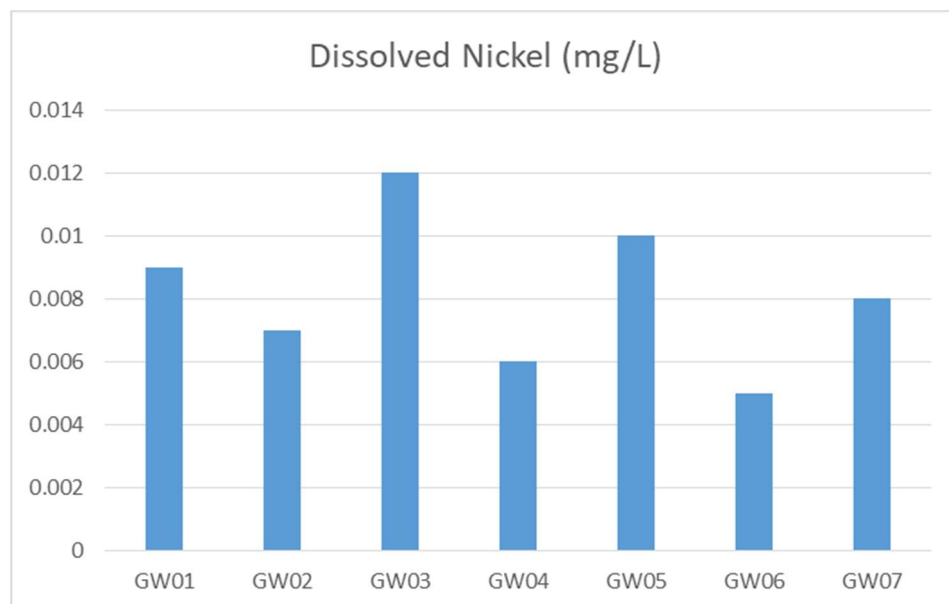
**Figure 16: Dissolved Nickel May 2021**

The levels of Dissolved Nickel were similar between all piezometers.

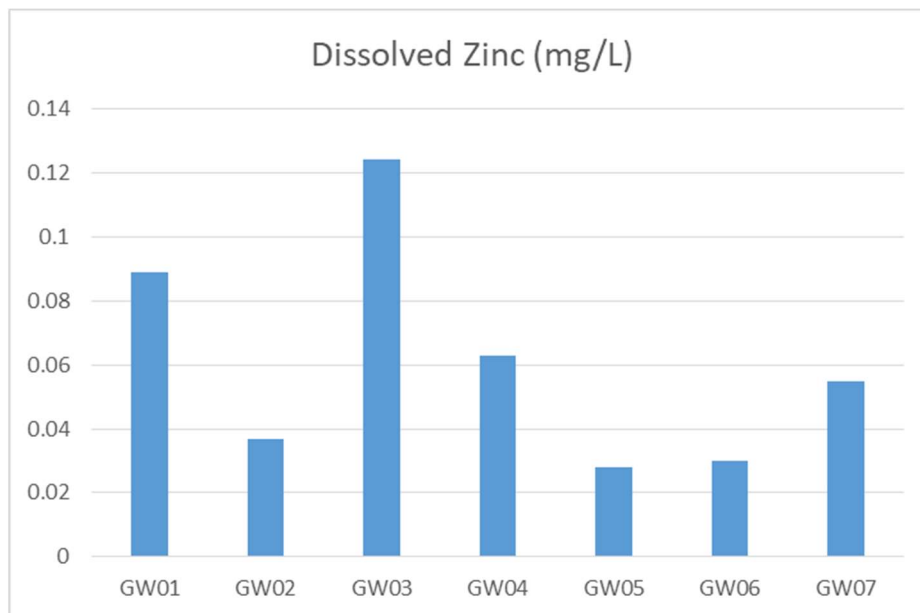
**Figure 17: Dissolved Zinc May2021**

The levels of Dissolved Zinc were elevated at GW01 down gradient of the landfill cell and GW03 a control site.

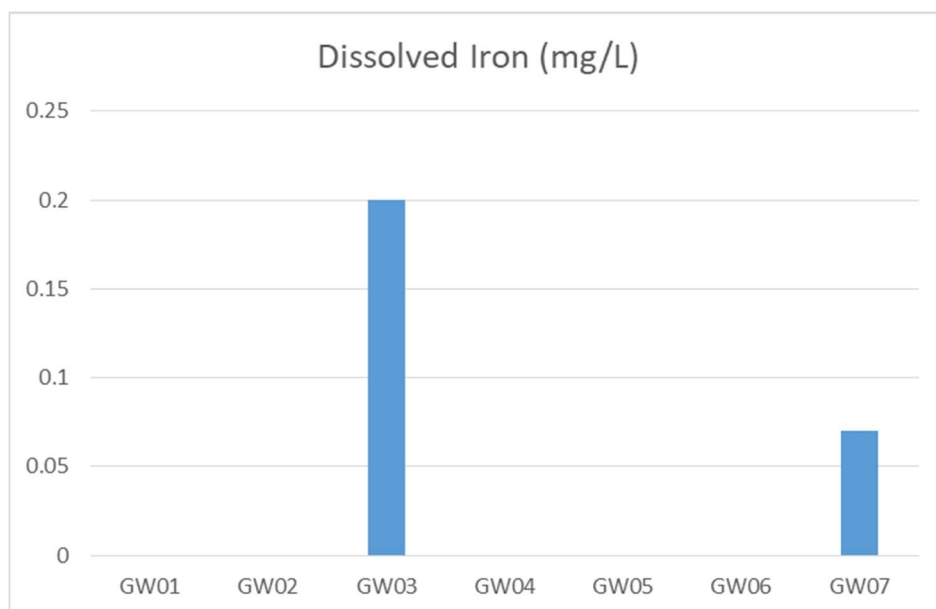
**Figure 18: Dissolved Iron May2021**

The levels of Dissolved Zinc were elevated GW03 a control site and GW07 on the northern side of the newest cell.
