# EPL 297 Monitoring Report Darwin Crocodile Farm

*Reporting Period: 1 June 2023 – 31 May 2024*

Porosus Pty Ltd

# Main Pond Discharge Rating Derivation

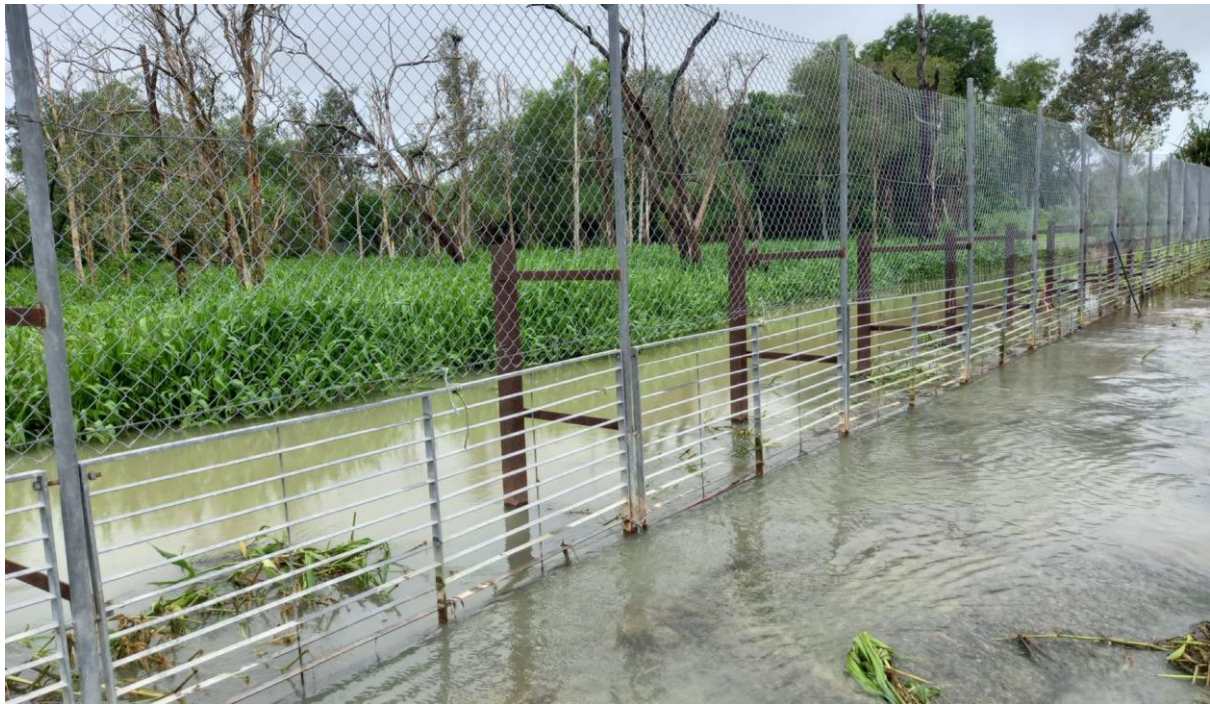
The spillway design is a 60m low cut section of the southern earthen embankment wall which has been covered in rough concrete to prevent scouring. The boundary chainmesh fence and steel gates (to facilitate water flow through the fence) transect the spillway surface.

*Figure 1 - Spillway and boundary fence*

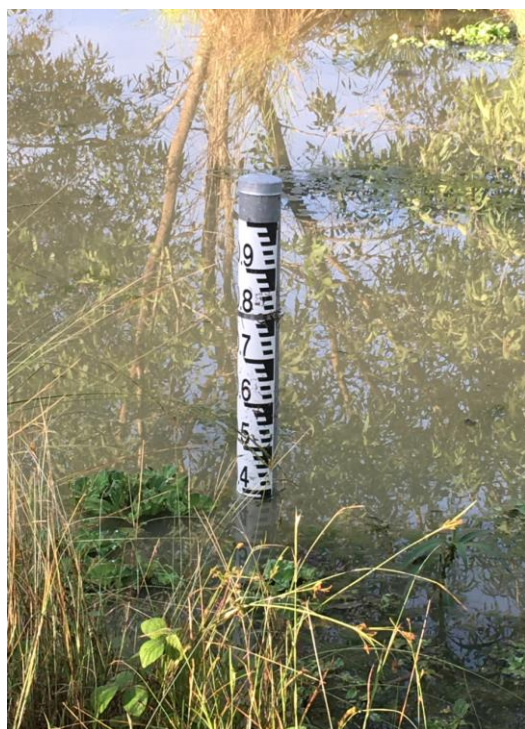
A staff gauge was installed to the main pond in October 2020 when water levels were low. The gauge was installed on the northern side of the pond along the access road to the water supply bore located in the main pond. This location was chosen to permit ease of access for reading during the wet season by Porosus staff.

*Figure 3 – Main pond staff gauge*

The nearby bore was utilised as a benchmark. Its local datum value at the time of installation was 1.542m. A water level logger was later installed on 30/12/2020 next to the staff gauge to collect continuous measurements of pond water level. After derivation of the rating, such logged data could then be used to calculate the annual volume of pond water discharging over the spillway.

Very few manual records were kept over the 2020-21 wet season of water levels in the pond. It is generally good practice to record manual reading of the staff gauge so such data can be used to validate the logged data, as well as act as a backup in case the pressure sensor fails.

The wetting and drying of the soil will cause the gauge to move over time. Depending on the amount of movement the water level will be in error to the rating and incorrect flows derived. The gauge should be surveyed at least once a year against the benchmark and adjusted if necessary, to ensure the rating table remains valid. The gauge was checked last on 29/4/21 and differed from installation by only 2mm.

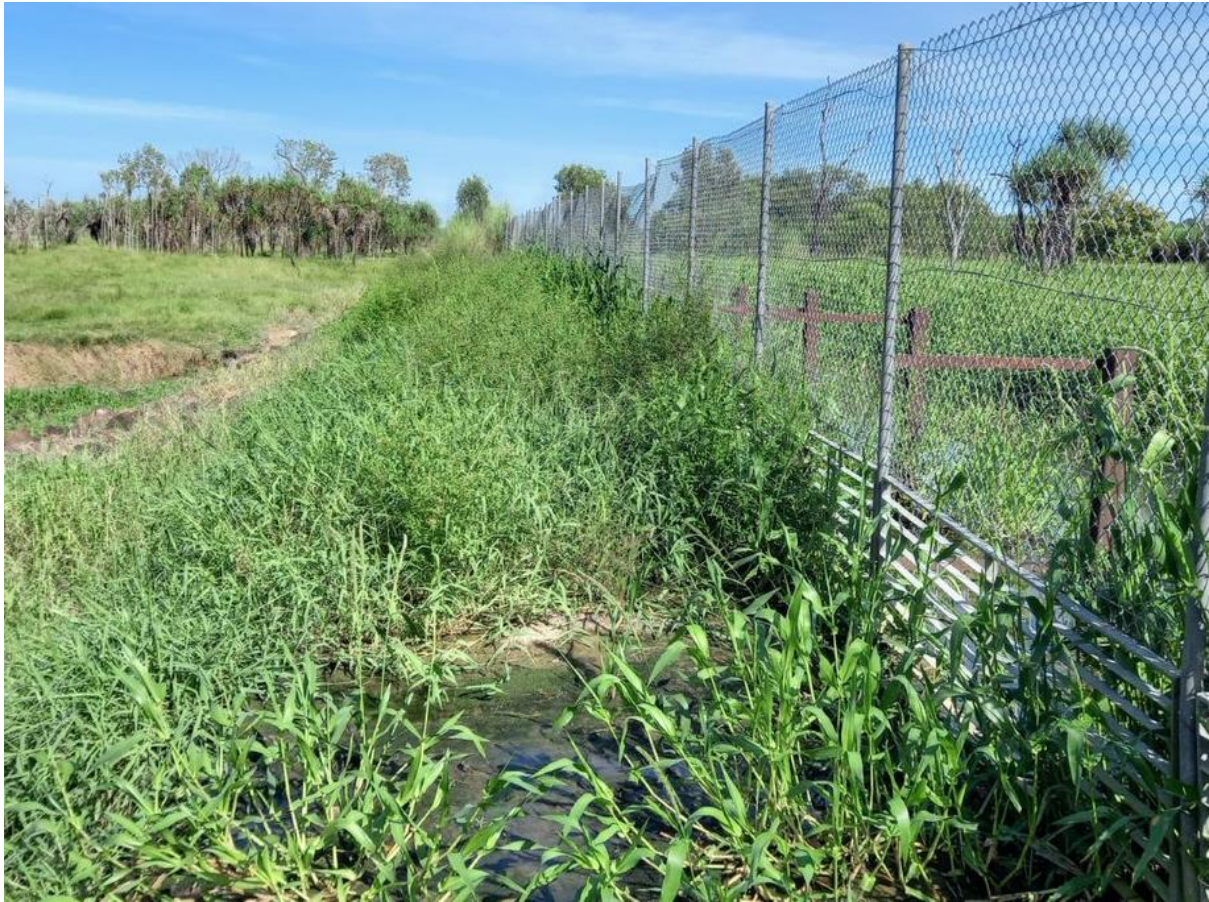
Due to the large width of the spillway, a small increase in water level in the pond will result in a comparatively large increase in flow volume. It only takes a small amount of build-up on the fence line to inflate the pond water level. If such values are used directly against the rating table then the referenced flows have the potential to be over 100% in error of the true flow in the downstream gully.

*Figure 5 - End of wet season vegetation growth along the spillway*
