## SECTION 14 INCIDENT REPORT (*Waste Management and Pollution Control Act*)

| <b>Incident:</b> | Umbakumba power station – oil water separator discharge (hydrocarbon) to environment. |

### Umbakumba Power Station – Oil Water Separator Discharge

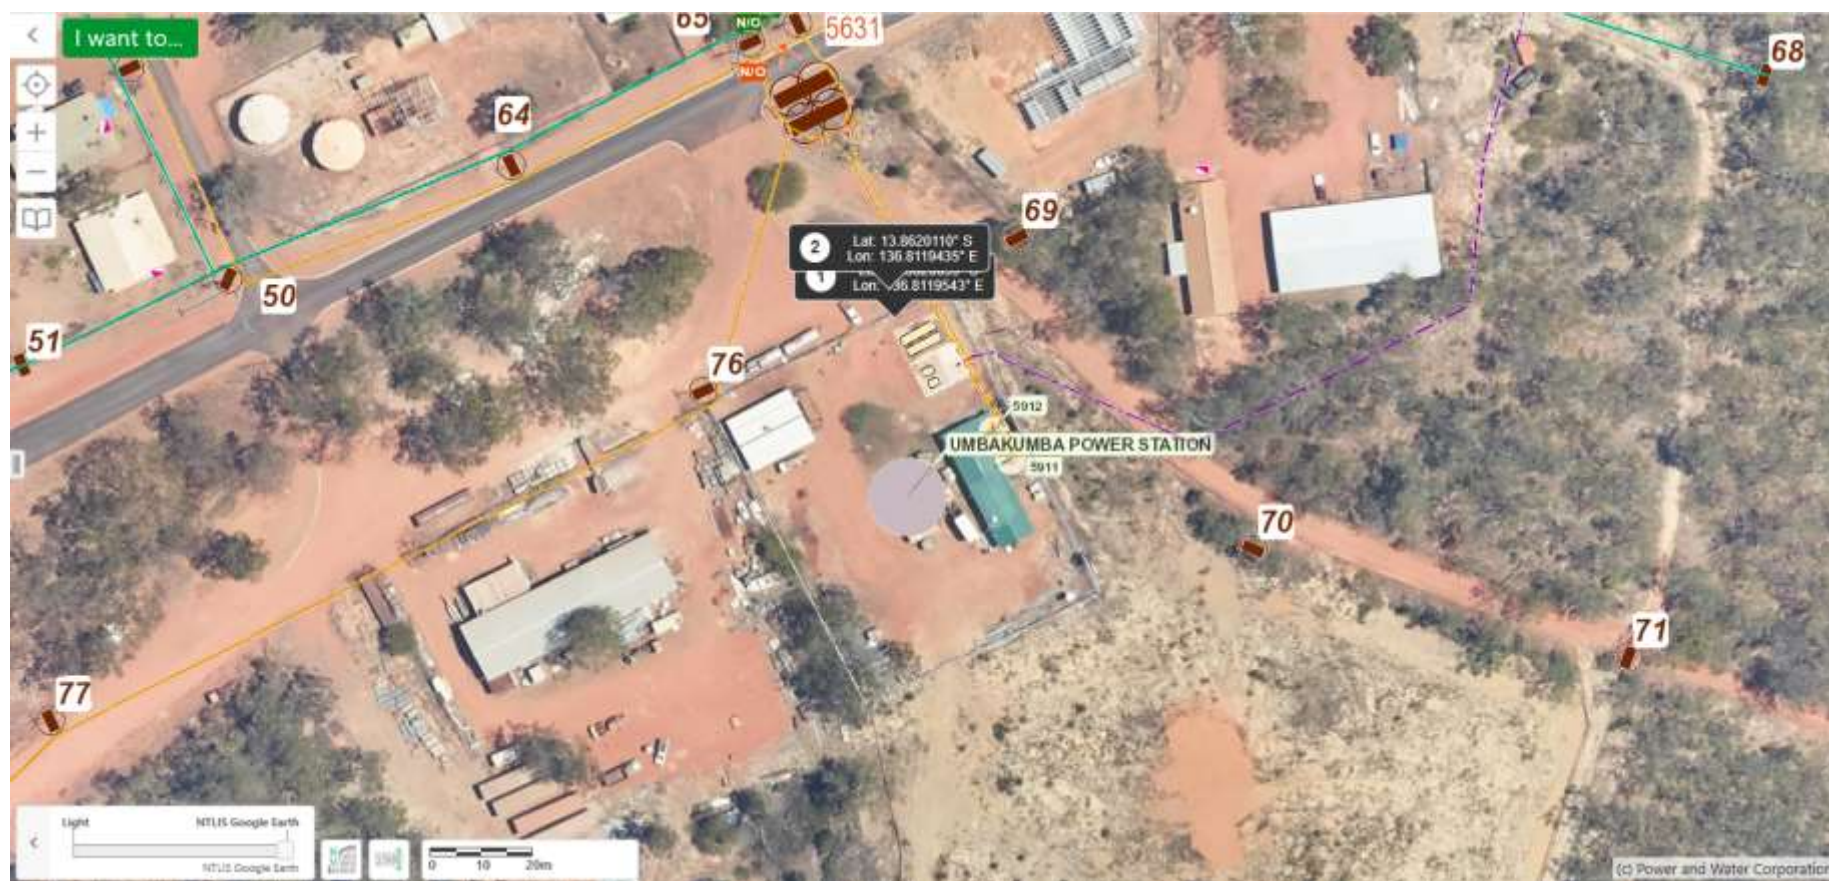
| <b>(b) the place where the incident occurred</b> | <p>Umbakumba power station – oil water separator.</p> <p>It should be noted that the oil water separator is no longer onsite. It was decommissioned and removed from the lot in 2019 during installation of new fuel tanks and bunding.</p> <p>Discharge point: 13.862065 S, 136.811954 E<br/>Approx. Sample point: 13.862011 S, 136.811943 E</p> |

1. Historical Oil Water Separator site
2. Approx. recent sample location (2020)

| <b>(e) the attempts made to prevent, reduce, control, rectify or clean up the pollution or resultant environmental harm caused or threatening to be caused by the incident</b> | <p>It is believed that the contaminated surface soil was removed and remediated. However recent soil samples (Sept 2020) taken at the site indicate some contamination is present.</p> <p>PWC is currently having a detailed site investigation report developed for the Power Station site which will include an assessment of this contamination.</p> |
