# EPL228 Annual Environmental Monitoring Report 2022-2023

Document No.: L060-AH-REP-70055  
Security Classification: Public

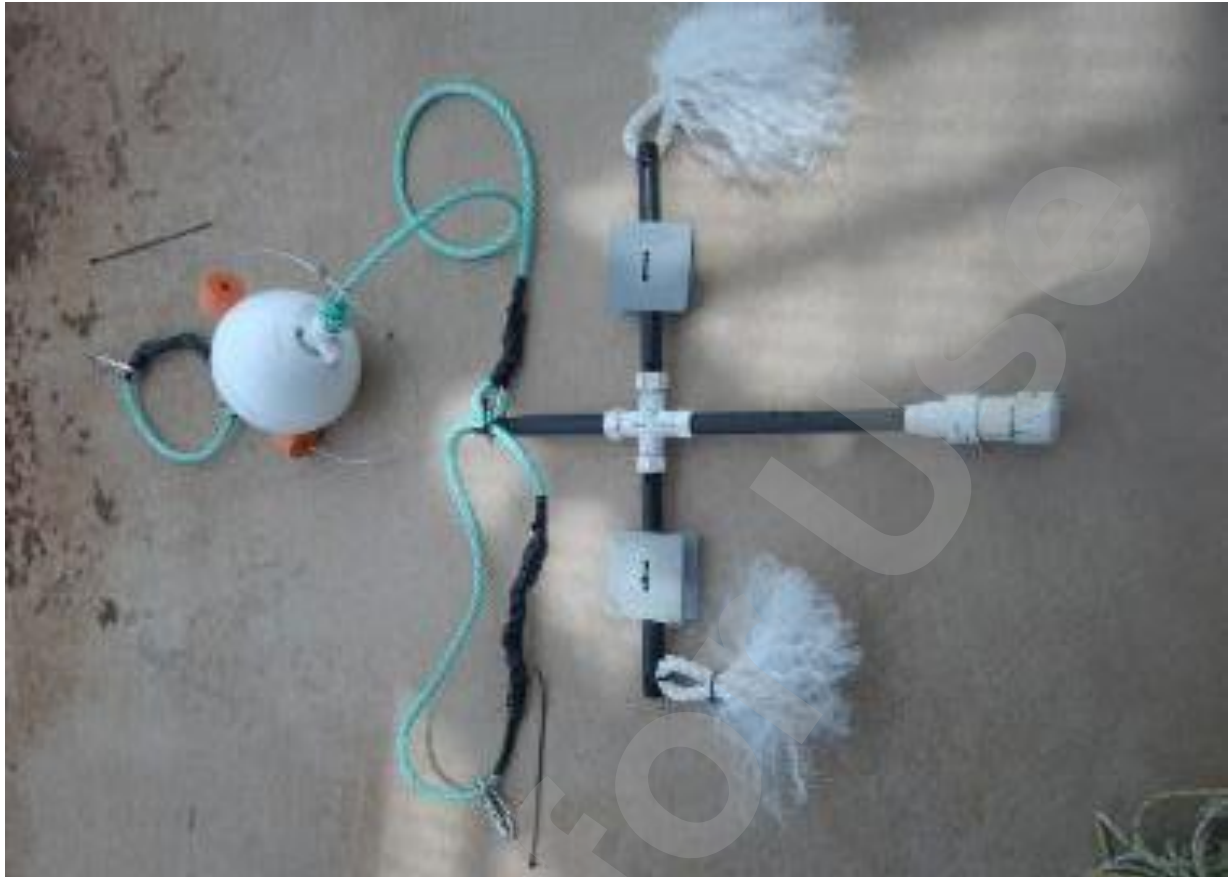
**Figure 5-2: Nearshore marine pest ASU**

Nearshore monitoring is undertaken to assess the presence/absence of invasive marine species at the Ichthys LNG LPG/condensate product loading jetties (Figure 5-1). The two sites located on the product loading jetties have been incorporated in the wider Darwin Harbour program, managed by NT Aquatic Biosecurity Unit, within the Fisheries Division of the Northern Territory Department of Industry, Tourism and Trade (NT DITT). NT DITT provide the artificial settlement units (ASUs; Figure 5-2) for INPEX to deploy at the jetties. Each ASU consists of four settlement plates (back-to-back) and two rope mops.

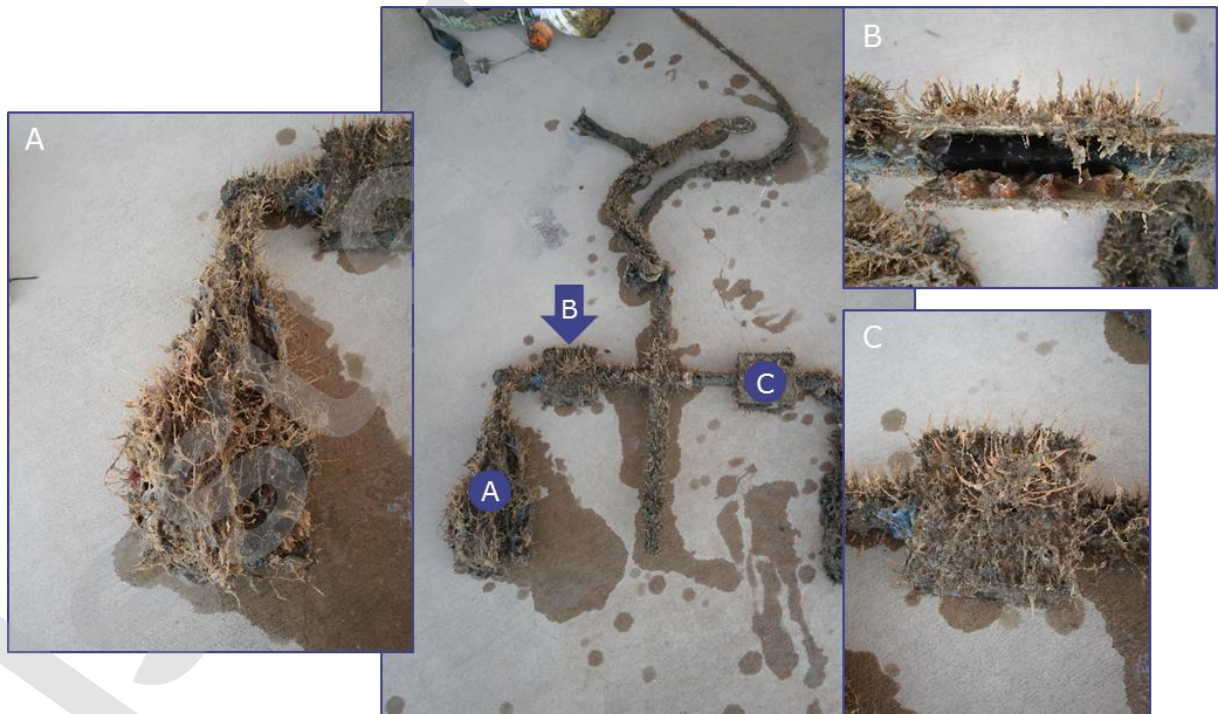
**Figure 5-3: Example of monitoring photographs taken during monthly inspection a) rope mop, b) inside the plates and c) plates surface biofouling conditions**

Photo-monitoring of ASUs is undertaken monthly with ASUs collected and replaced every fourth month (an example of monitoring photographs is shown in Figure 5-3). Collected ASUs and monthly photos of the traps are sent to NT DITT for species identification.
