**Browns Oxide Project Tailings Storage Facility  
Batchelor NT Preliminary Design Report  
(Revision 1)**

**BROWNS OXIDE PROJECT  
TAILINGS STORAGE FACILITY  
BATCHELOR  
NT**

**PRELIMINARY DESIGN REPORT  
(REVISION 1)**

**Job No. 105026.01**

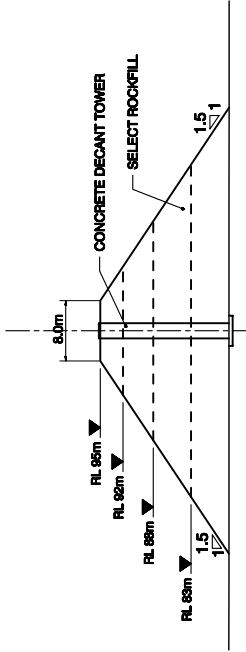
SECTION 3  
FIG 1  
SCALE 1:1000

| ZONE | MATERIAL | SOURCE | PLACEMENT AND COMPACTION |
|---|---|---|---|
| 1 | CLAY, Sandy Clay, Clayey Sand (low permeability material) | Stage 1: Internal borrow<br>Stage 2: Borrow from footprint<br>Stage 3: External borrow | Place in layers 0.15m max. compacted thickness, compact at not less than 95% Standard DD at moisture content in range (omc -2%) to (omc +2%) |

INTERNAL EMBANKMENT

PERIMETER EMBANKMENT

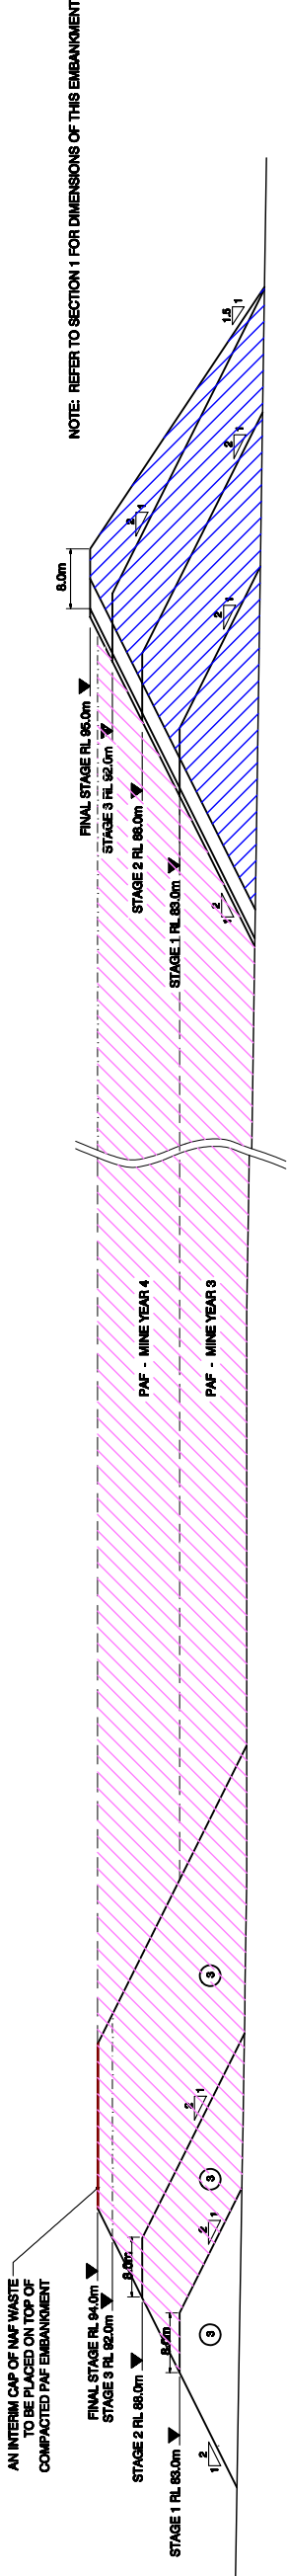
SECTION 2  
FIG 1  
SCALE 1:1000

NON-ACID FORMING (NAF) ONLY  
NON-ACID FORMING AND POTENTIALLY ACID FORMING (PAF)

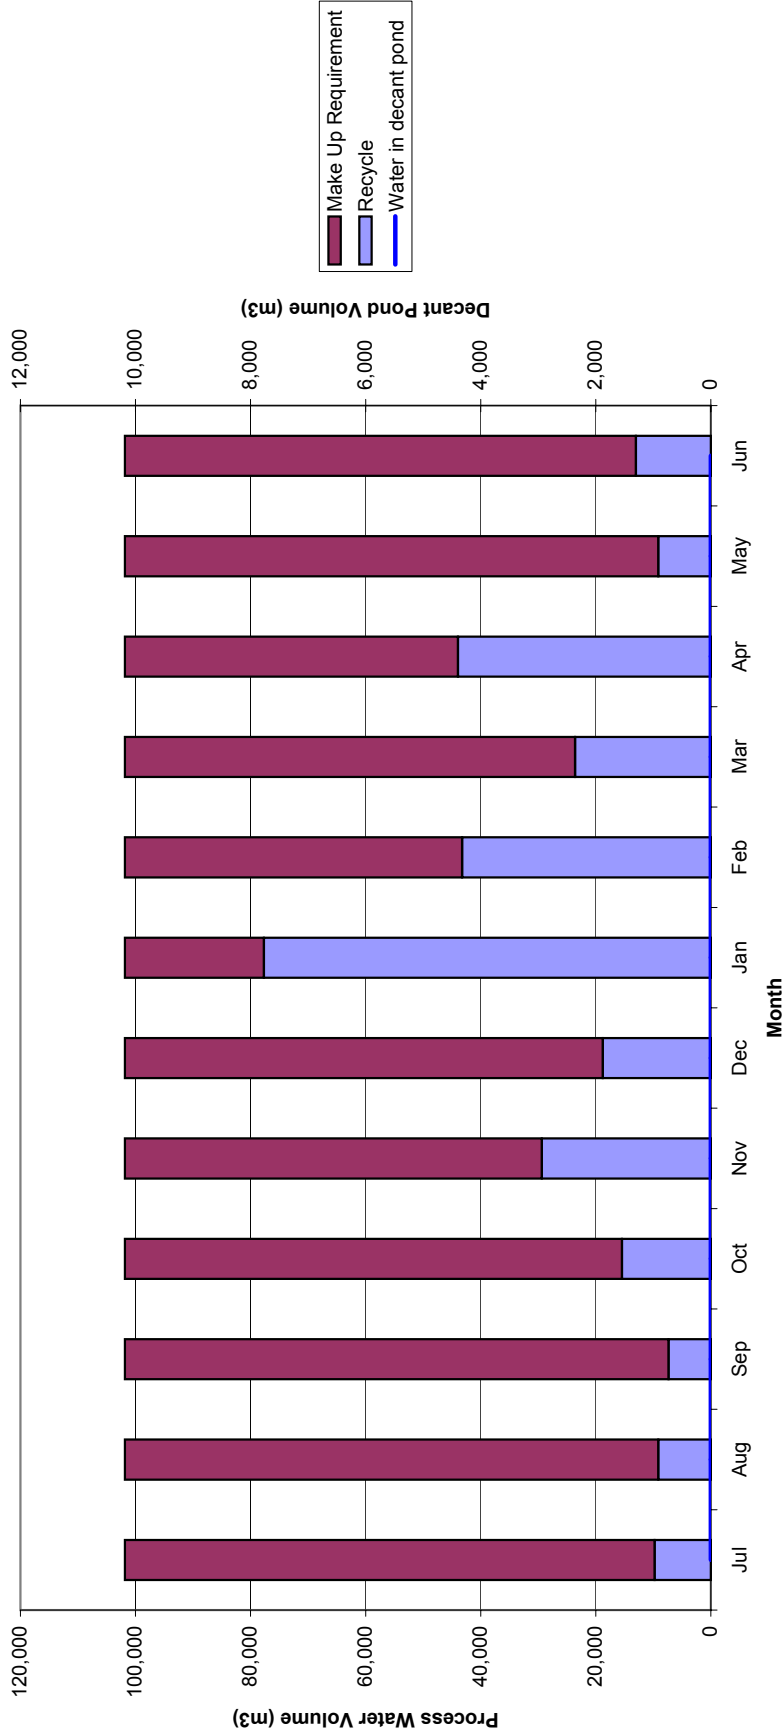
**Figure 6**

**B.O.P \_ Water Balance - DryYear**

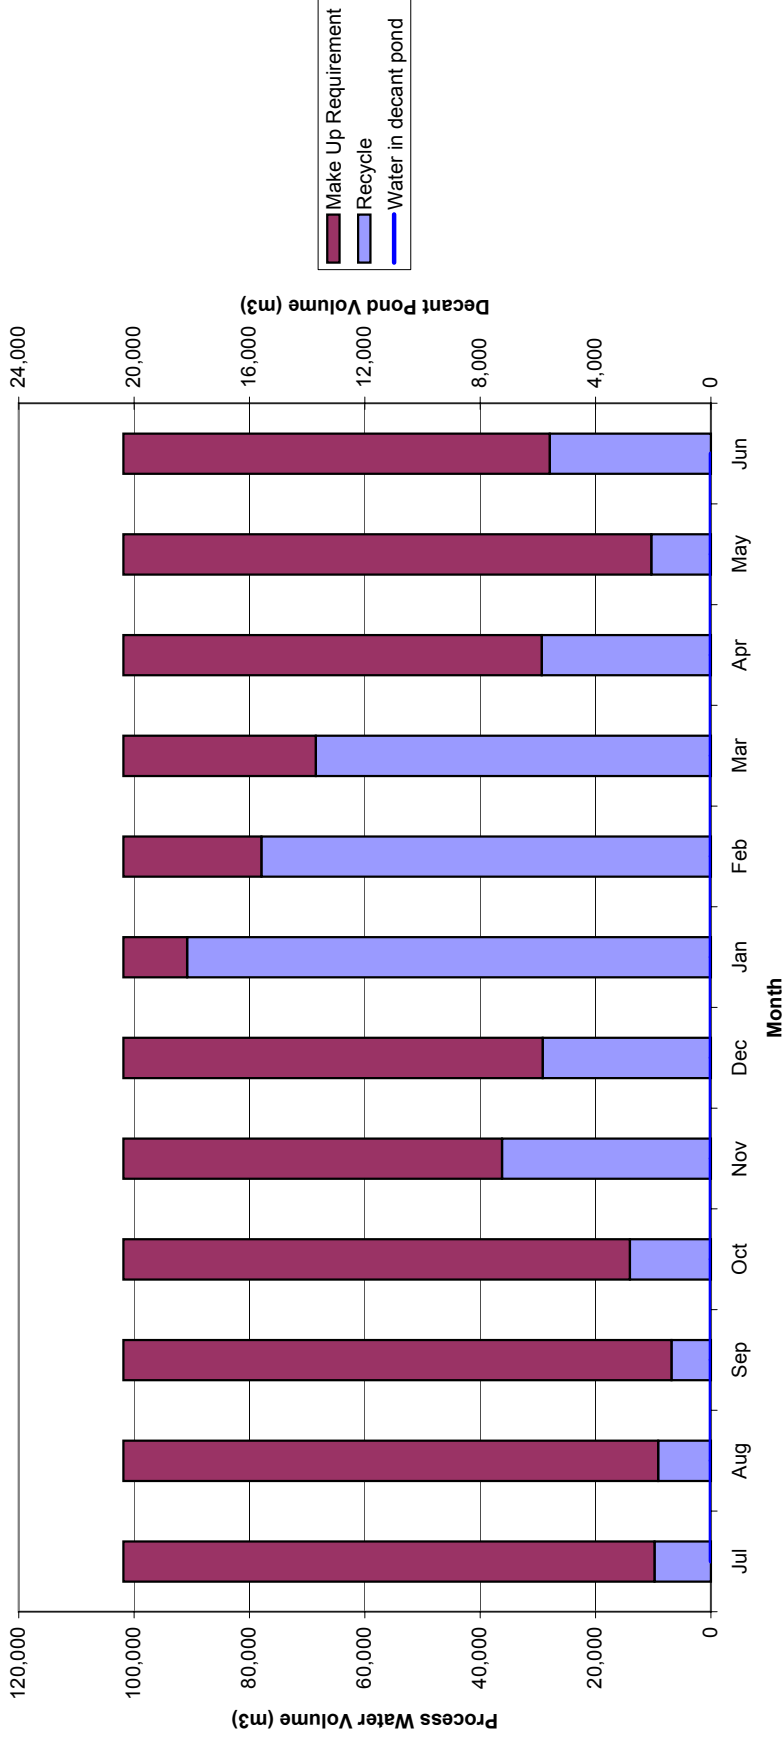
Figure 7

B.O.P \_ Water Balance - Mean Year

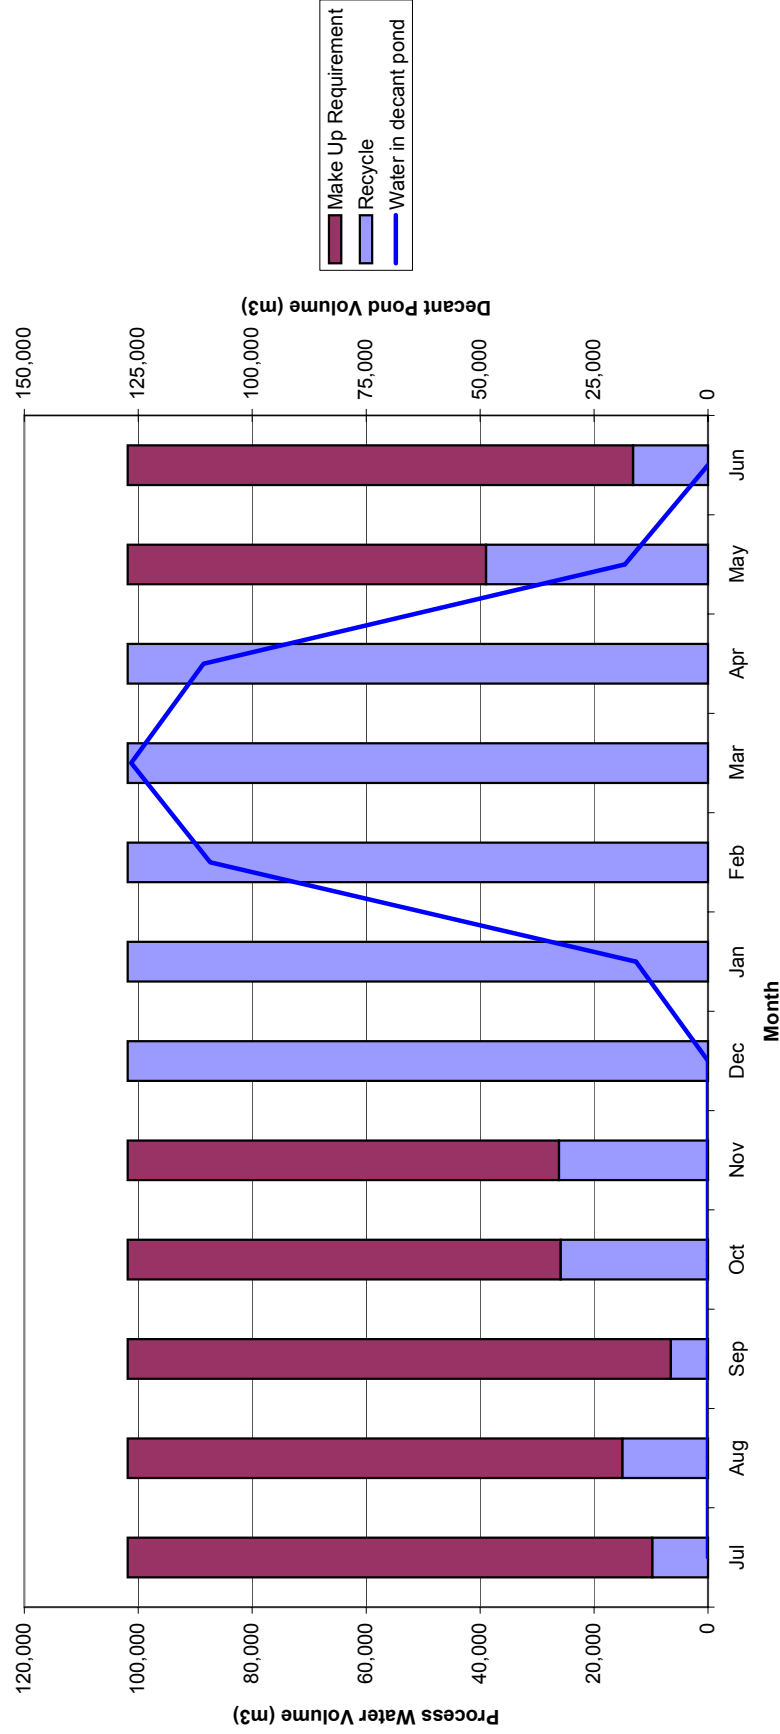
**Figure 8**

**B.O.P. \_ Water Balance - Wet Year**

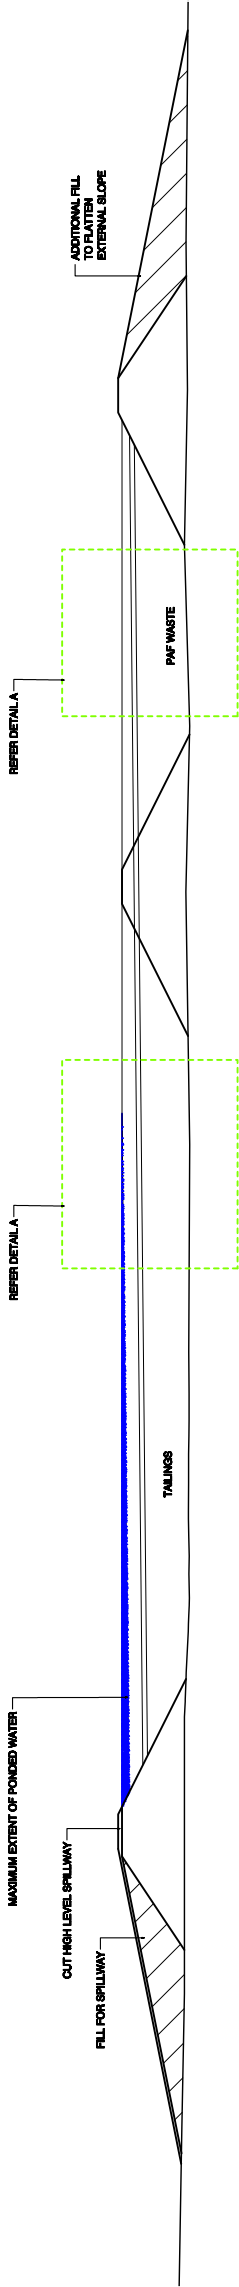
Schematic Closure Provisions

This design only provides a cover of 0.4 m over the top of the low permeability layer. On the basis of current understanding of the seasonal effect of wetting and drying, it is our assessment that this would be insufficient to stop the Zone 1A layer from drying out throughout the dry season. Almost all clay soils show a degree of reactivity (i.e. exhibit shrink-swell movements in response to moisture change). The formation of shrinkage cracks in the Zone 1A is an inevitable consequence of the seasonal drying. Subsequent invasion by vegetation roots and/or burrowing insects would follow.

However it is noted that for cover design to limit the development of acid generating conditions, the most critical factor is the air/oxygen diffusion rate through the cap, not the rate of seepage. Test work has shown that a saturated clay layer is practically "air tight", and hence the primary design criteria will be to ensure that there is sufficient depth of water available in the "store and release" layer to protect the clay layer from drying out.

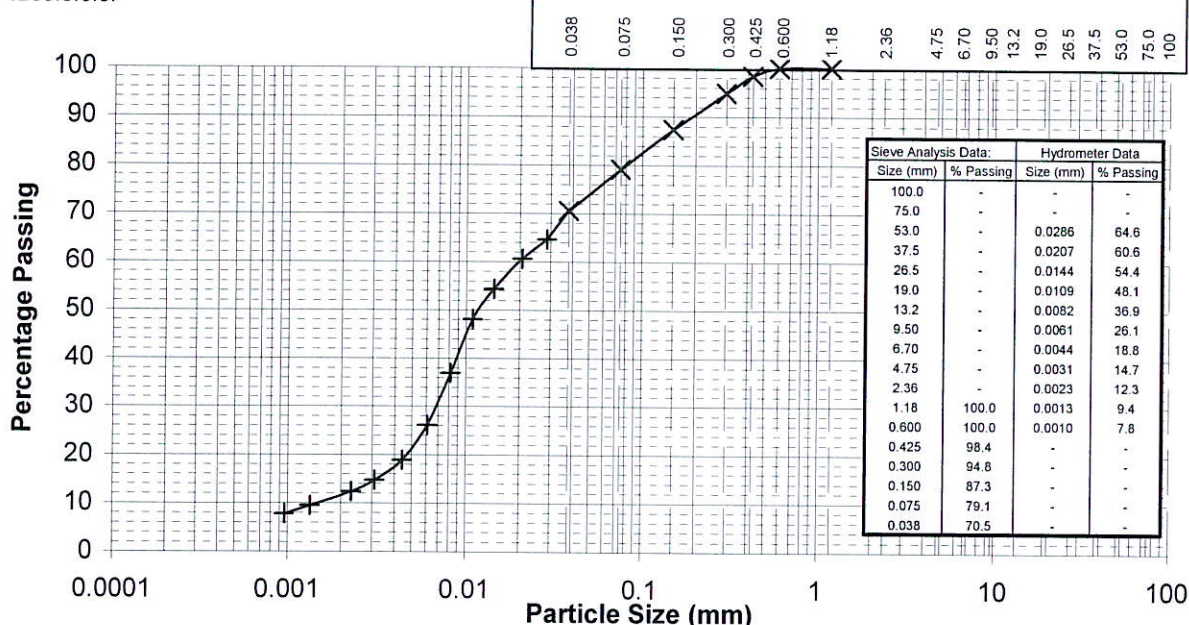
Notes: Hydrometer sample was washed on a 38mm rather than a 75mm sieve. The sample was mixed with a propeller type stirrer rather than inverting the cylinder as described in AS 1289.3.6.3.

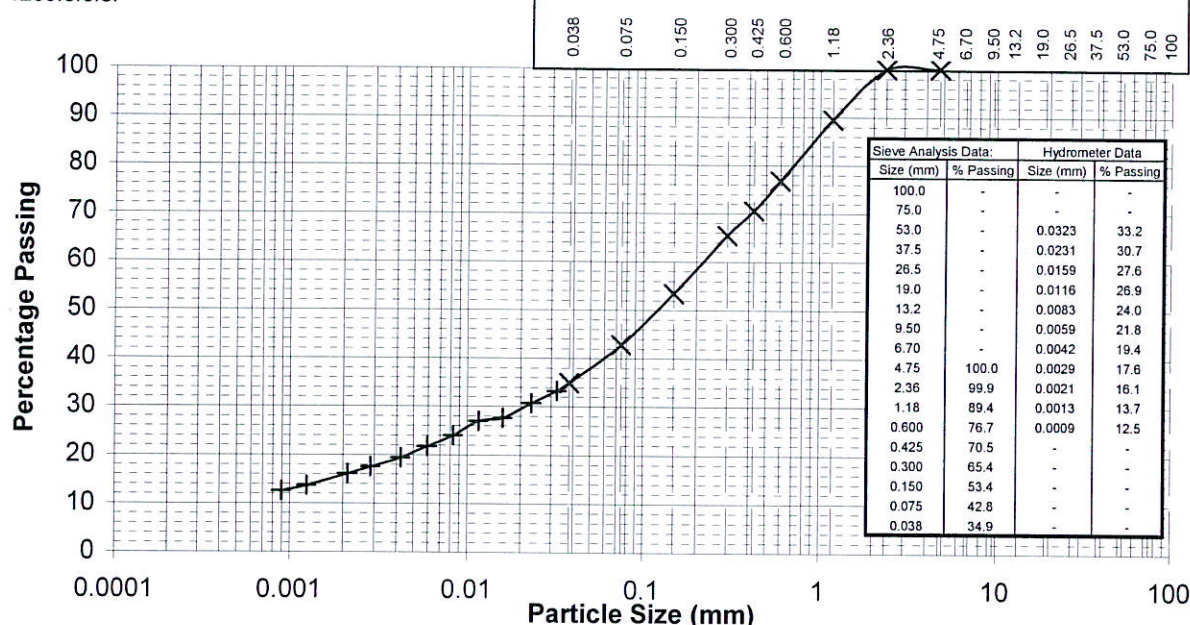
Notes: Hydrometer sample was washed on a 38mm rather than a 75mm sieve. The sample was mixed with a propeller type stirrer rather than inverting the cylinder as described in AS 1289.3.6.3.

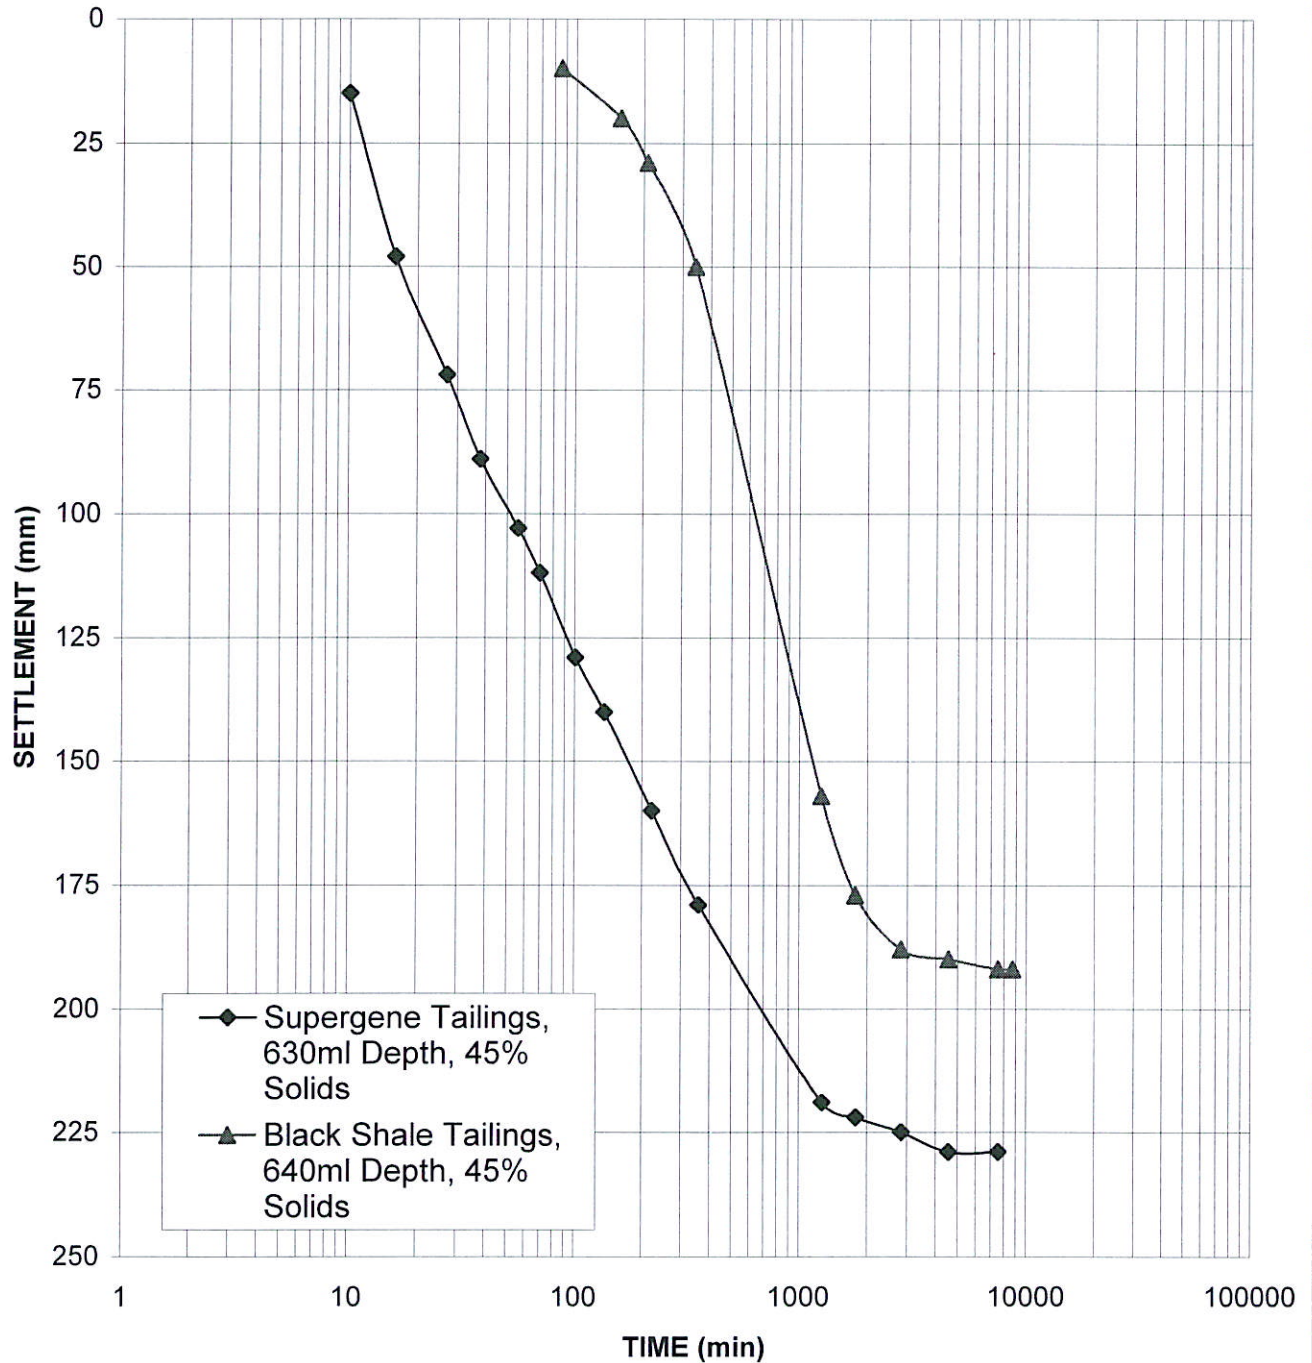
**SETTLING TEST RESULTS**  
 Sample Nos. 10505, 10605

**Cylinder Settlement**  
**105026.01**  
**Browns Oxide Project**  
**#10505, Supergene Tailings**  
**#10605, Black Shale Tailings**

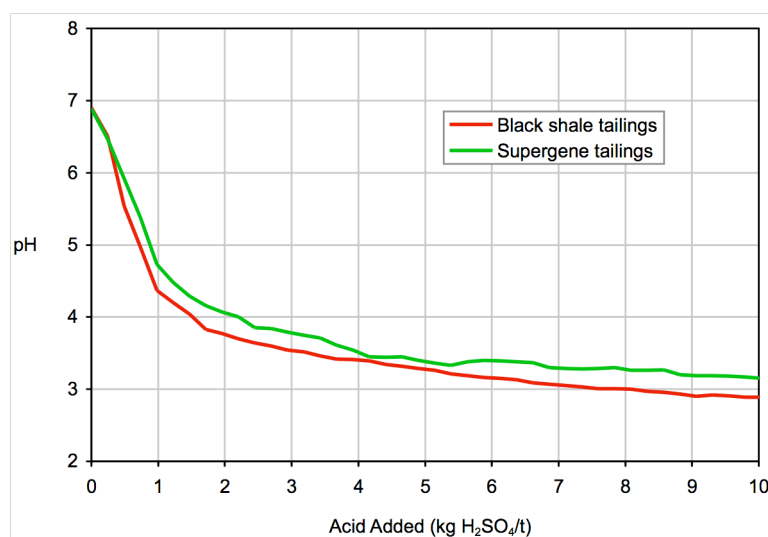
Acid buffer characteristic curves were produced for the two tailings samples to verify the low ANCs (Figure 1). The buffer characteristic curve is determined by slow addition of weak acid to a sample, and it represents a far less aggressive treatment of a sample than that applied in the ANC method. The acid buffer curve provides an indication of the presence of more soluble carbonates within a sample such as calcite and dolomite.

The shapes of the curves in Figure 1 suggest there is little, if any, reactive carbonate within either of the two tailings samples. When carbonate mineralisation is present, and is the main contributor of ANC, it typically produces a plateau region in the buffer curve between pH 7 to 8. Clearly, no plateaus were produced by the tailings, and the curves indicate that an addition of only 2 kg  $\text{H}_2\text{SO}_4/\text{t}$  was sufficient to acidify the tailings to around pH 4.

**Figure 1. Acid buffer characteristic curves for tailings samples**

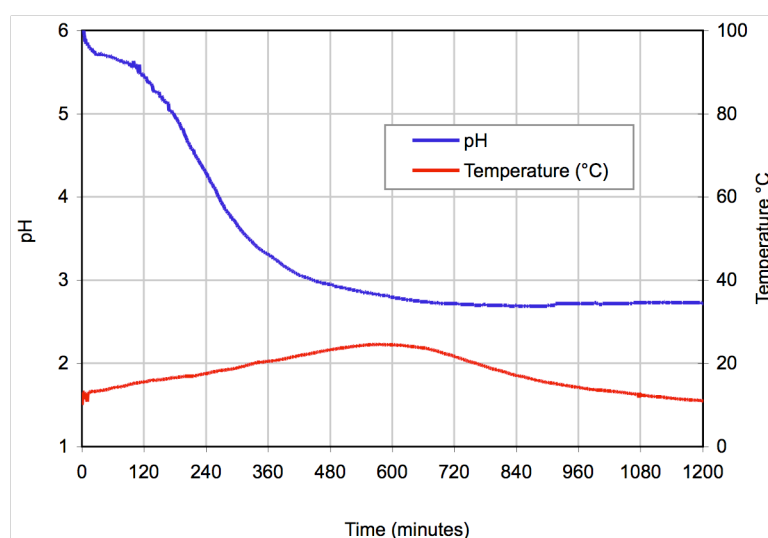
Given the low acid buffer capacity within the black shale tailings it might be expected that such tailings would acidify rapidly (*i.e.* have a short lag) if exposed to atmospheric conditions within a tailings storage. However, the results of the kinetic NAG test (Figure 2) suggest that the sulphides within the tailings are not highly reactive and that it may take some time for a low pH condition to be reached. The pH profile indicates a small amount of buffering at around pH 5.7 during the first two hours, after which the tailings steady acidified to pH 2.8.

The overall time for acidification was relatively slow for a PAF material under NAG test conditions. Based on EGI's experience with similar behaving materials from other mine sites, the kinetic NAG results suggest a lag of several months or more. Further clarification of the likely lag period will require longer-term column testing.

Another feature of the kinetic NAG test was that there was only limited heating of the NAG liquor during the test. Typically, samples that contain more than 1 %S as pyrite produce a significant temperature increase, often to the point of the NAG liquor reaching boiling point. The temperature increase can be attributed primarily to catalytic decomposition of the peroxide (which is an exothermic, or heat generating, process) which usually only occurs in the presence of significant pyrite content (*i.e.* at least 0.5 %S as pyrite). The absence of this type of response with the black shale tailings is consistent with the expectation that only some of the sulphur within the tailings occurs as pyrite. Sphalerite, which probably accounts for the majority of the sulphur, does not generate acidity when oxidised, nor does it result in catalytic breakdown of the hydrogen peroxide.

**Figure 2. Kinetic NAG profiles for the Black shale tailings**

The kinetic NAG test provides an indication of the reactivity of sulphides within a sample and provides a quick, qualitative assessment of the likely lag time for acidification to occur under field conditions. The method is similar to the standard NAG test, except that pH and temperature are constantly recorded during the test. The reaction kinetics exhibited in the NAG test are extrapolated to the field situation on the basis of correlations previously derived by EGi from numerous leach column tests and field observations at other mine sites.
