Xstrata PLC
GROUNDWATER AND SURFACE WATER
INVESTIGATIONS OF THE McARTHUR RIVER
BORE LOCATION PLAN

Xstrata PLC
 GROUNDWATER AND SURFACE WATER
 INVESTIGATIONS OF THE McARTHUR RIVER
**EASTERN PIT EXTENT
 HYDROGEOLOGICAL SECTION**

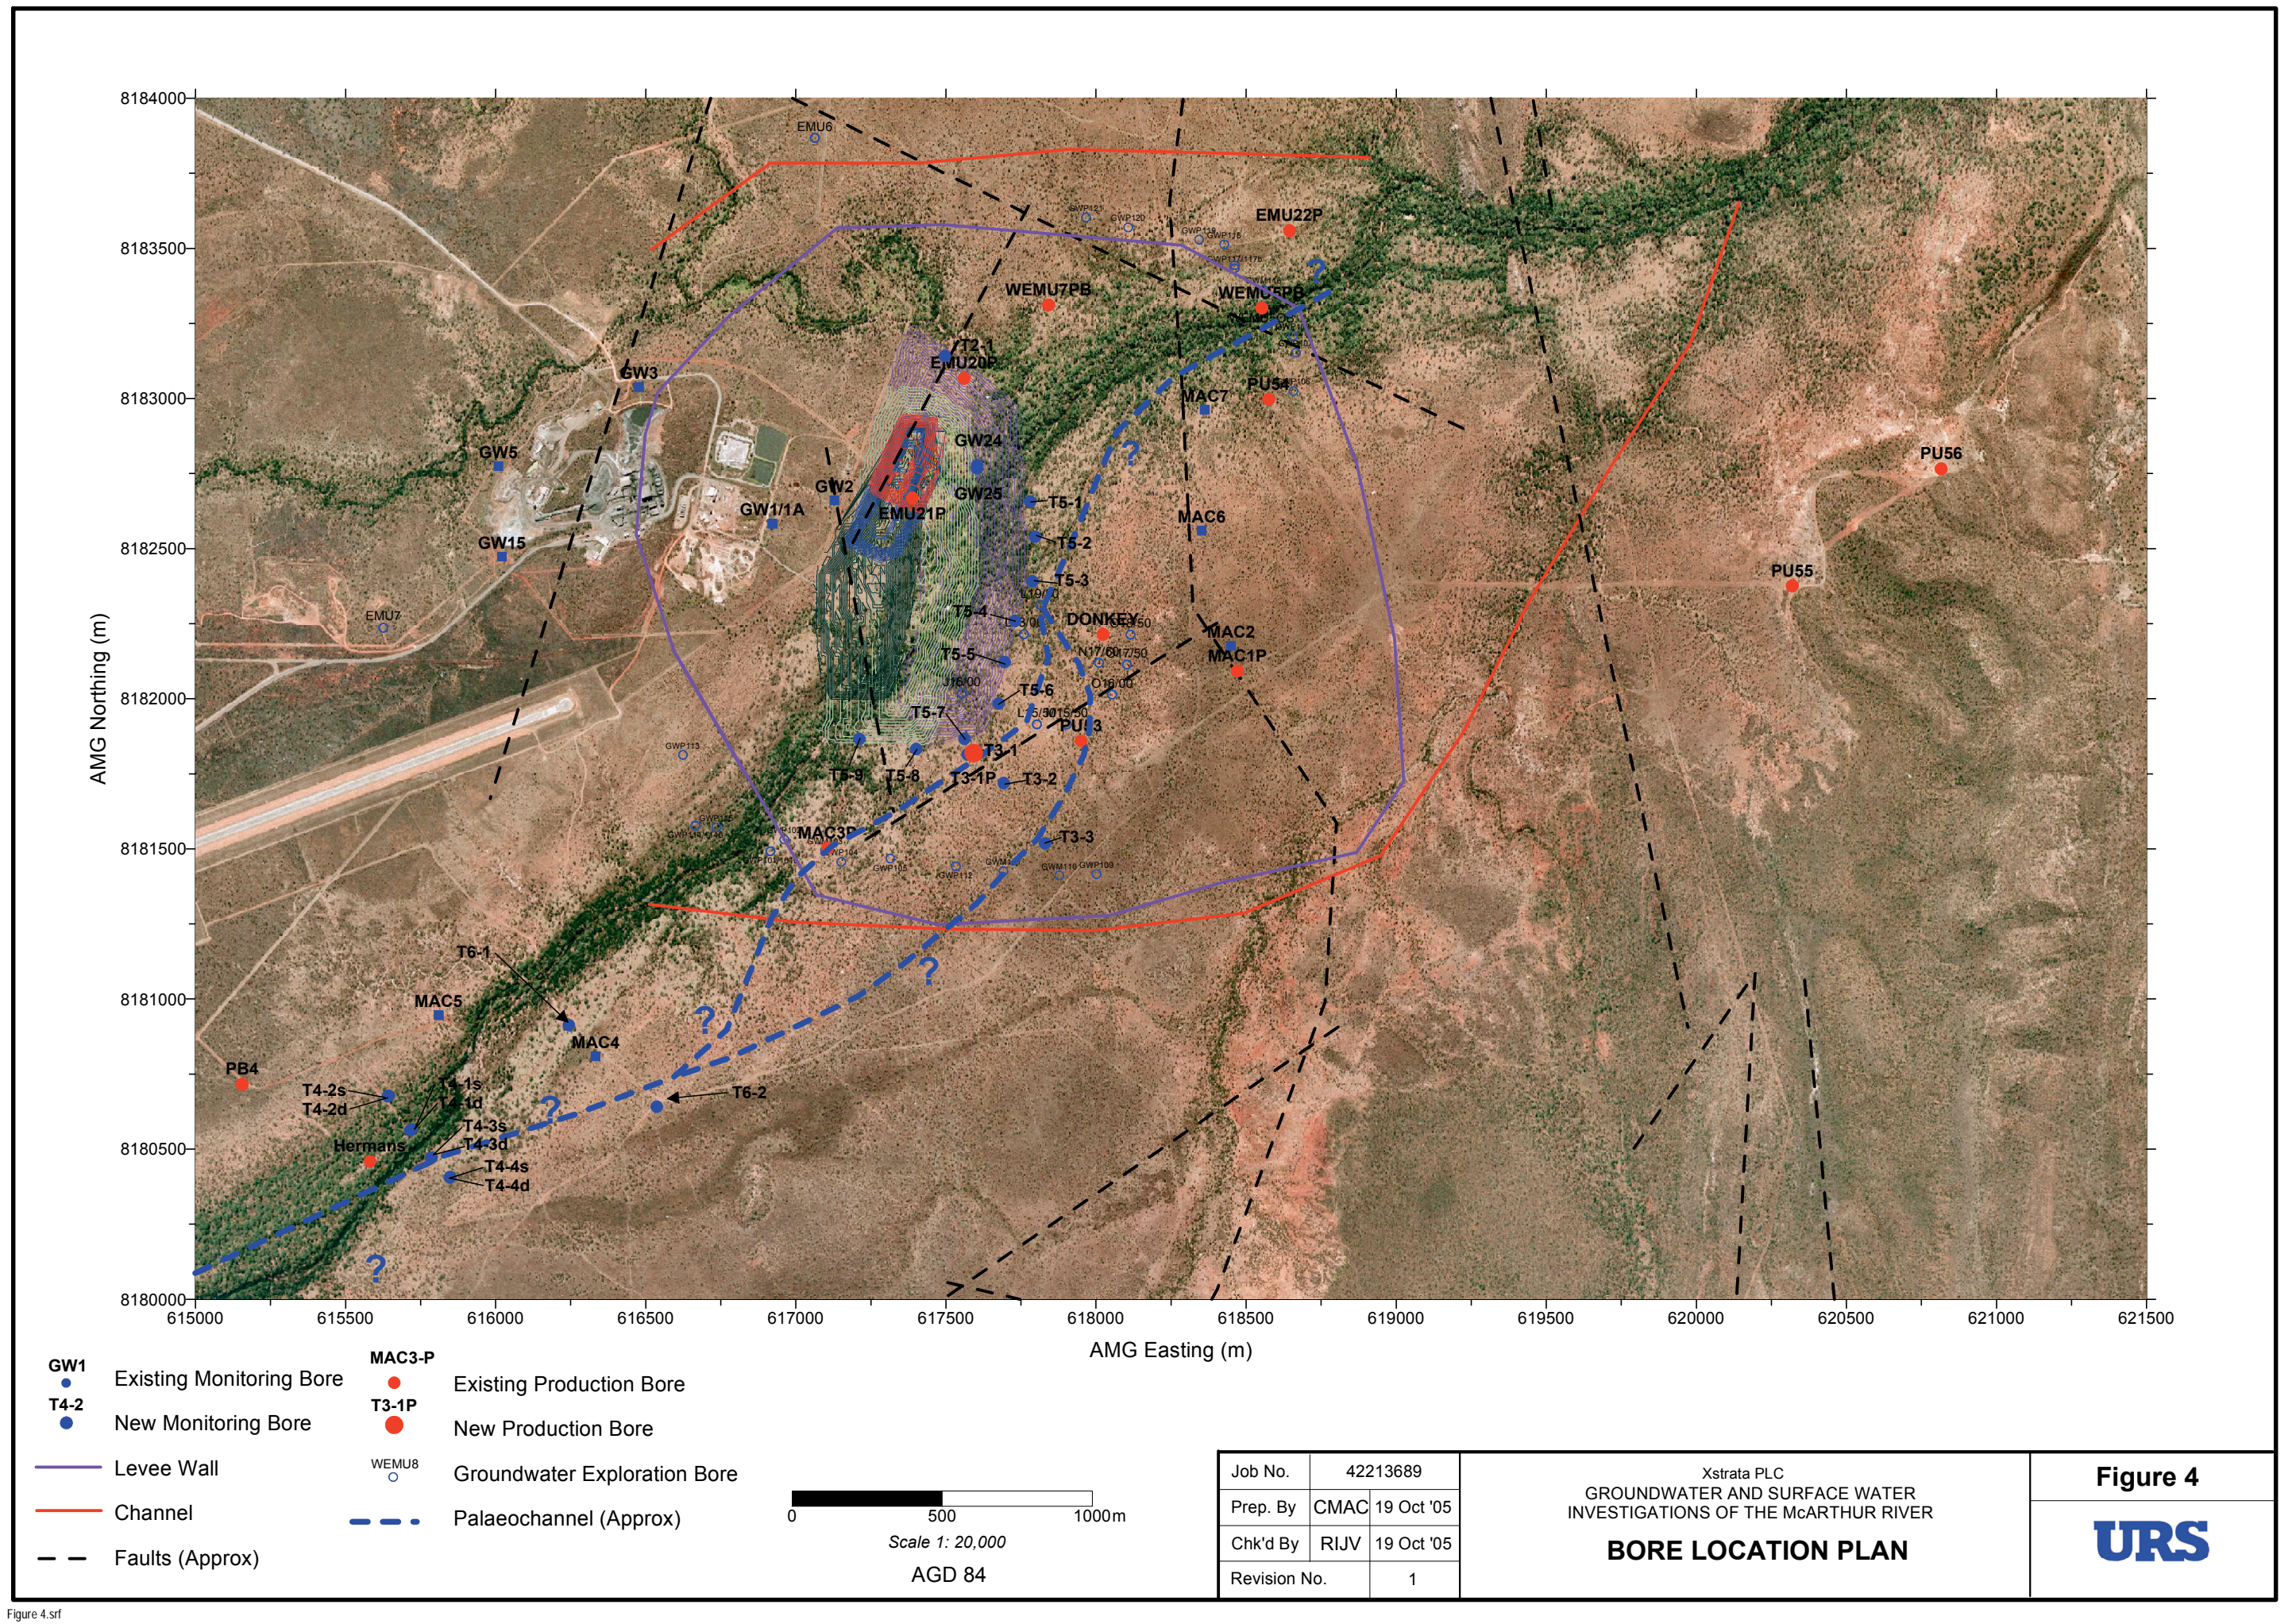
Figure 4
URS

- **GW1** Existing Monitoring Bore
- **T4-2** New Monitoring Bore
- Levee Wall
- Channel
- - - Faults (Approx)
- **MAC3-P** Existing Production Bore
- **T3-1P** New Production Bore
- **WEMU8** Groundwater Exploration Bore
- - - Palaeochannel (Approx)

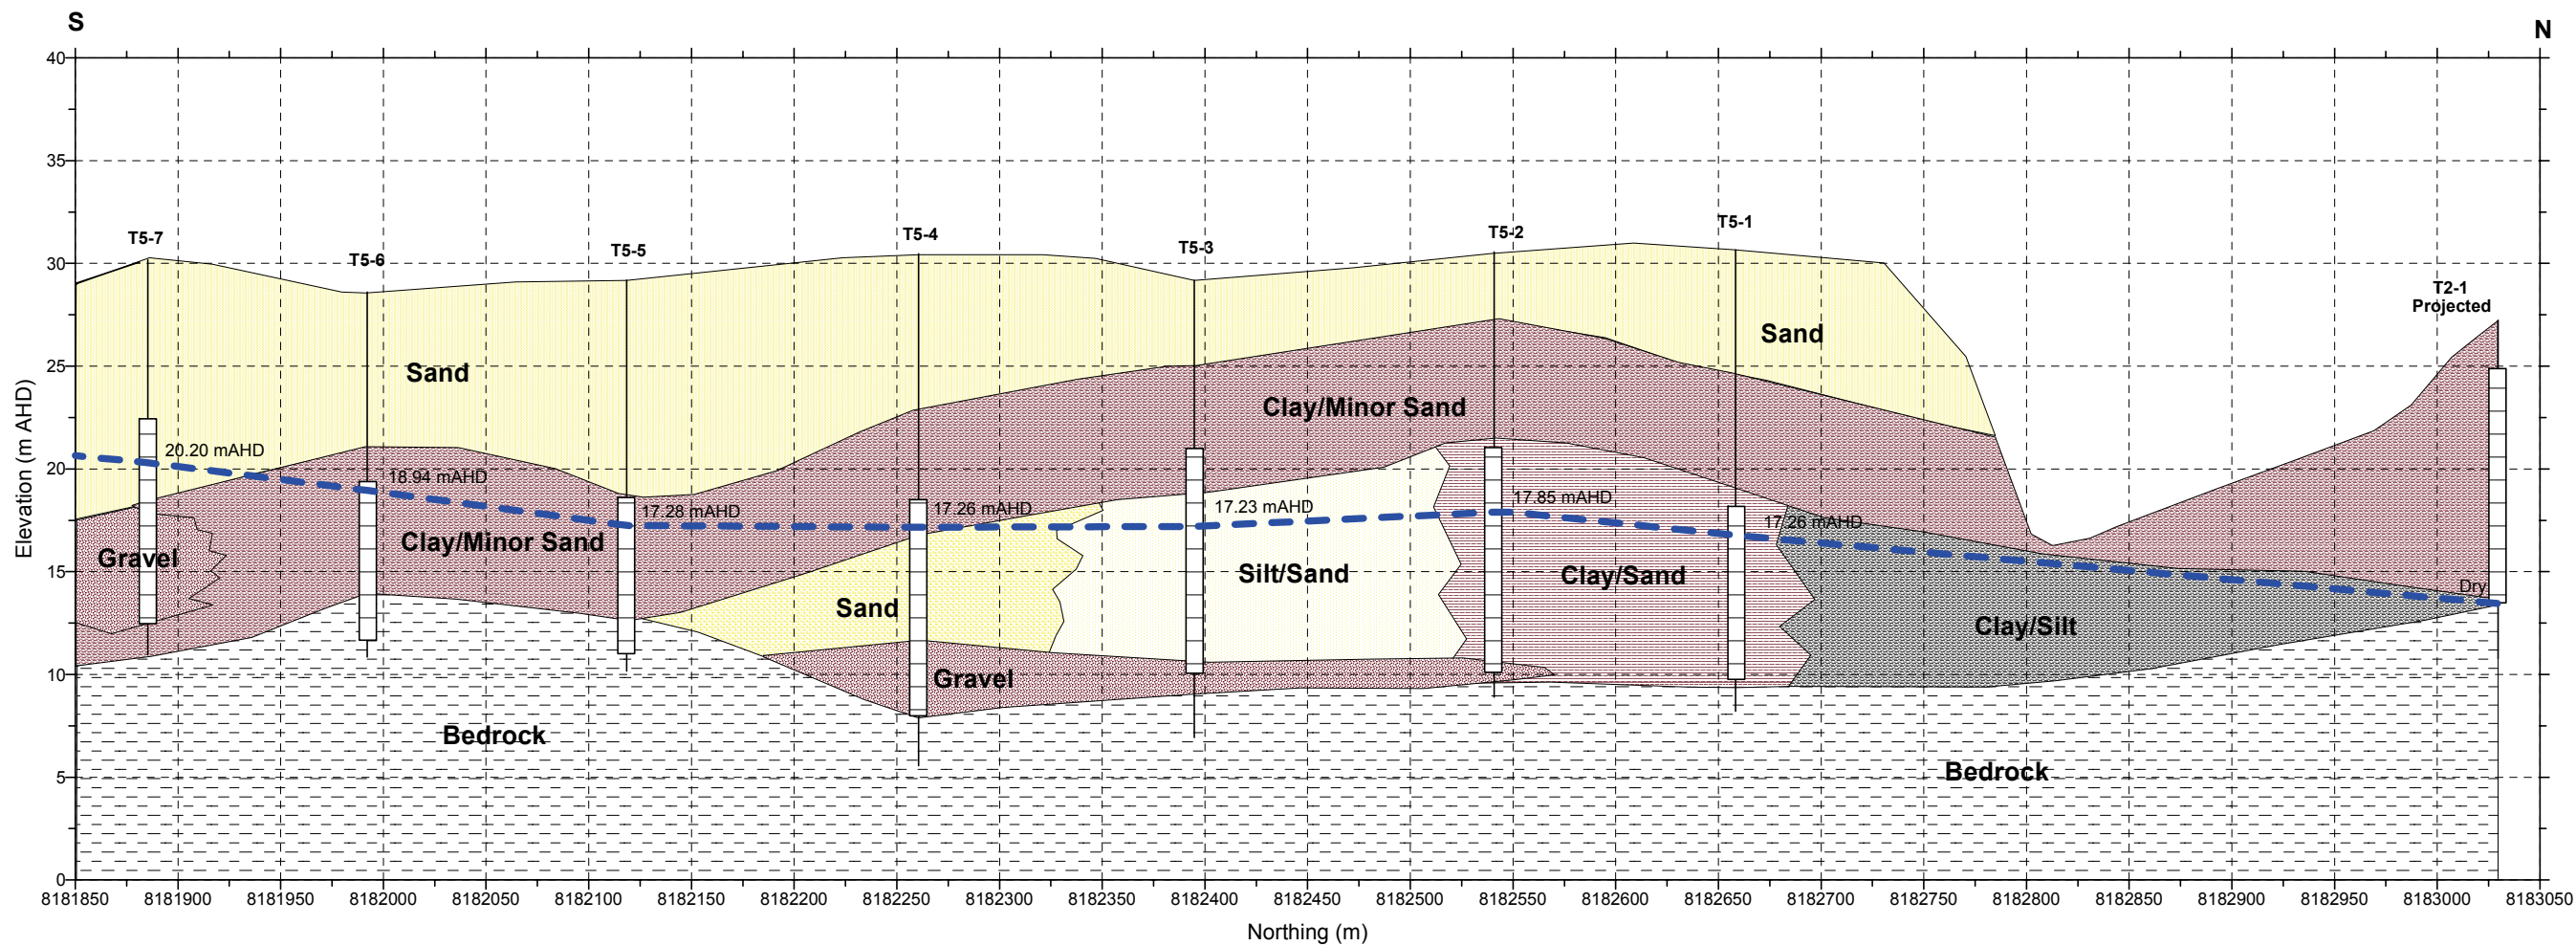
Figure 6

S.W.L Date - 16/10/2005

Groundwater Elevation

Screen Section

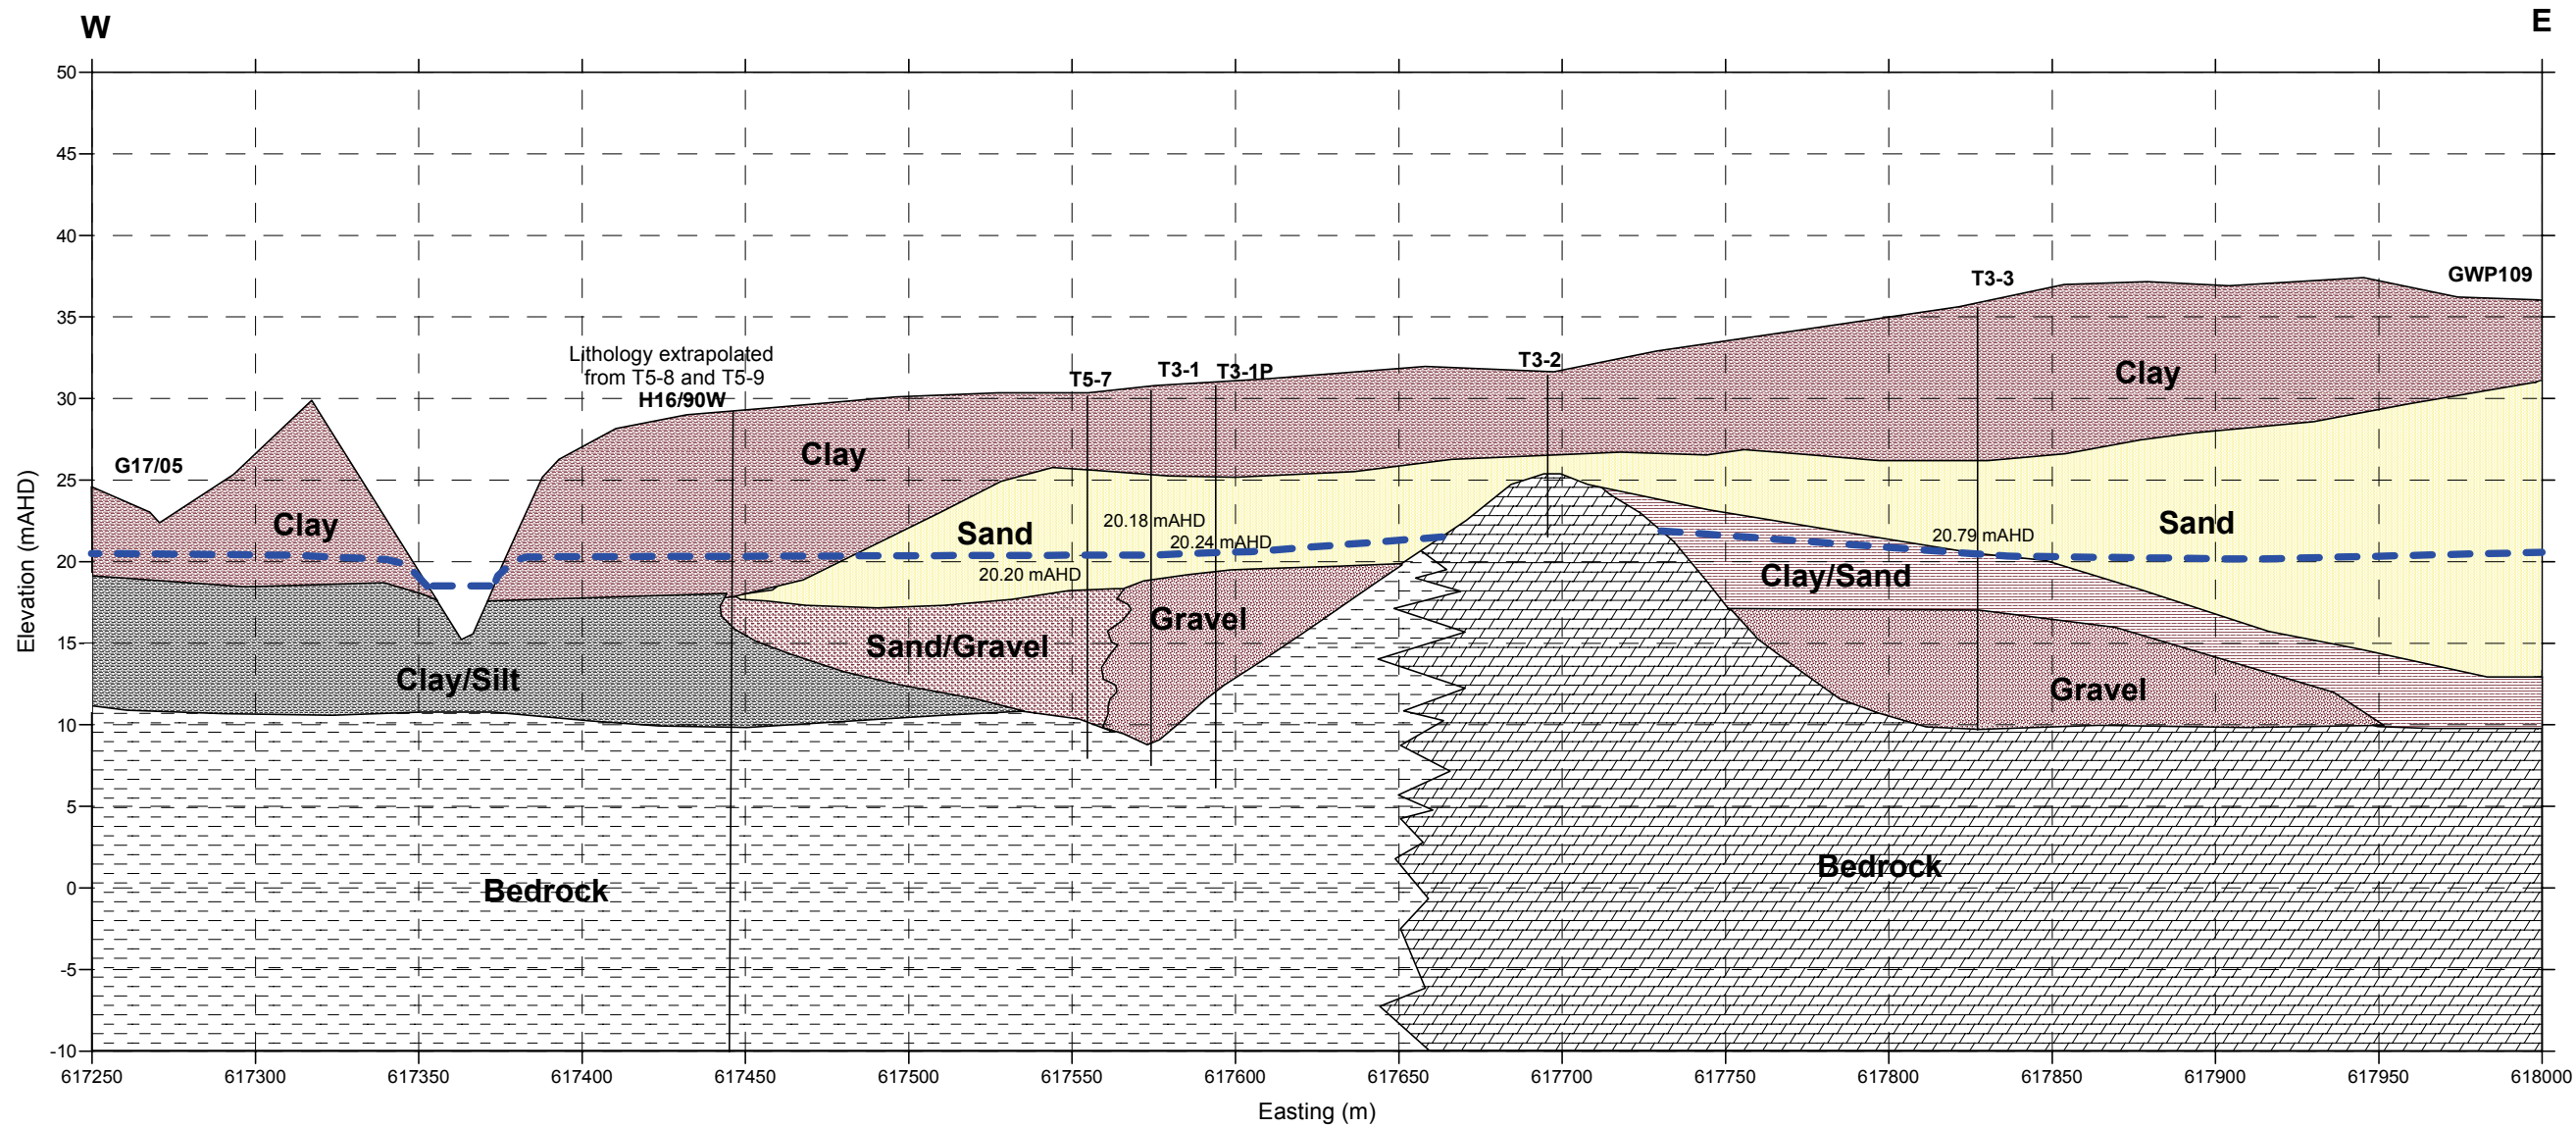
Figure 7

S.W.L Date - 16/10/2005

Groundwater Elevation

Screen Section

Xstrata PLC
 GROUNDWATER AND SURFACE WATER
 INVESTIGATIONS OF THE McARTHUR RIVER
**SOUTHERN PIT
 HYDROGEOLOGICAL SECTION**
