# **Mt. Todd Waste Rock Dump Closure**

## **ASSESSMENT REPORT**

**Project Number: 613**

**July 2020**

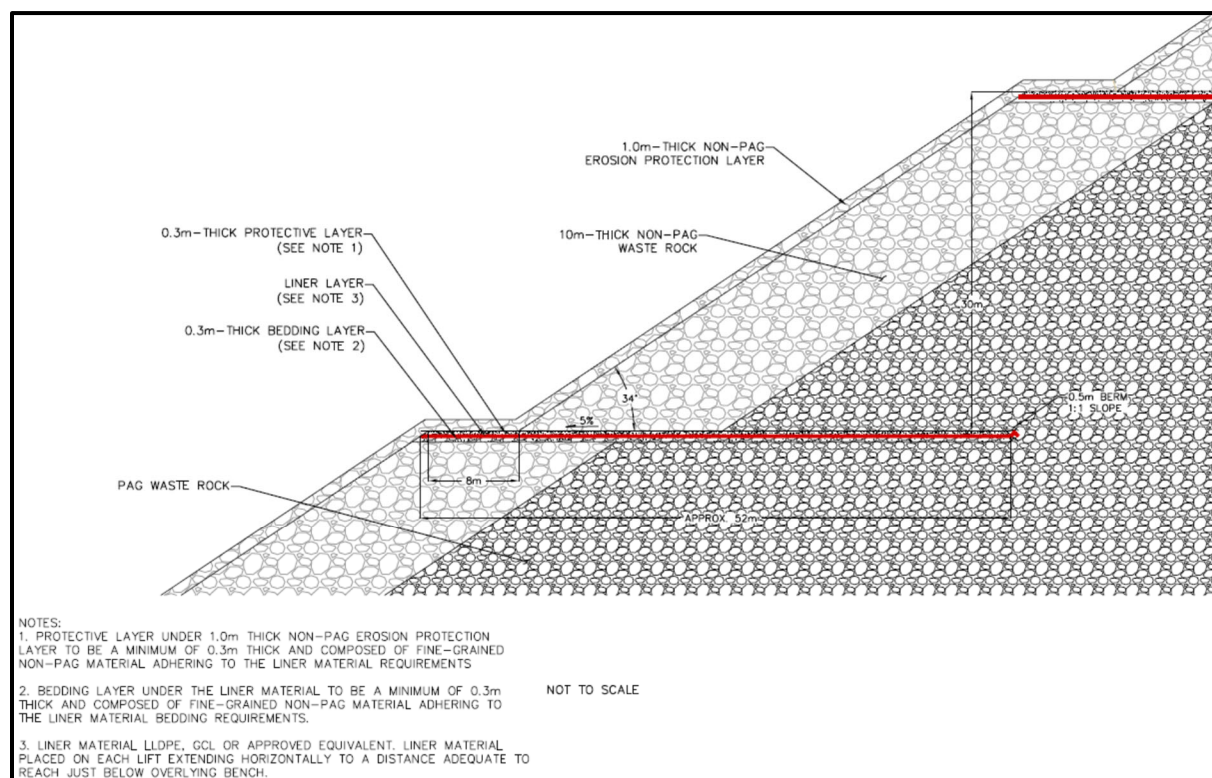
The WRD will be constructed with an encapsulating NAG waste rock outer shell on each waste rock lift. A low permeability liner (GCL or LLDPE) will be installed on top of each 30-m lift (Figure 3.5) as it is completed to limit infiltration into the PAG at the WRD’s core. The liner system will include a 0.3 m thick bedding layer of fine soil to act as a liner cushion and an additional 0.3 m of fine soil will be placed over the liner to prevent damage during waste rock placement. The liner will extend 52 m on top of the completed lift into the dump interior. The waste rock/liner bedding will be graded at 5% to drain to the WRD outer face. At ultimate buildout, a liner will be placed over the regraded WRD top surface to shed water to the WRD perimeter and prevent infiltration into the PAG core.

**FIGURE 3.5: WRD INTERLIFT LINER CONFIGURATION (TETRA TECH, 2019B)**

The proposed petticoat liner system proposed for the WRD introduces a liner (either GCL or LLDPE) into the WRD cross-section every 30 m (vertically). The liners will be installed on waste rock graded at 5% toward the outer WRD slope face. Generally, waste rock has a relatively high internal shear strength, as evidenced by the steep slopes (1.5H:1V of 35 degrees) proposed for the WRD. The introduction of a liner at the base of each 30m lift introduces a “slip plane” that can lead to slope instability. One of the key drivers to stability will be the interface friction angle achieved between the GCL (or LLDPE) and the fine-grained bedding material proposed to protect the liner. In the case of GCL, internal shear of the GCL itself must also be evaluated.

The effectiveness of the petticoat liner system approach to the WRD closure is dependent upon the liner installed on top of each 30m lift to drain intercepted seepage to the WRD bench minimizing contact with PAG waste rock. The liners will be installed at a minimum 5% slope to promote flow to the WRD exterior slope. Truck-placed, end-dumped waste rock will settle over time as additional lifts of waste rock are placed over the initial lifts. A 5% slope over 52 m, provides 2.6 m of vertical relief from the liner initiation point to its end point. The magnitude of waste rock settlement will be driven by the thickness of additional waste rock placed over the liner; areas out near the face will have less coverage (and experience less settlement) than areas under the crest of the next lift. If excessive settlement were to occur, the slope of the liner could be reduced and potentially reversed, allowing collected seepage to flow into the PAG as opposed to avoiding contact. This is stated as an extreme case but is nonetheless possible.

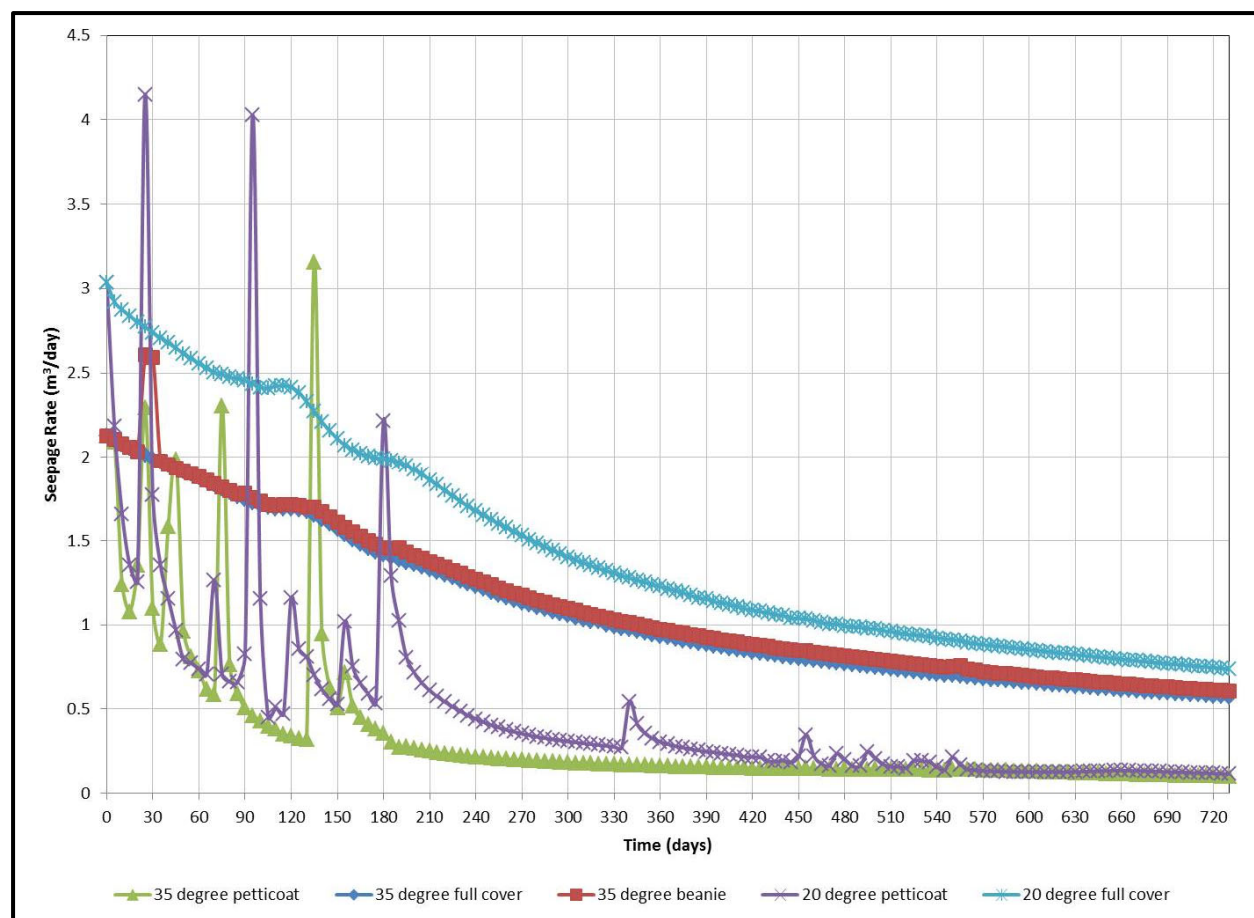
Table 3.1 presents a summary of the results obtained evaluating alternative WRD slope geometries and covers. Figure 3.6 provides a graphical summary of model output, focusing on the predicted seepage rate from the WRD base. Table 3.1 shows that modeling predicts the full cover option would result in the lowest seepage volume from the facility (measured as a percentage of annual precipitation); however, the full cover option has constructability limitations. GCL requires a soil cover providing confining pressure to resist bentonite swelling for optimal permeability performance. A GCL cannot be installed on a 35-degree slope and covered with a fine-grained fill, without significant erosion and soil loss occurring from the slopes. The 20-degree full cover option is limited due to the required footprint for the WRD cover. The 35-degree petticoat option provides the best performance without constructability limitations identified for the full cover options.

**FIGURE 3.6: FLUX RATES FROM 2011 ALTERNATIVES ANALYSIS (TETRA TECH, 2018)**

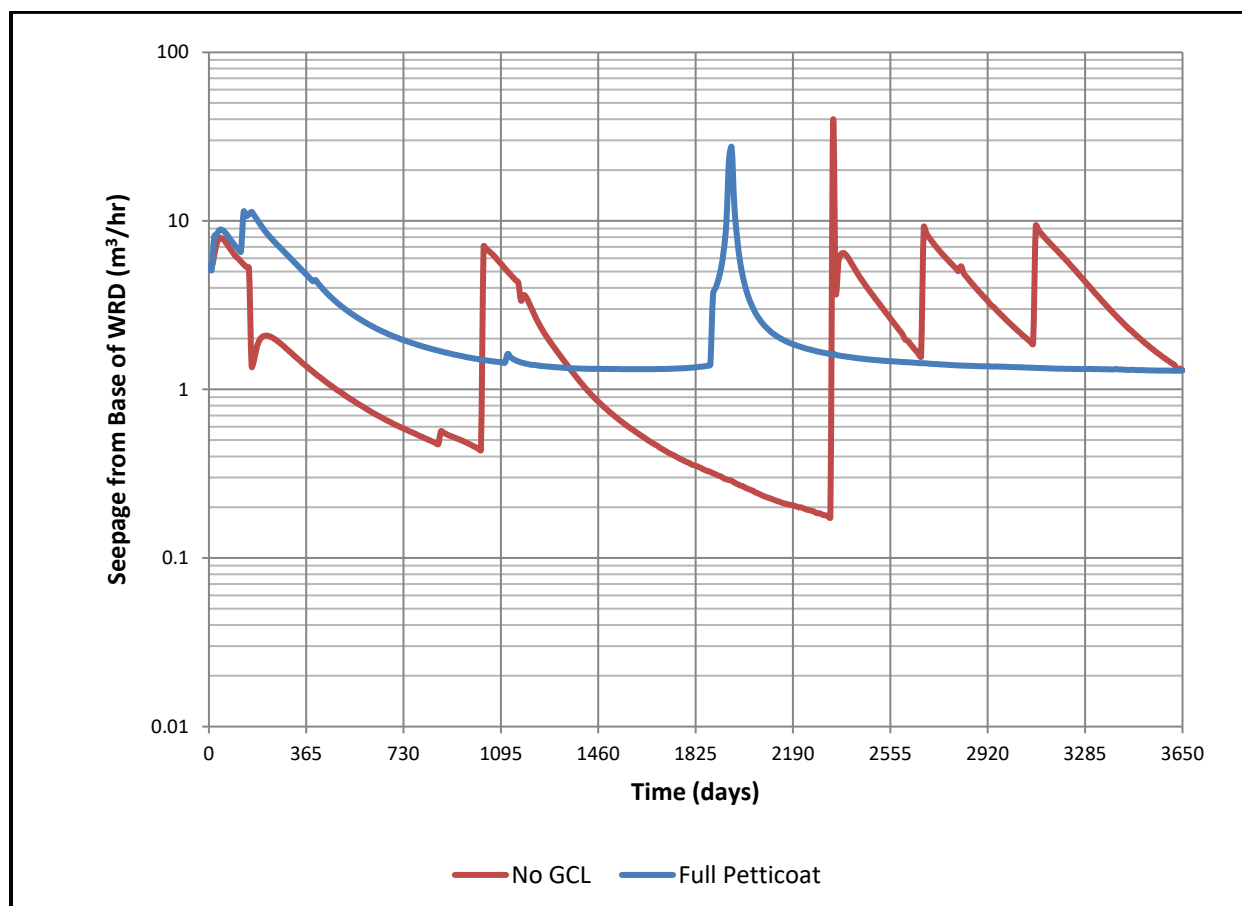
Tetra Tech revisited the petticoat design in 2012, extending the GCL further back along each bench from the outer edge into the waste rock a total of 52 m. The GCL length extends to a point vertically beneath the crest of the subsequent waste rock lift placed over the GCL. This configuration provides a more continuous measure to limit seepage along the outer waste rock shell and prevents contact with the PAG stored in the WRD interior. As can be seen in Table 3.2 and Figure 3.7, extending the length of the GCL significantly reduces the predicted amount of seepage from approximately 13% of annual precipitation down to approximately 7% of annual precipitation in the simulation. The 2012 modeling was completed using the same climate record (1 year of data from Katherine Aviation Museum meteorological station) as the previous modeling, but the model was run for a total of 10 years (as opposed to 3 years in previous modeling).

**FIGURE 3.7: FLUX RATES FROM 2012 SEEPAGE ANALYSIS (TETRA TECH, 2018)**

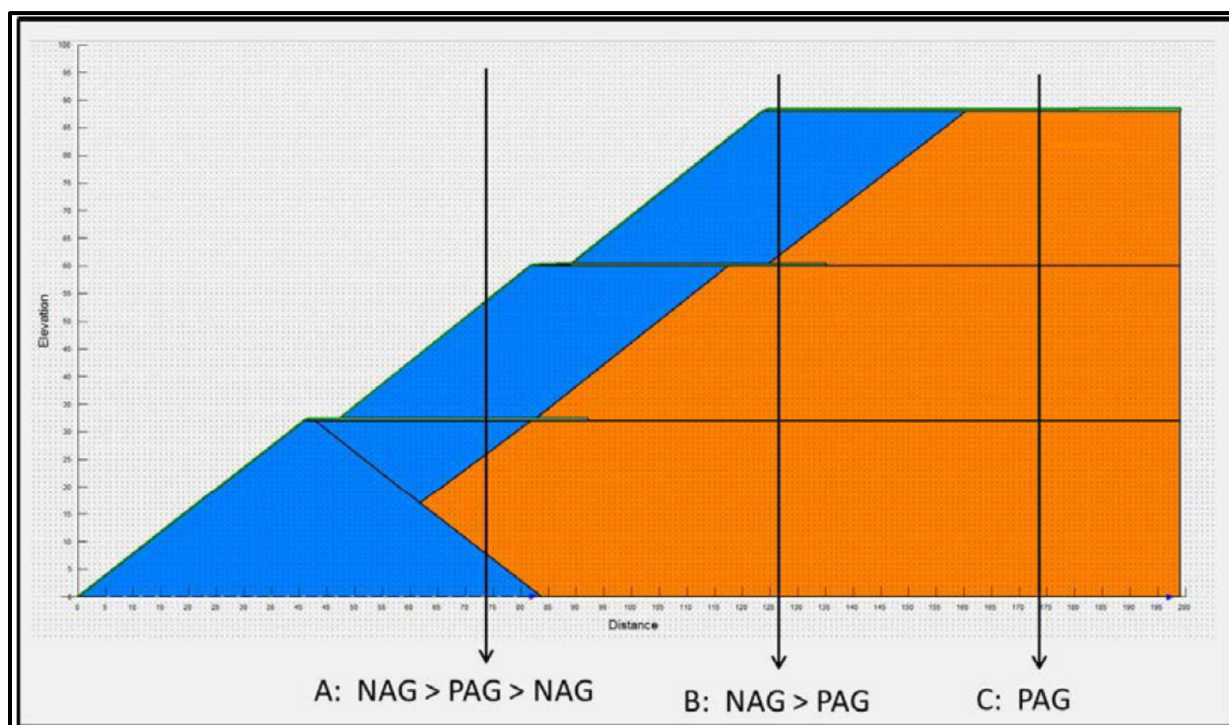
Tetra Tech evaluated resultant seepage water quality using the computer code PHREEQC. The model was used to evaluate the resultant seepage water quality of three potential pathways through the WRD, each containing differing relative amounts of contact with PAG and NAG waste rock. The three paths described by Tetra Tech are presented in Figure 3.8.

**FIGURE 3.8: EXPECTED WRD FLOW PATHS AND MATERIAL CONTACTS (TETRA TECH, 2019a)**

Table 3.3 is a summary of predicted water quality from the PHREEQC model. A detailed review of the PHREEQC modeling was not completed by Tierra Group. The results of the modeling appear to be reasonable and follow the anticipated outcome that seepage flowing through PAG resulted in lower pH, higher sulfate concentrations, and higher constituent (metals) loads.
