FOUNTAIN HEAD GOLD PROJECT

MINE CLOSURE PLAN

01238D_3_V5

NOVEMBER 2021

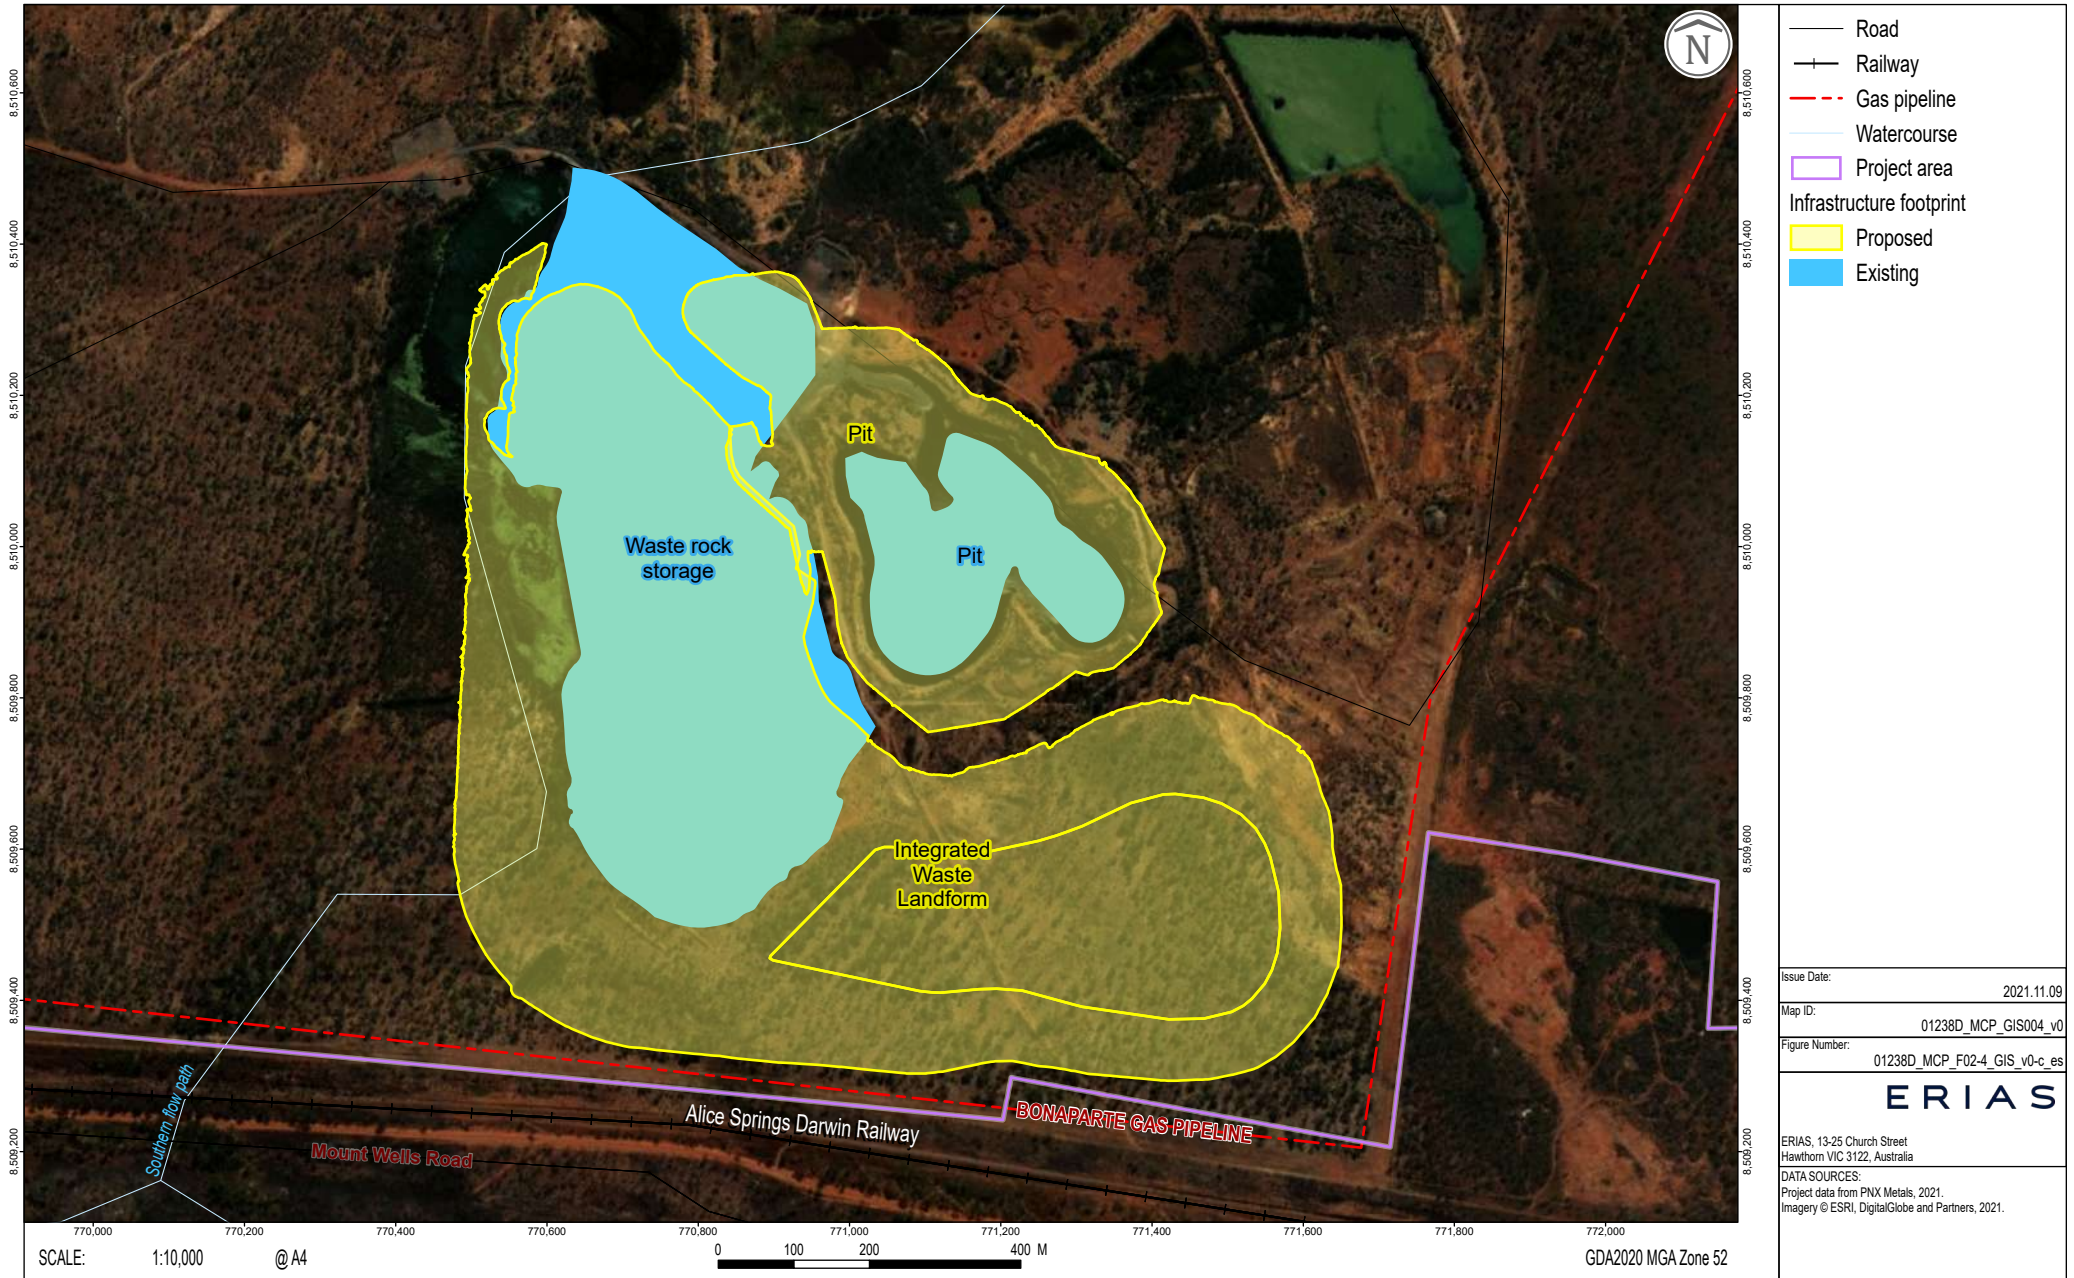
PROPOSED FOUNTAIN HEAD PIT AND IWL IN COMPARISON TO EXISTING PIT AND WRS

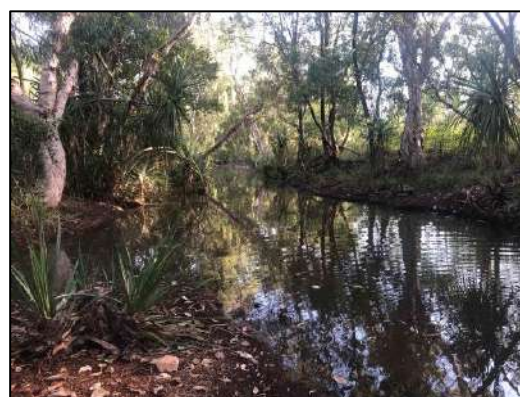
Plate 5.4 – Pit Lakes and Tailings Dams

Flora and fauna surveys were conducted by Low Ecological Services in May 2017 and August 2019 (Appendix 8 of the EIS). Five habitats were identified during the on-ground survey within the Project area; open forest on alluvial floodplain, open woodland on sandstone plain, creek lines and riparians zones, pit lakes and tailings dams and disturbed areas. Examples of these habitats in the Project area are shown in Plates 5.1 – 5.5, and their locations are shown Figure 5.2.
