SLR Consulting Australia (2020) *Rum Jungle Rehabilitation – Stage 2A Detailed Design – Main Pit Backfill Strategy, Geotechnical Considerations*. Report to the Department of Mines and Energy, Northern Territory. PART A.

RUM JUNGLE REHABILITATION - STAGE 2A DETAILED DESIGN

**Main Pit Backfill Strategy
Geotechnical Considerations
Issued for Client and External Peer Review**

SLR Ref: 680.10421.90030-R03
Version No: -v2.0
June 2020

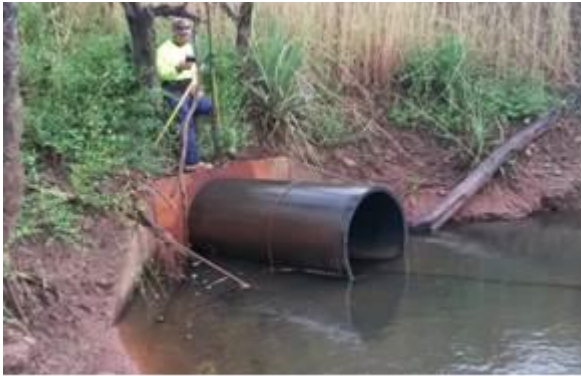
Figure 2 Main Pit Entrance April 2015 (left) and August 2019 (right). Steel Plate under rubble blocking pipe entrance visibility

Between April 2015 and August 2019 flows from the East Branch Finnis River (EBFR) were blocked from entering the Main Pit and all flow were diverted south of the Main and Intermediate Pits via the man-made Main Diversion drain. The inlet to the Main Pit has been sealed by means of a steel plate and loose earth placed over a DN1000 HDPE stub pipe protruding from the upstream headwall of a 1.5 m x 0.75 m reinforced concrete box culvert (RCBC) (refer **Figure 2**). Blockout material (most likely steel) has been used to seal the void between the two conduits. Prior to April 2015, low flows in the EBFR entered the Main Pit when water depths exceeded RL 60.64m AHD at the confluence of the Main Diversion drain and Main Pit spur channel to the south east of the Main Pit.

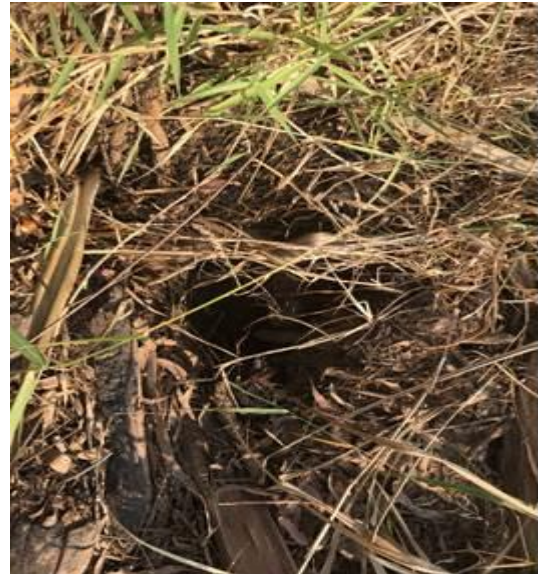
Main Pit Entrance August 2019

Flows into the Main Diversion drain commenced when water levels exceeded RL 62m AHD at the Main Pit entrance.

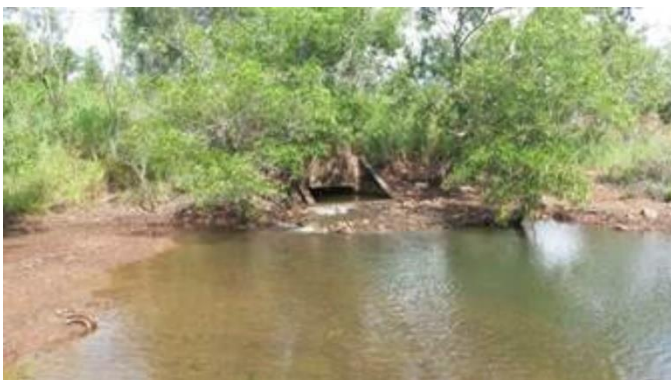
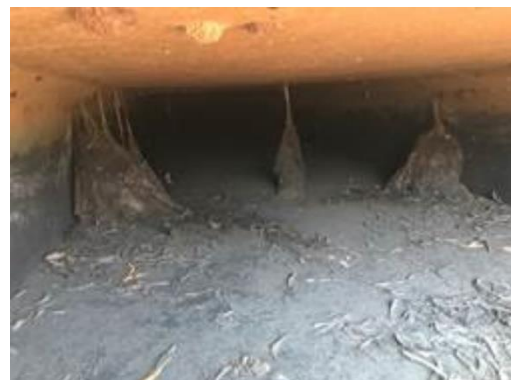
Figure 3 Outlet of the Main Pit. April 2015 (left) and August 2019 (right)

The water level in the Main Pit is controlled by a 2.4 m x 0.75 m RCBC outlet in north western embankment of the Main Pit. The invert of the culvert is 59.98m AHD. Sometime between April 2015 and August 2019 it appears the outlet of the Main Pit was blocked (**Figure 3**).

Main Pit outlet April 2015

Main Pit outlet August 2019

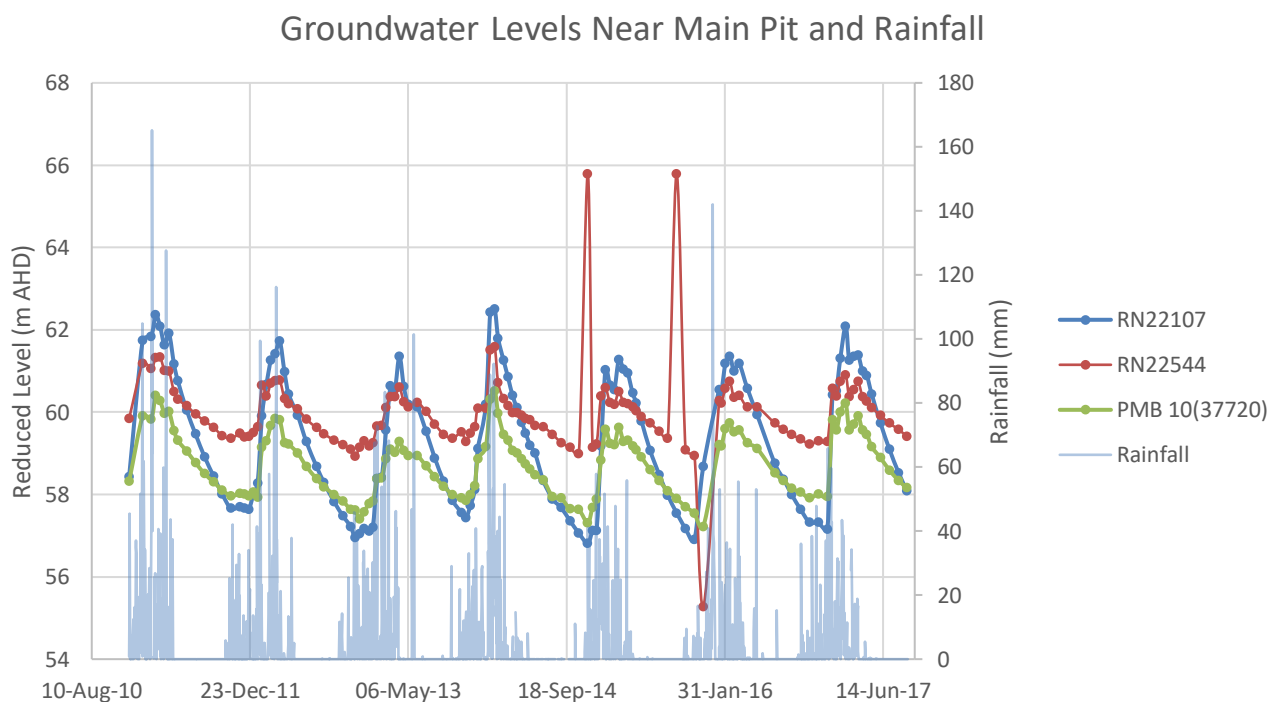
Figure 4 Annual Main Pit Surface Water and Groundwater Levels (DPIR Monitoring Data Dec-2010 to Aug-2017)

Seasonal fluctuations in the Main Pit’s water level have been recorded based on Main Pit proximal groundwater monitoring wells. Main Pit water level has been observed to be well connected to Monitoring Well RN22544. Groundwater levels in RN22544 vary between +58.95 m RL and +61.59 m RL and are presented in **Figure 4** along with proximal ground monitoring wells (RN22107 and PMB 10) and rainfall data collected from Batchelor Airport (Station No. 14272) (Bureau of Meteorology) located approximately 8 km south of the Rum Jungle Mine Site. It is noted the graphed maximum and minimum results recorded on 24-11-14, 01-09-15 and 24-11-15 are considered anomalous, and are ignored in the seasonal variation consideration.

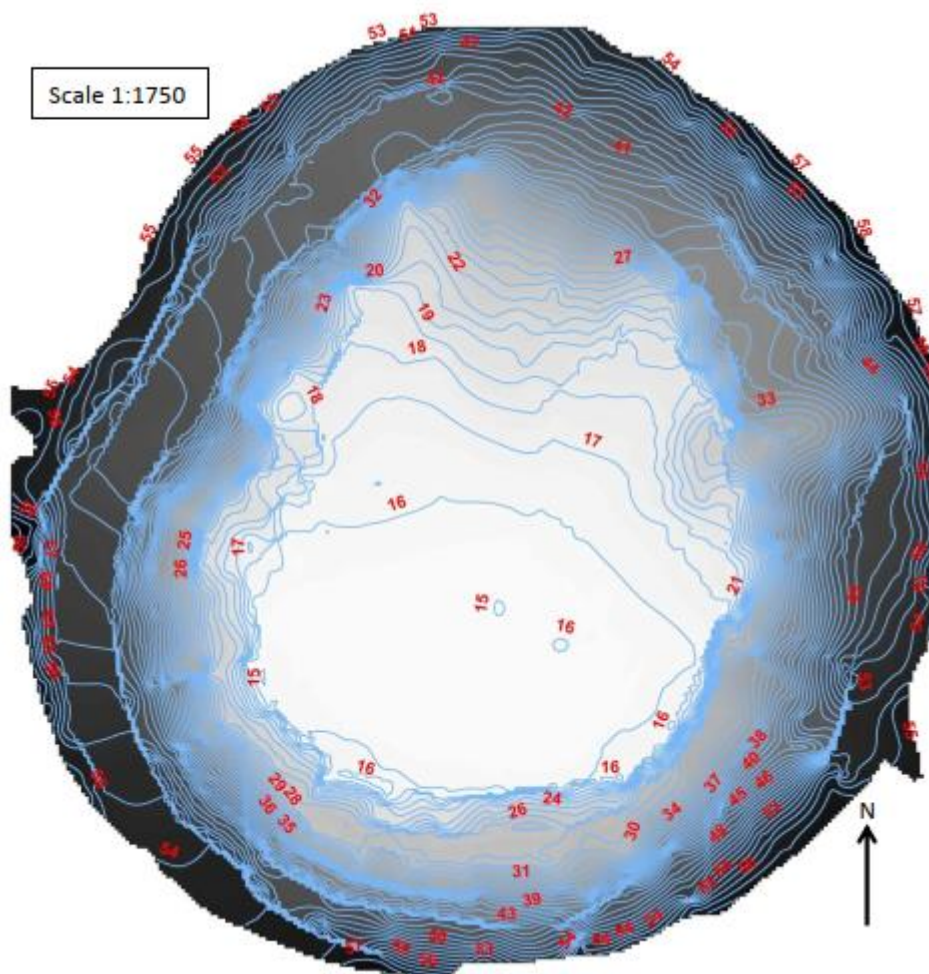
Figure 5 2015 Main Pit Bathymetric Survey (Miloshis and Fairfield [16])

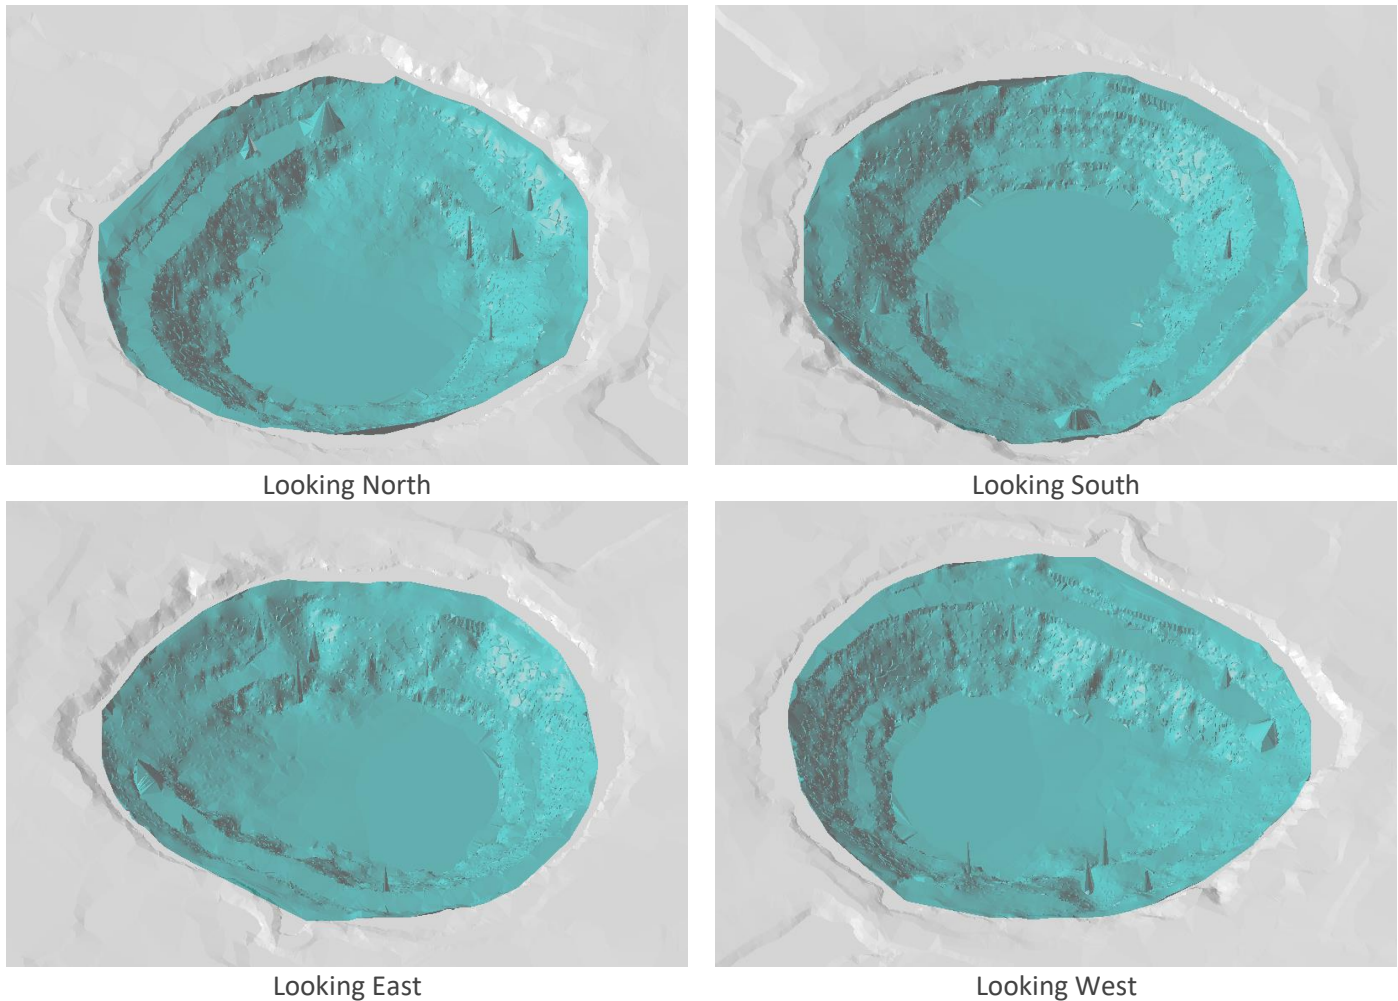
Figure 6 3D Obliques of Main Pit 2015 Surface (2015 Bathymetry Survey)

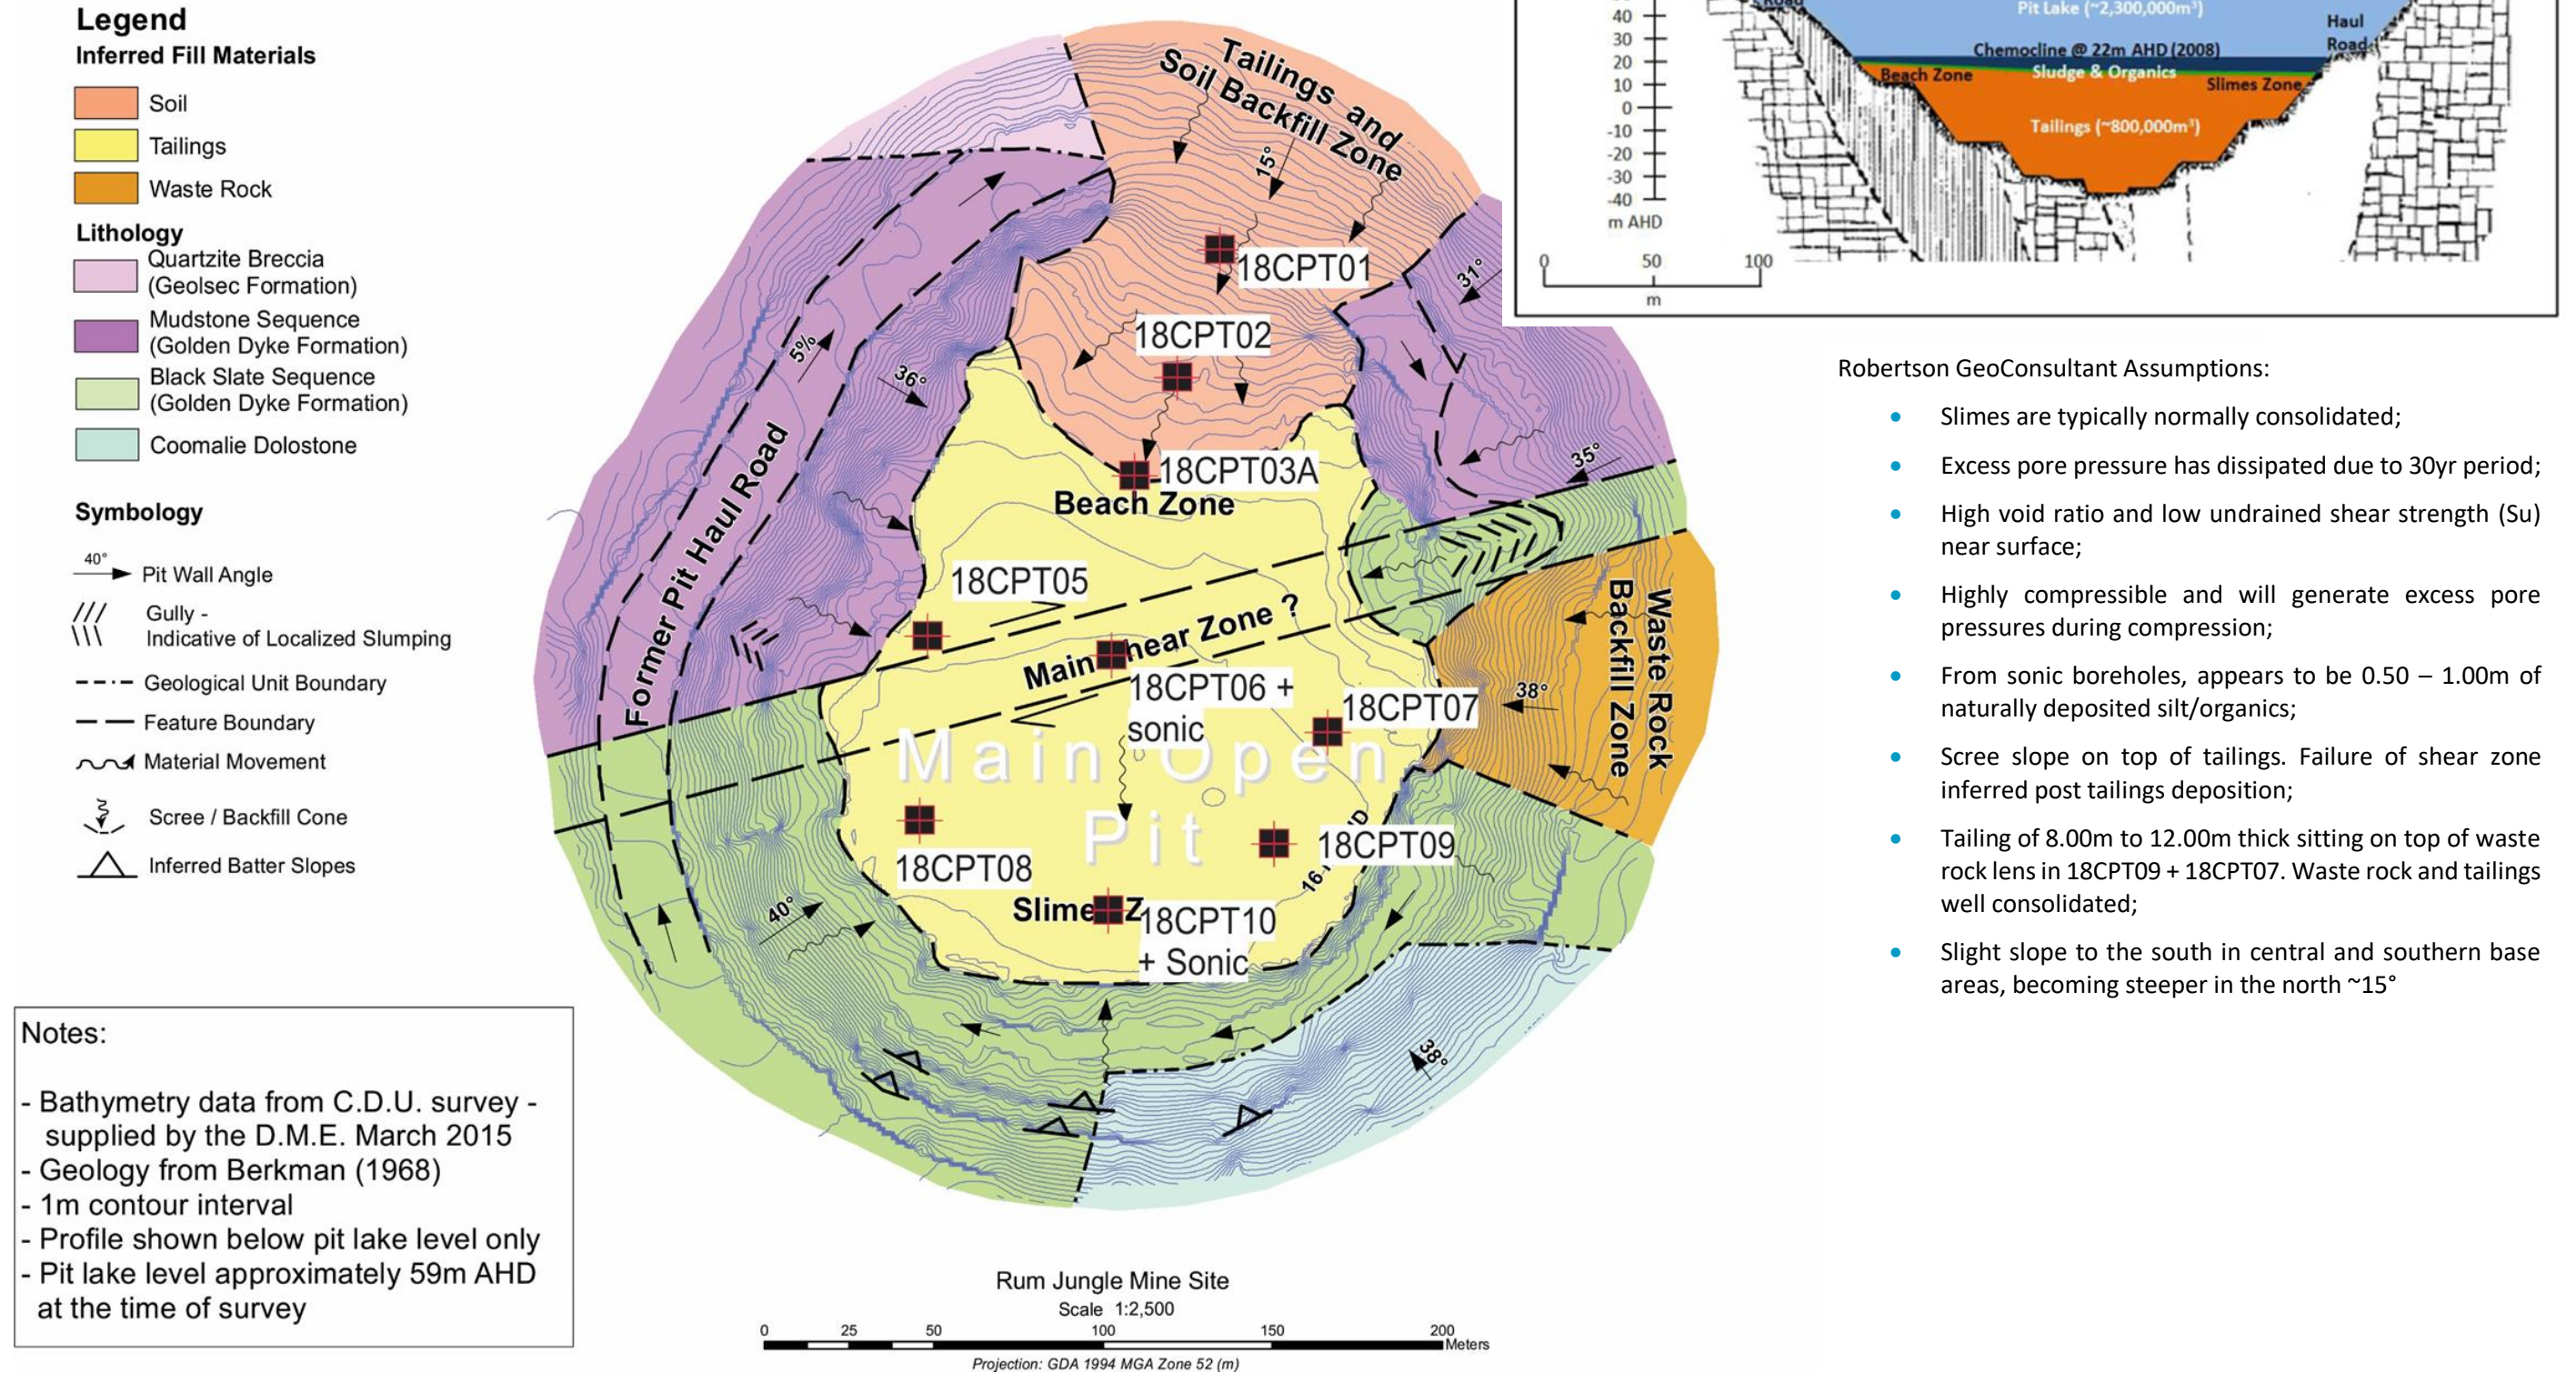
Figure 7 Historic Findings and Assessments

The geometry of the beach fan in the north (**Figure 7**) indicates coarse-grained material rather than tailings, which is consistent with test results in this area.

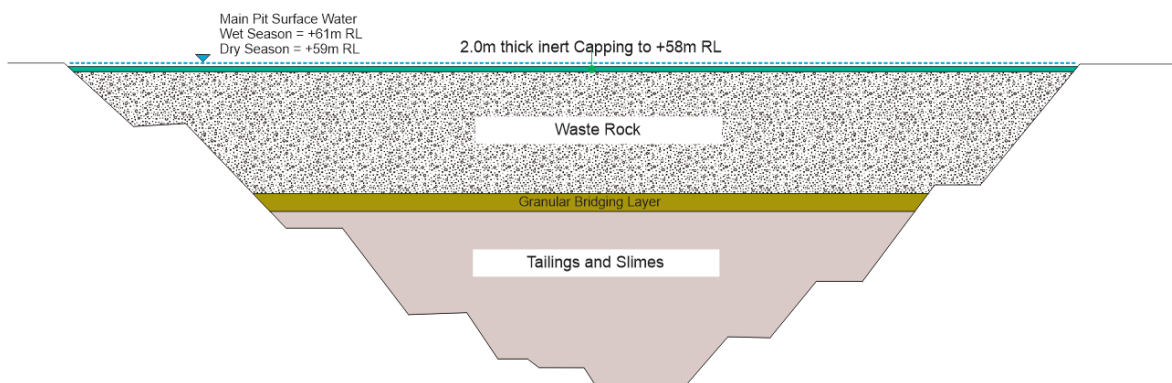
Figure 8 Generalised Main Pit Backfilled Profile

Further detail on the granular bridging layer material and inert capping layer material characteristics can be found in the 2020 SLR Geotechnical Report [26]. Details on the waste rock material characteristics, can be found in the Robertson GeoConsultants 2016 Physical and Geochemical Characteristics of Waste Rock and Contaminate Material Report [18]. The following provides a summary of the material characteristics as presented in the aforementioned reports.

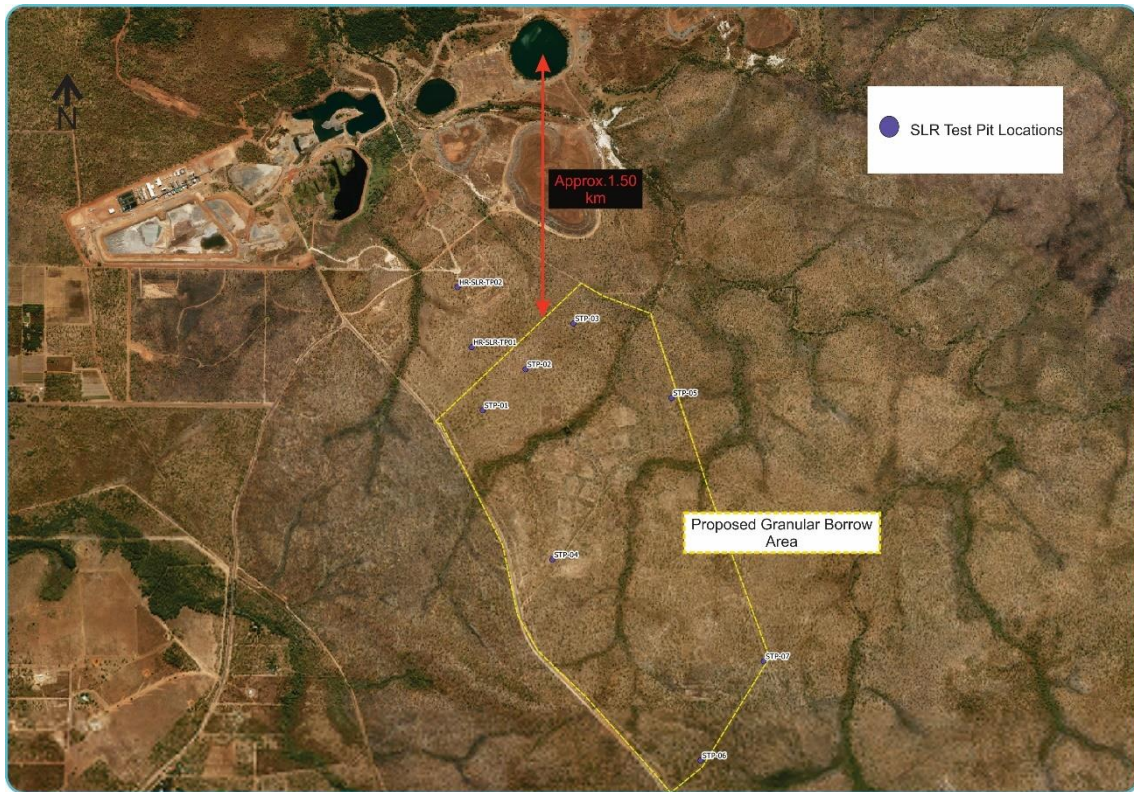
Figure 9 Granular Borrow Location

The granular borrow (Borrow Area B), located approximate 1.50 km south of the Rum Jungle Mine site was investigated by SLR in July and October 2019. The ground conditions encountered included thin and discontinuous topsoil and alluvium over residual soil derived from the underlying granite bedrock. The residual soil descriptions ranged from clayey SAND, gravelly SAND to sandy GRAVEL. The layer was found to be dense to very dense comprising fine to coarse sand and fine to coarse, sub-rounded to sub-angular gravel with occasional pale grey quartzite inclusions and granite derived cobbles. This material will be the main source of the bedding and inert capping backfill layers.

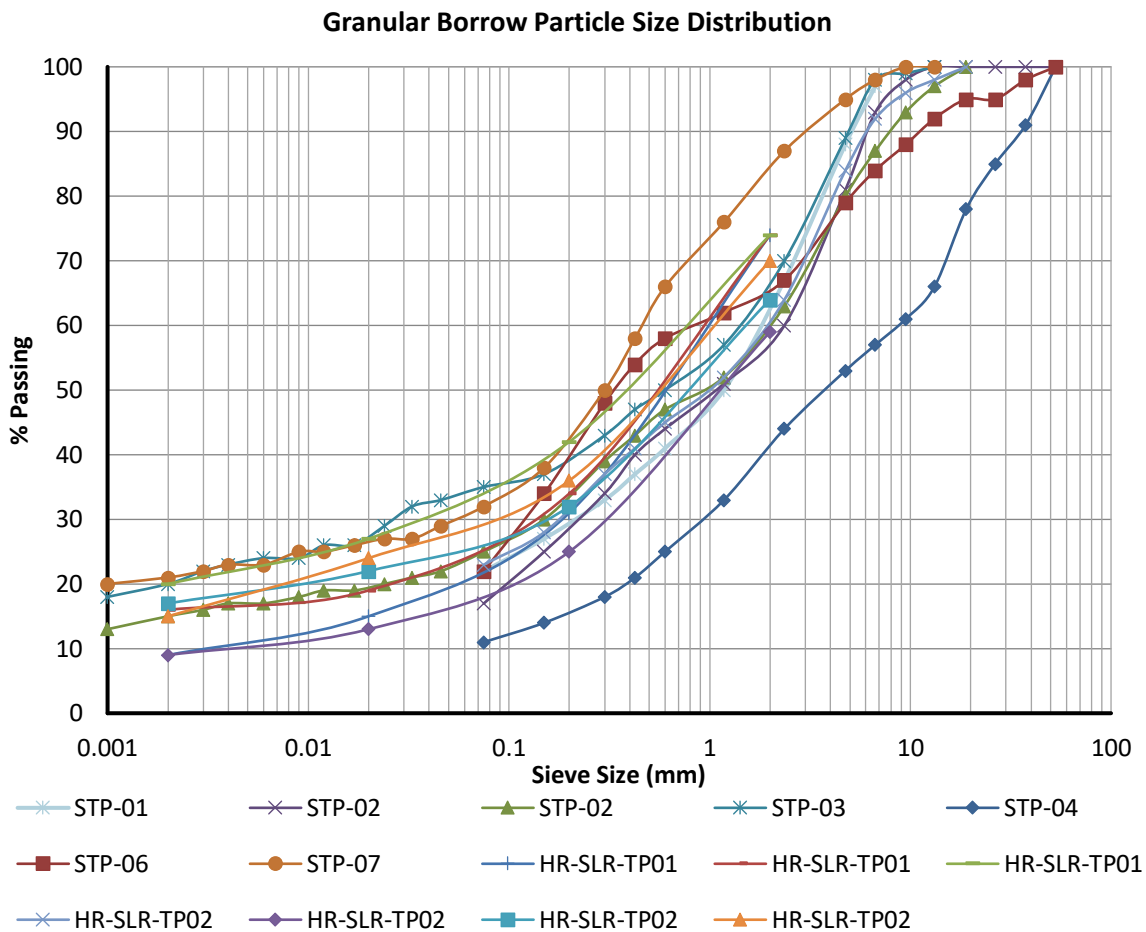
Figure 10 Compiled PSD Curves - Granular and Growth Borrow (Borrow Area B)

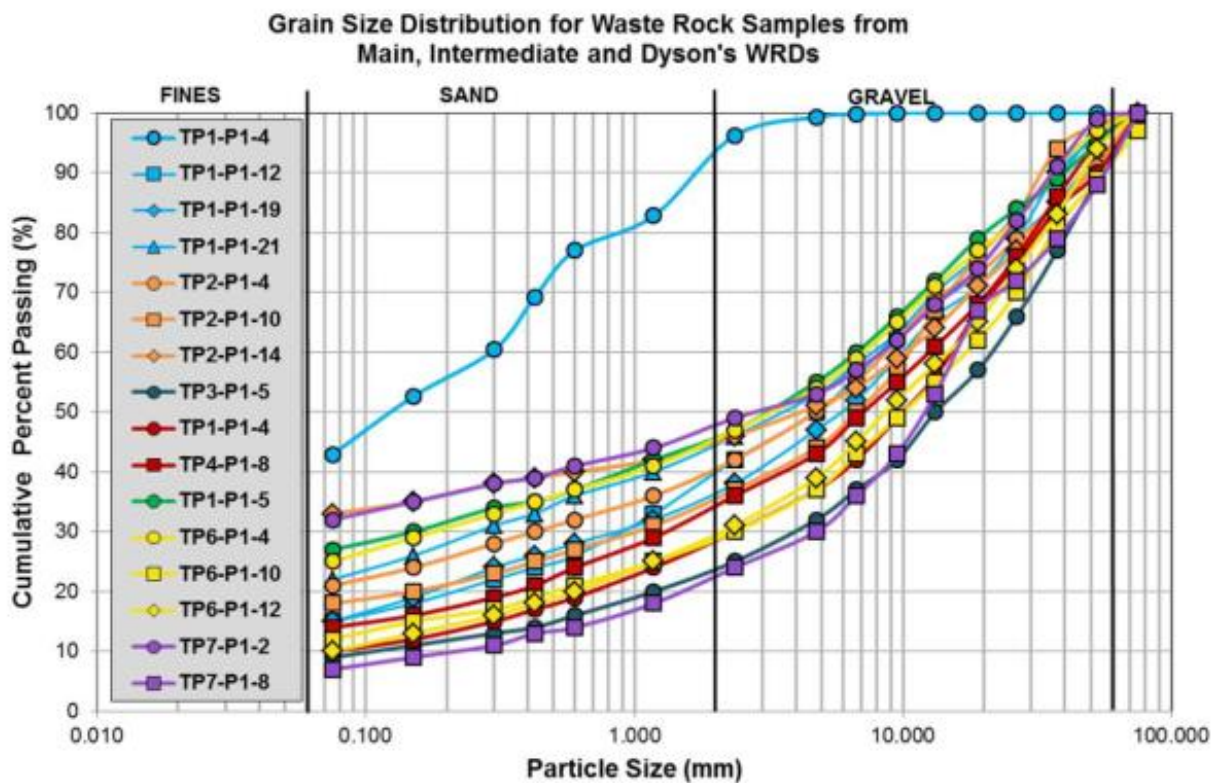
Figure 11 Waste Rock PSD Curves for Material <75mm (From RGC [18])

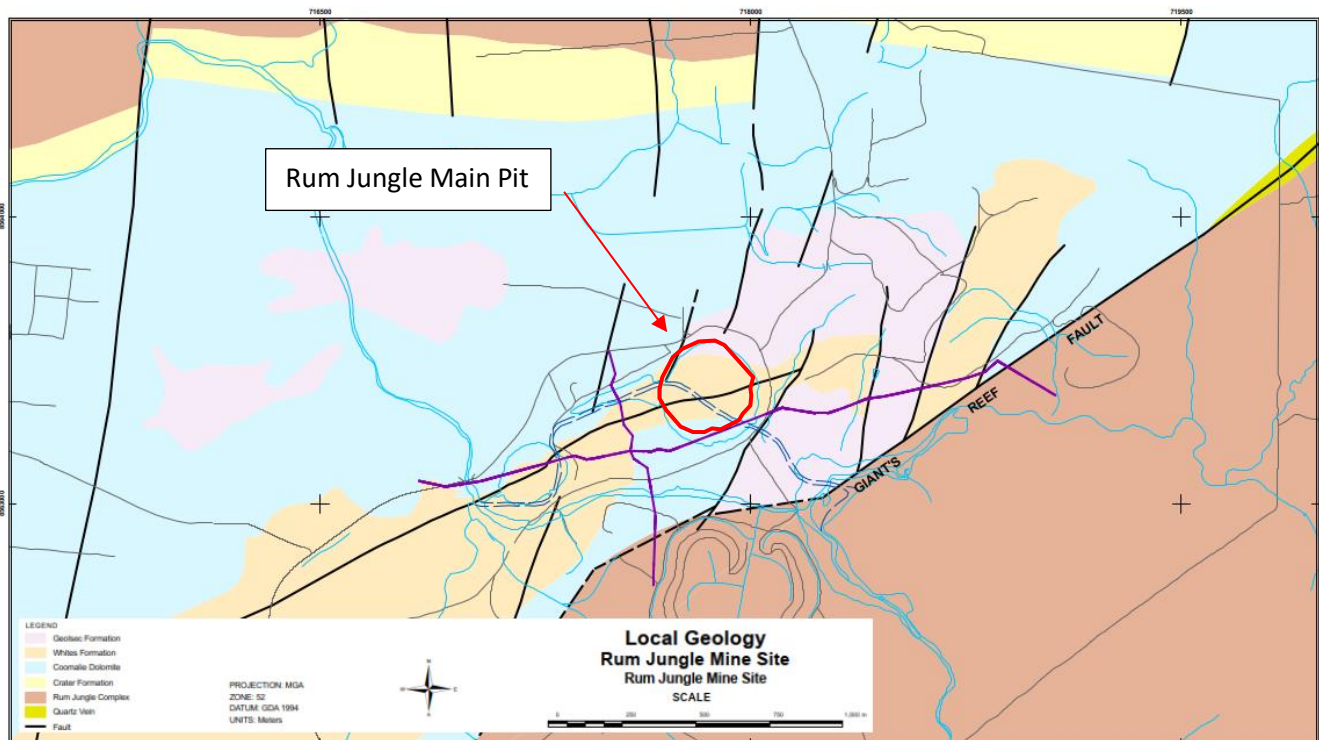
Figure 12 Rum Jungle Geological Setting – Reproduced from Robertson GeoConsultants (2012) [13]

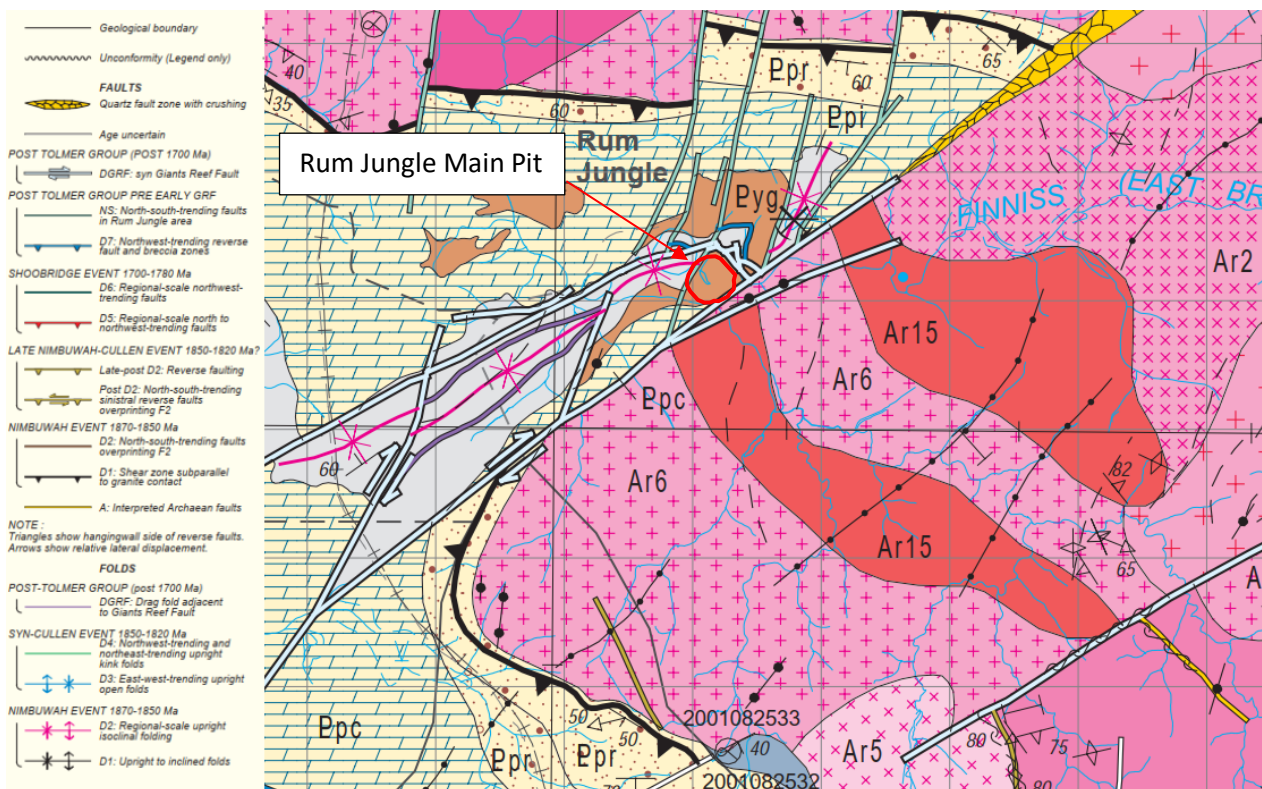
Figure 13 Rum Jungle 1:100:000 Geological Interpretation [30]

A series of north-north-east trending, steep and inferred westerly dipping faults associated with tectonic shattering cross-cut the syncline. A number of the contacts between the rock units of the Partridge Group are bound by these faults.

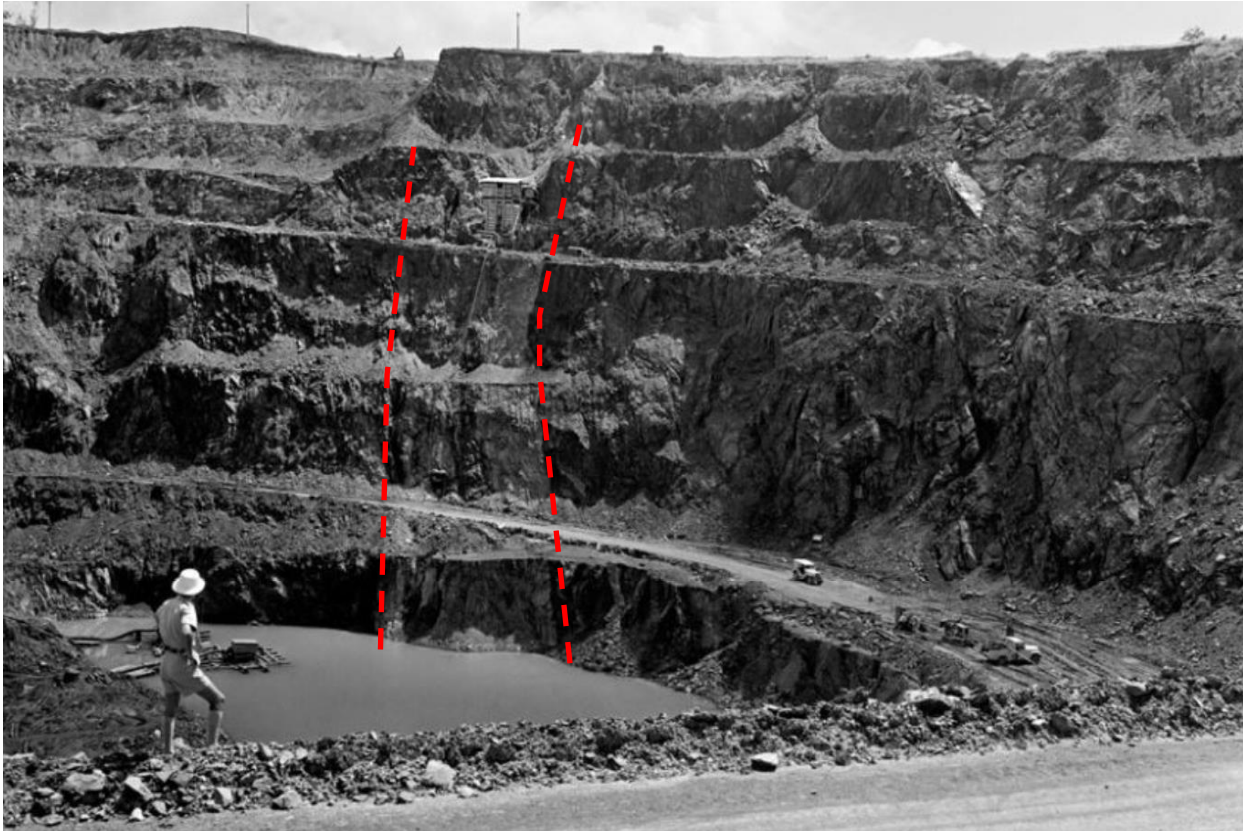
Figure 14 Photograph of White's Open Cut (Main Pit) in 1958 looking north-east along strike of the main shear zone (photo courtesy of National Archives of Australia:A1200,L25494 [8])

According to Williams (1963) [7], no detailed geological structural analysis was carried out in the Main Pit at the time of operations. The structure around the periphery is very complex, having been subjected to at least four generations of movement with brecciation in the later stages.

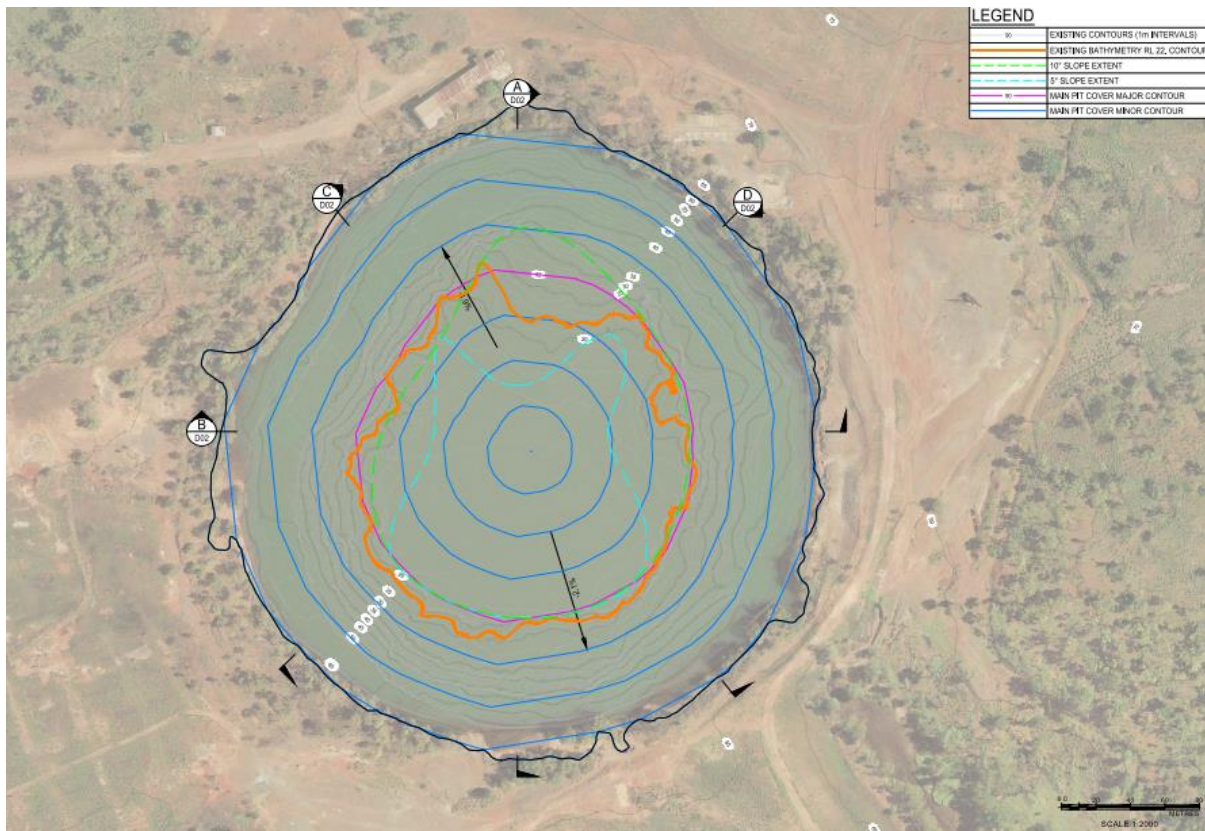
Figure 15 5° and 10° Slope Extent from Main Pit Centre

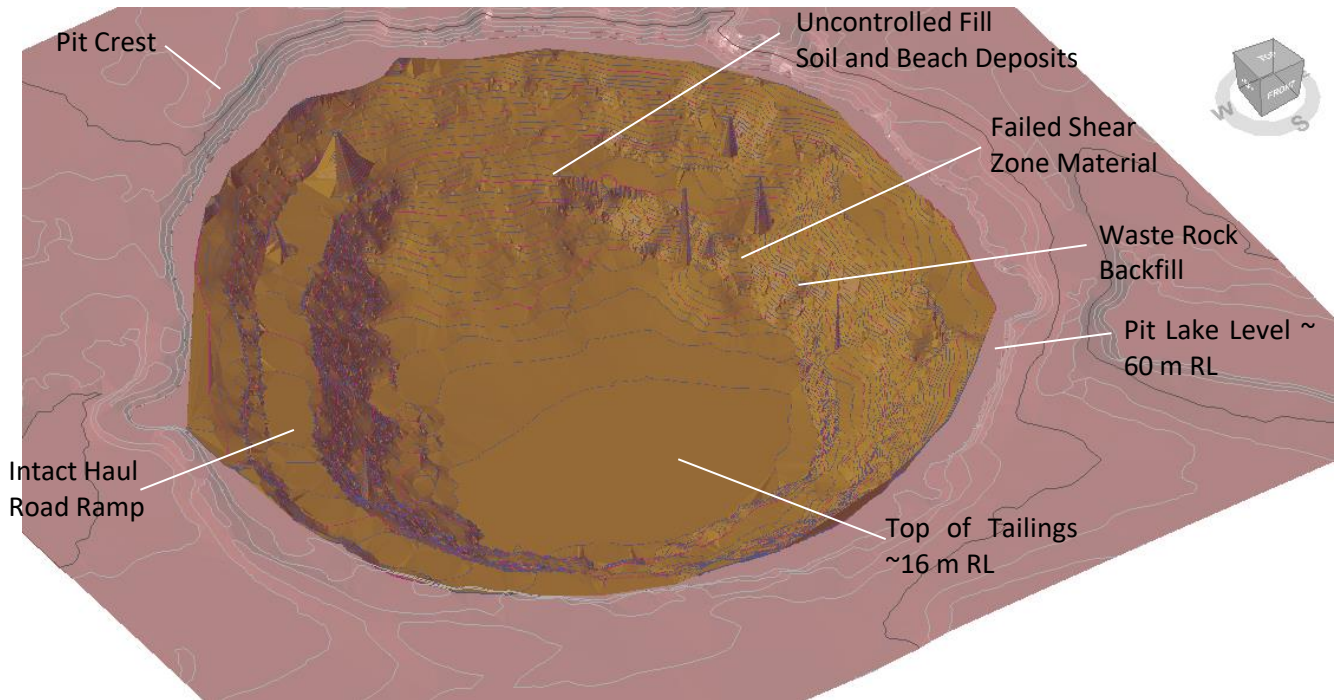
Figure 16 Oblique View of Main Pit 2015 Bathymetry Survey

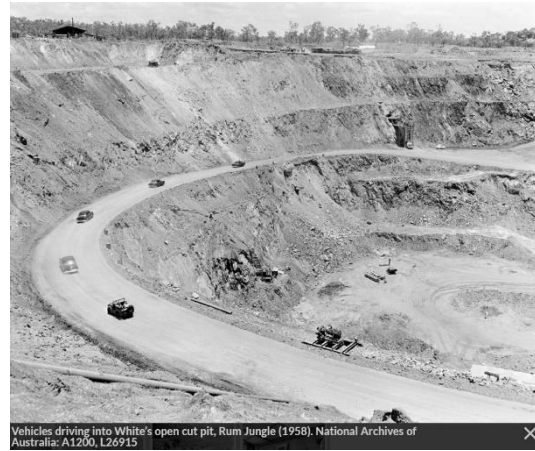
Pit Wall Conditions Near Pit Completion in 1958

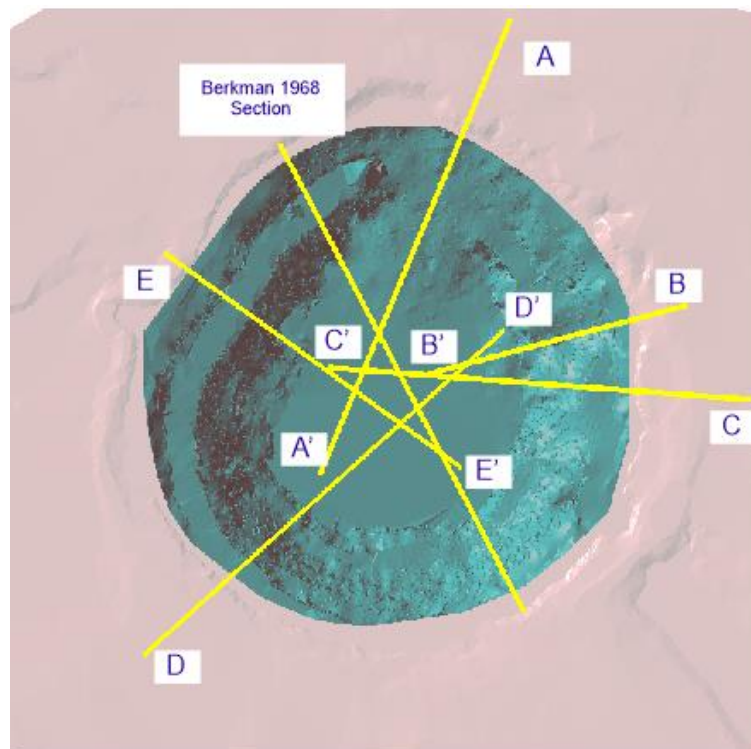
Figure 18 Main Pit Section Lines

In order to assess the stability aspects of the main pit rehabilitation activities, a geotechnical model was derived from the available information. A series of geotechnical sections (characterising the various rock types and their orientation with regard to the Pit Geometry) have been developed. The sections (**Figure 18**), are included in **Appendix B**.

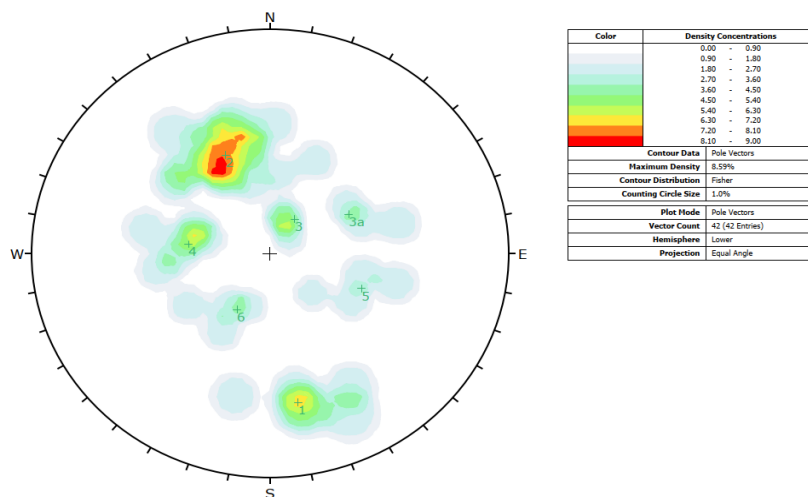
Figure 19 Pole Plot of Orientated Defect Data for Dolostone

A summary of the converted defect orientation data extracted from SRK boreholes is presented in **Appendix C** and a summary of the main joint sets (+/- 20°) identified is included in **Table 10** below.

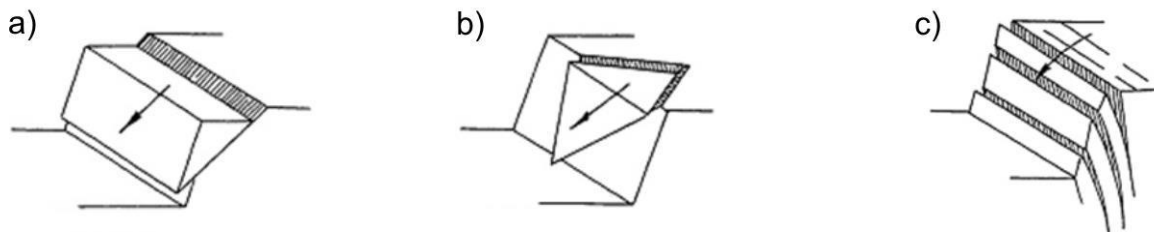
Figure 20 Failure Mechanism Types

- (a) Planar
- (b) Wedge
- (c) Toppling

The analyses take into consideration the likely failure mechanisms in relation to the proposed pit wall geometry analysis, including Factor of Safety – Risk and Likelihood of failure for:

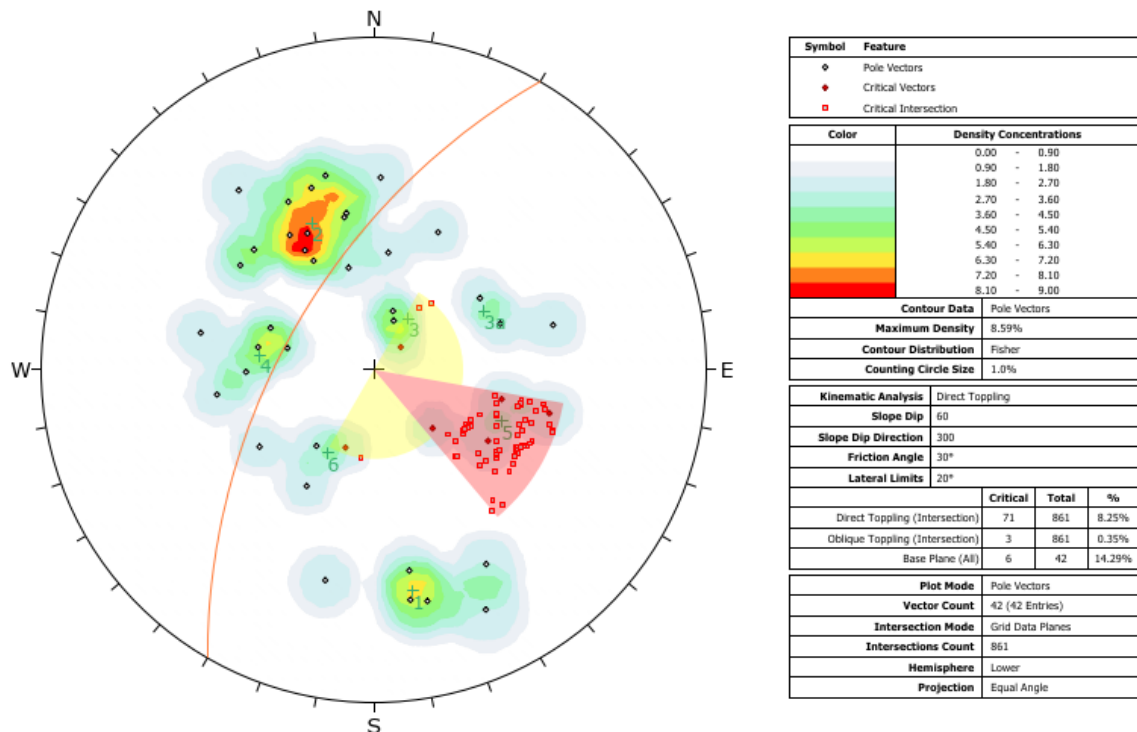
Figure 23 Direct Toppling Failure Analysis for South East Quadrant Slope

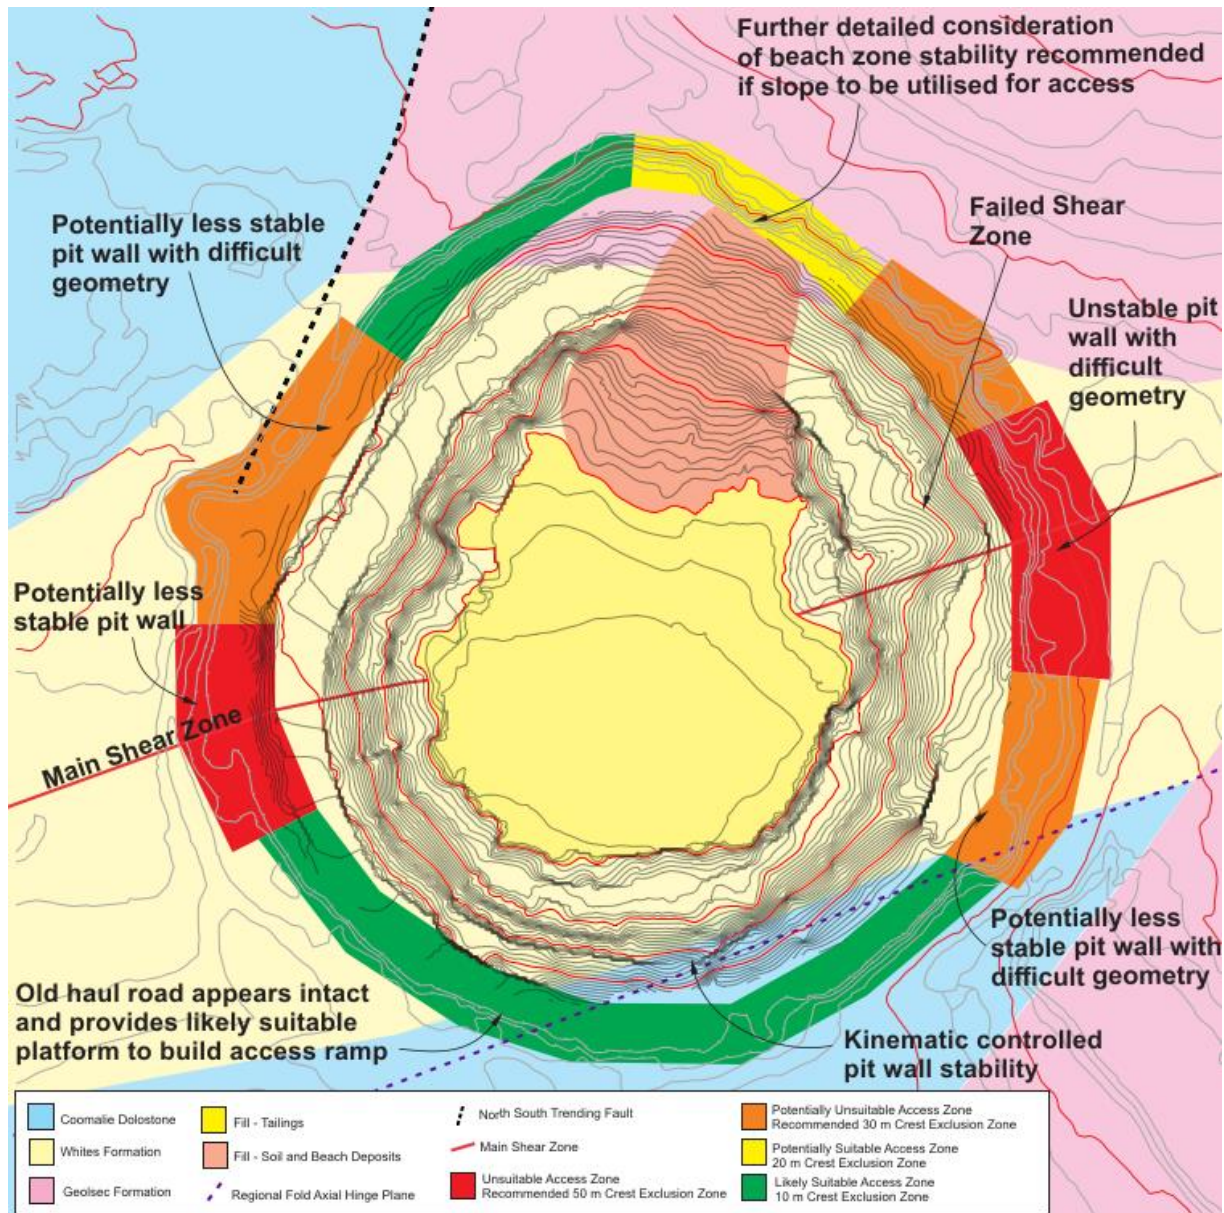
Figure 25 Rum Jungle Main Pit Stability Observations

As discussed in **Section 7.6**, the critical soil and rock components which pose the greatest risk of instability in the vicinity of the pit crest include over-steepened, potentially saturated exposures of saprolite and extremely weathered or disintegrated rock masses. Further, deep seated instability is noted to have occurred within the submerged profile of the main shear zone in the eastern wall of the main pit, based on interpretation of bathymetry indicating scree slope debris at susceptible locations.

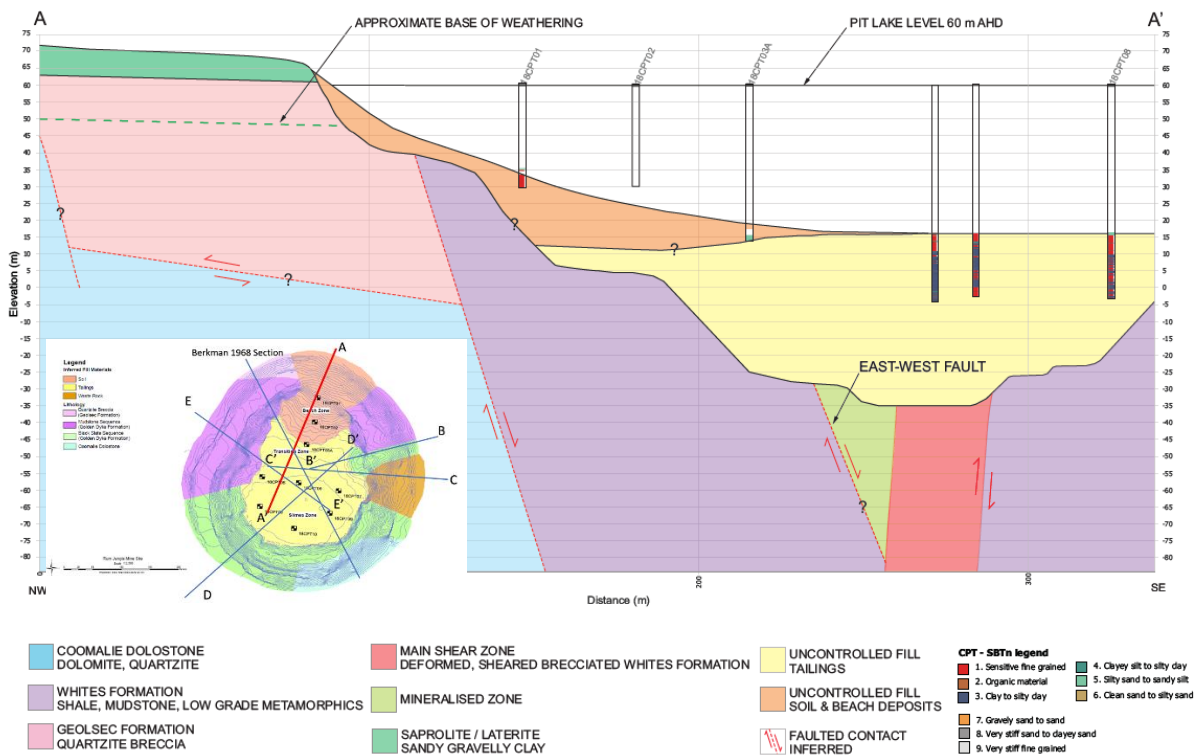
Figure 26 Generalised Section A-A' Showing Geological Units
