SLR Consulting Australia (2020) *Rum Jungle Rehabilitation – Stage 2A Detailed Design – Main Pit Backfill Strategy, Geotechnical Considerations*. Report to the Department of Mines and Energy, Northern Territory. PART A.

RUM JUNGLE REHABILITATION - STAGE 2A DETAILED DESIGN

**Main Pit Backfill Strategy
Geotechnical Considerations
Issued for Client and External Peer Review**

SLR Ref: 680.10421.90030-R03
Version No: -v2.0
June 2020

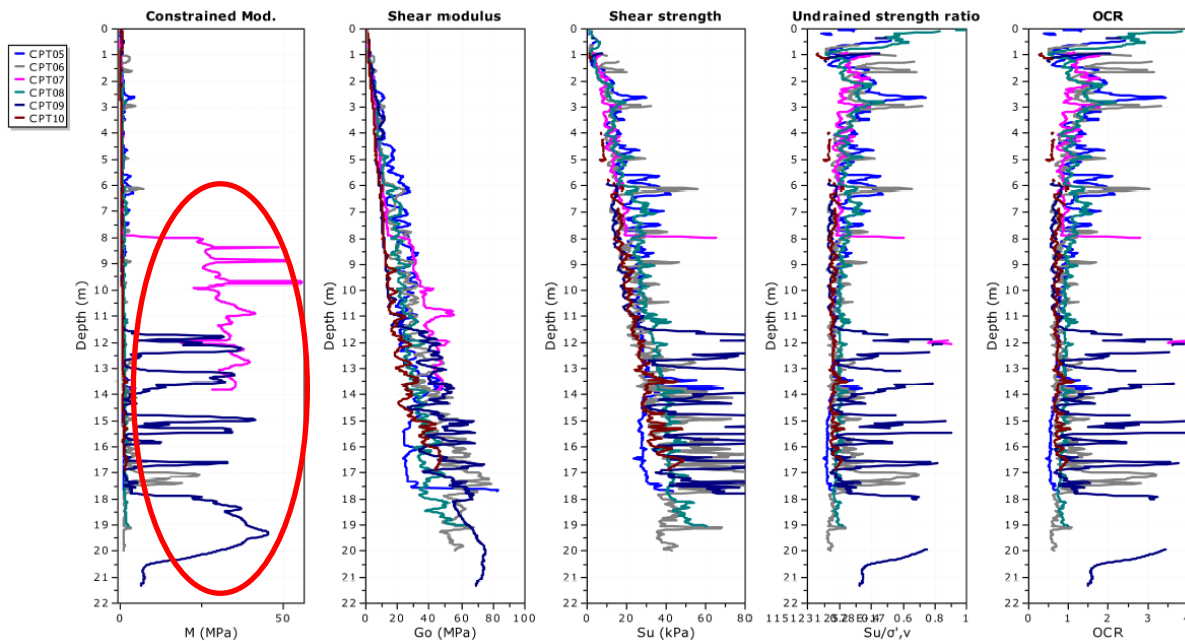
Figure 27 Inferred slopewash soils within tailings (circled)

As the shallow side-slope deposits are generally to be progressively buttressed by fill placed from the bottom up, and dewatering of the pit lake is not planned, it is anticipated that stability will generally be improved through the process of backfilling.

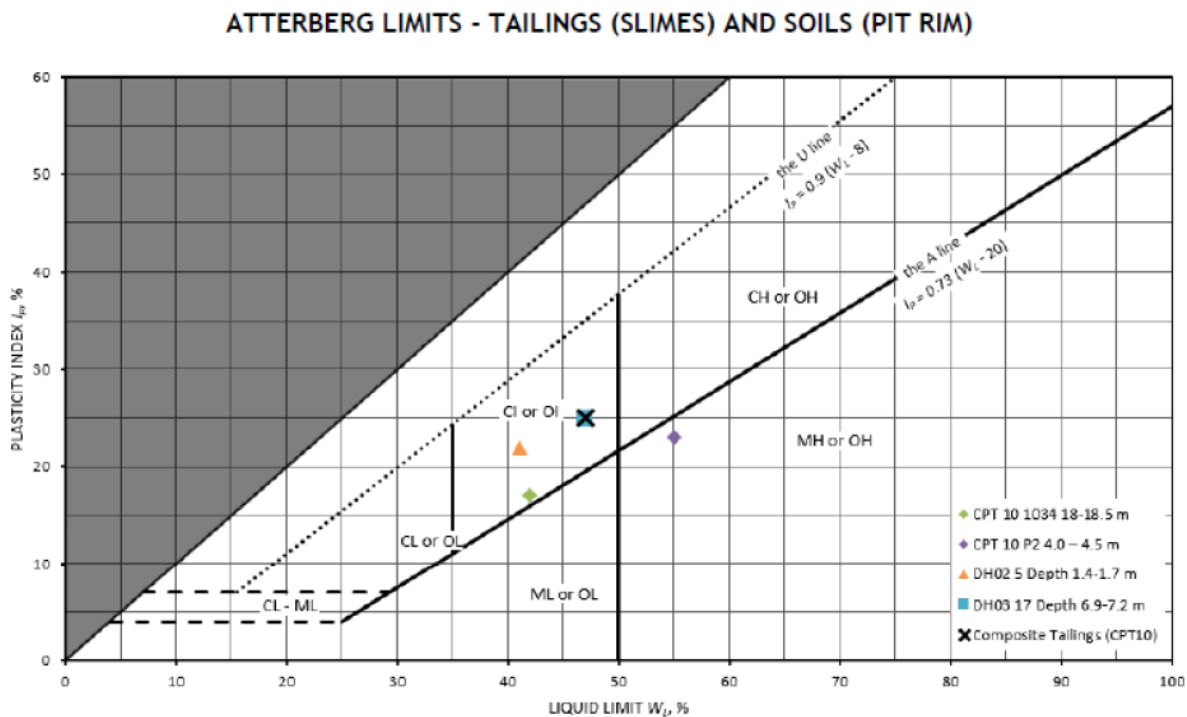
Figure 28 Tailings and Pit Rim Soils Atterberg Limits

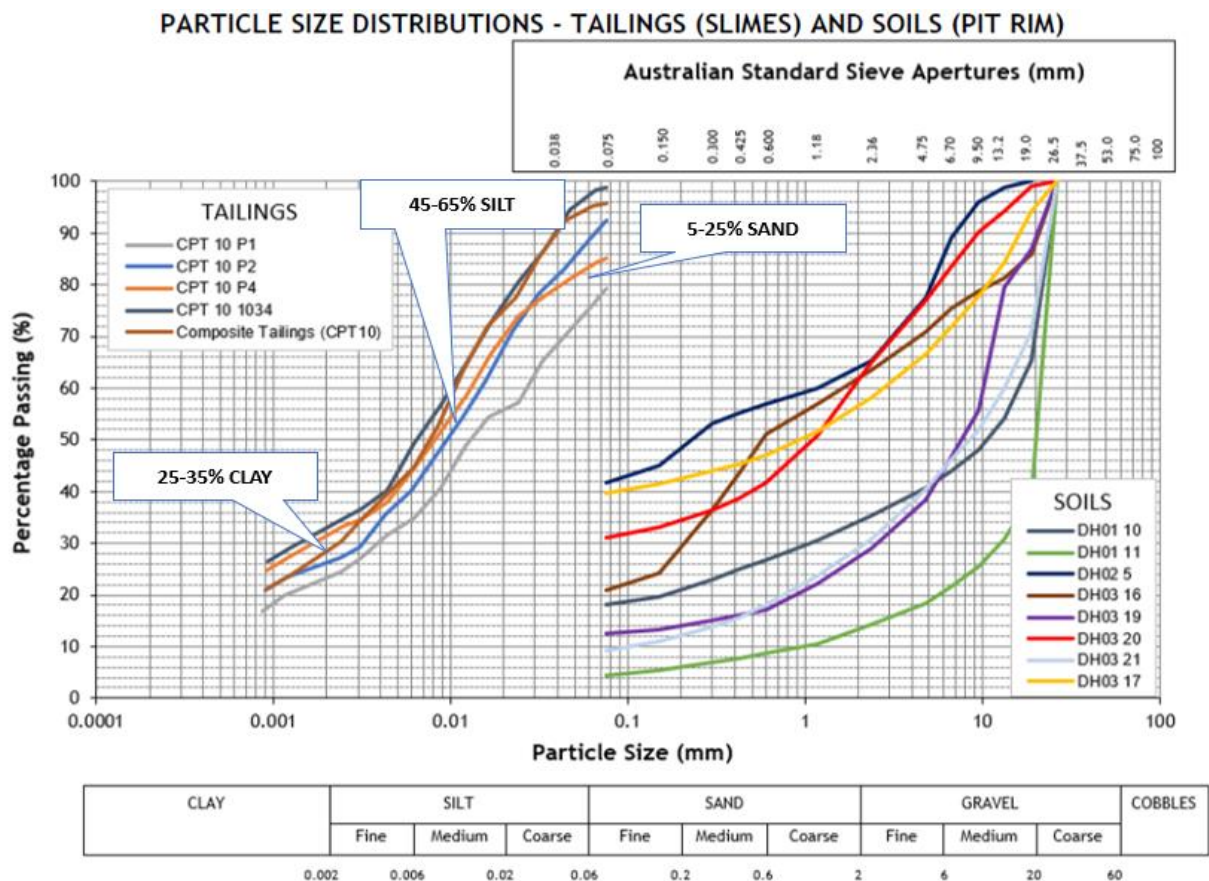
Figure 29 Particle Size Distribution Tailings and Pit Rim Soils

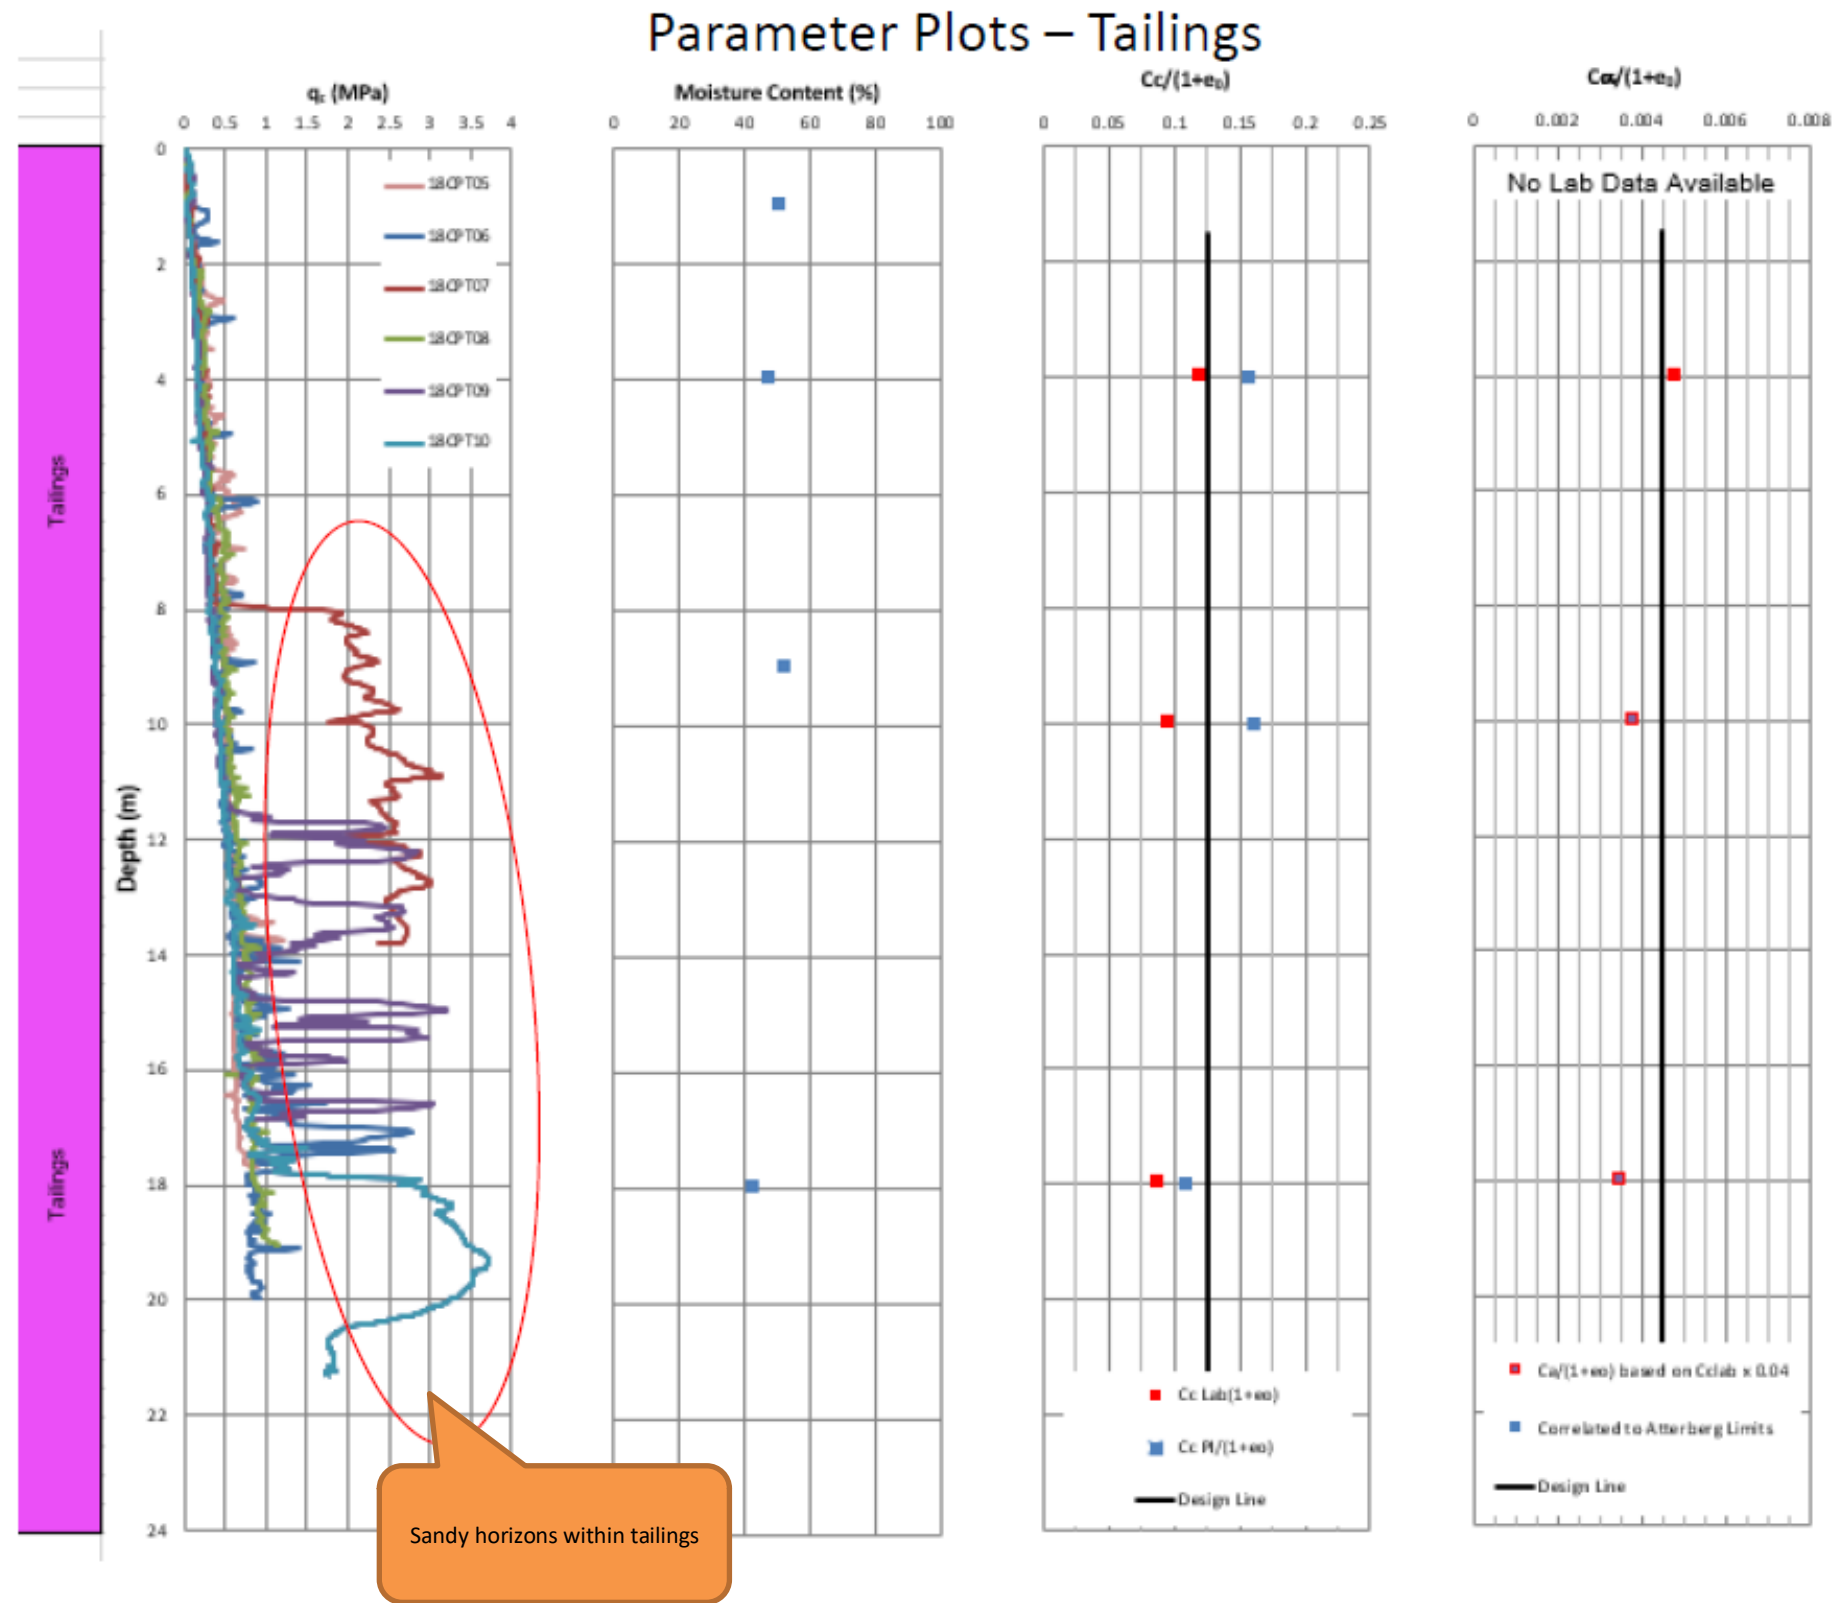
Figure 30 Tailings Parameter Plot (1)

As expected, CPT and BCPT plots indicate the thick tailings deposits of cohesive material exist in a near-normally consolidated condition and therefore loading of these soils will result in significant consolidation and creep settlements as pore pressures dissipate over time. In order to assess settlement behaviour, compressibility properties including consolidation and creep indices and rate (coefficient) of consolidation have been assessed by reviewing laboratory test results (Rowe Cell), by correlation with plasticity test data and from CPT data.

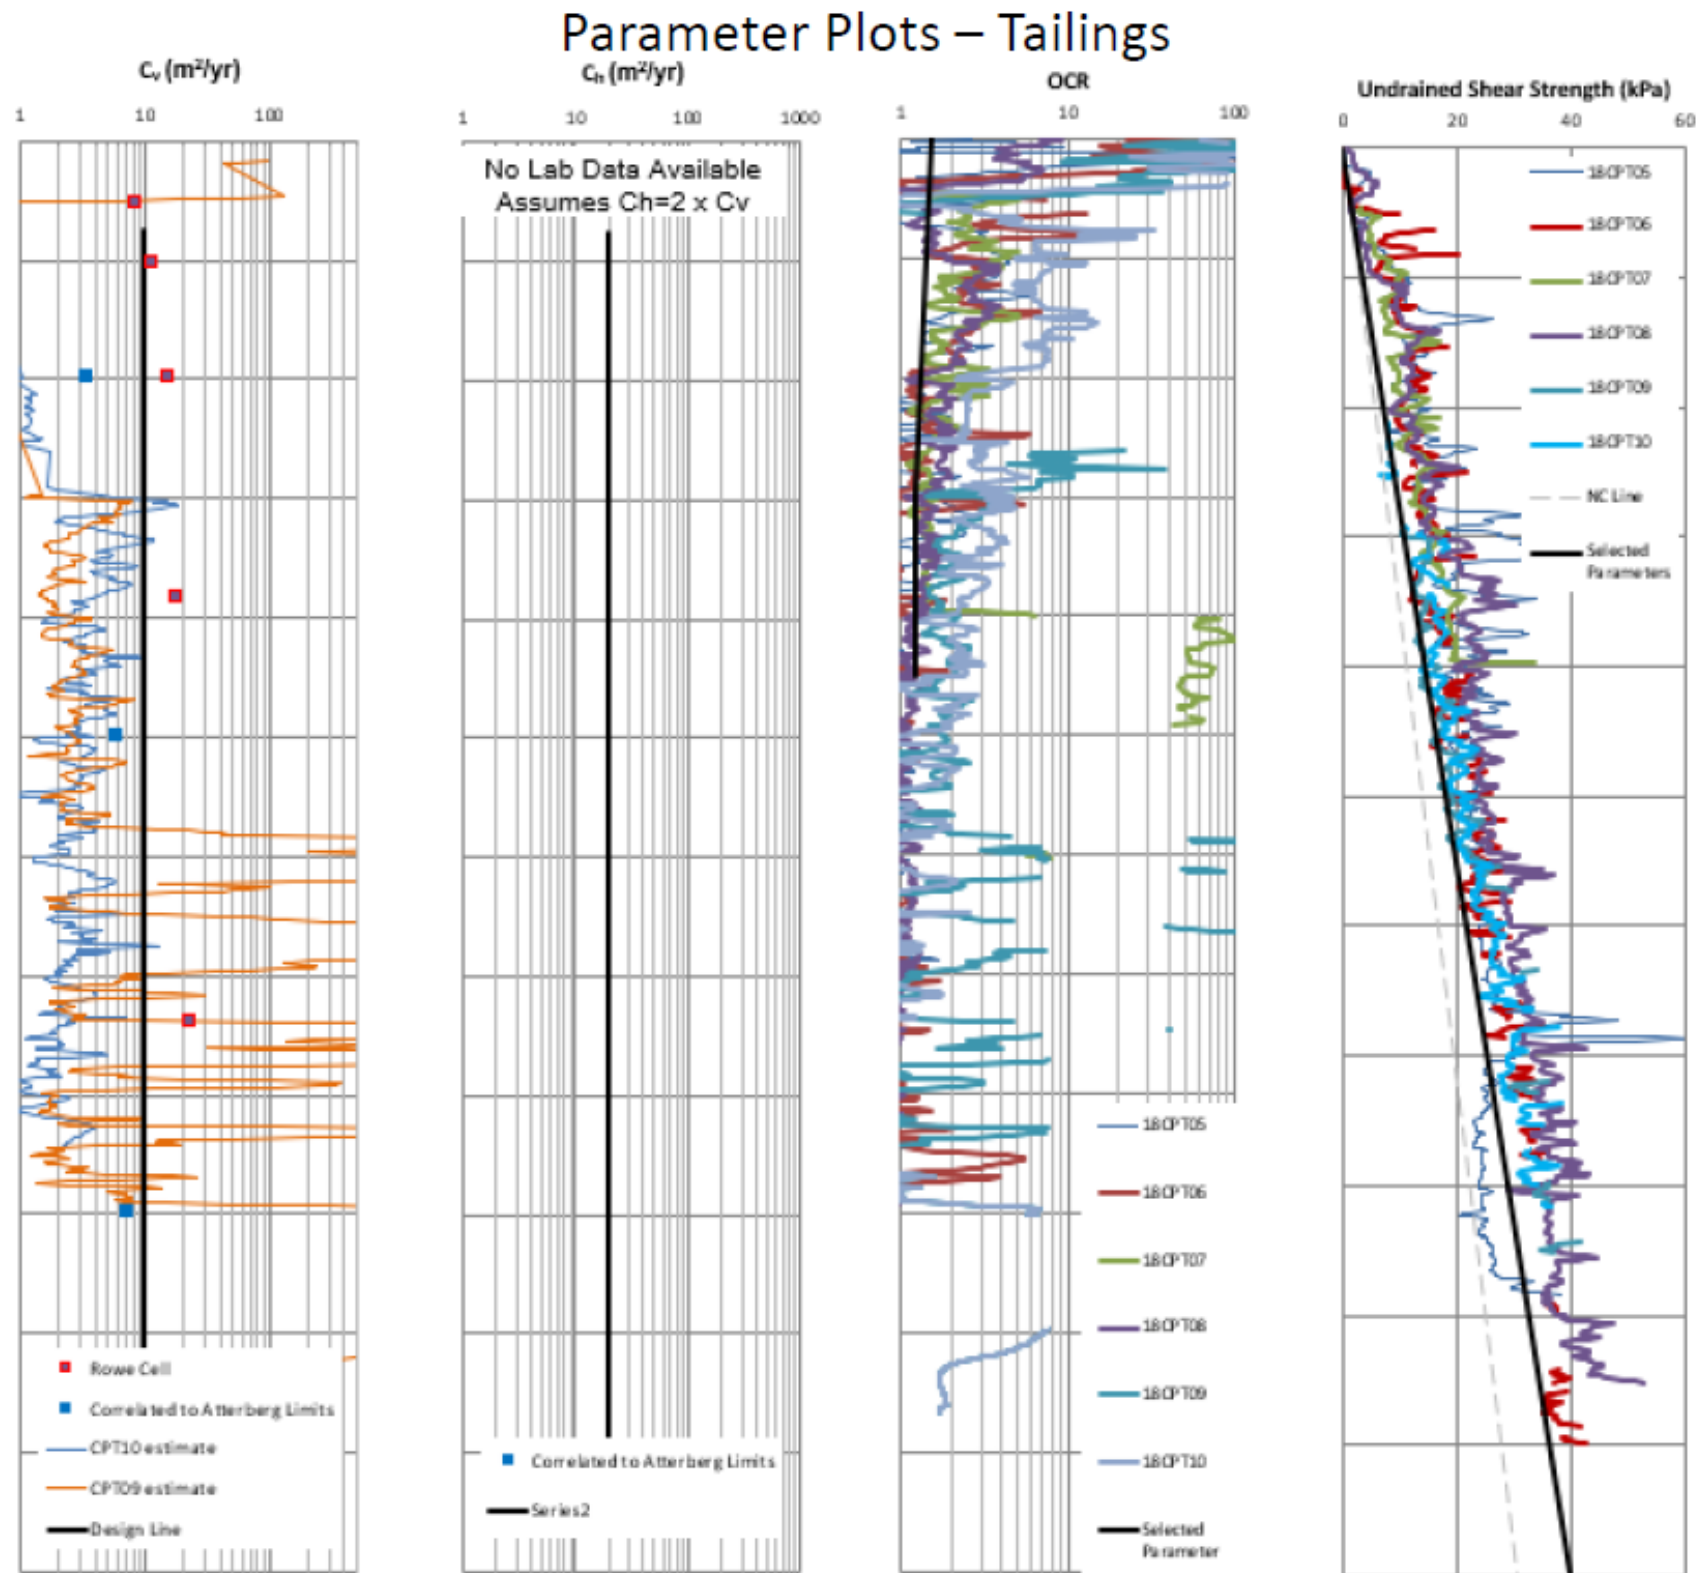
Figure 31 Tailings Parameter Plot (2)

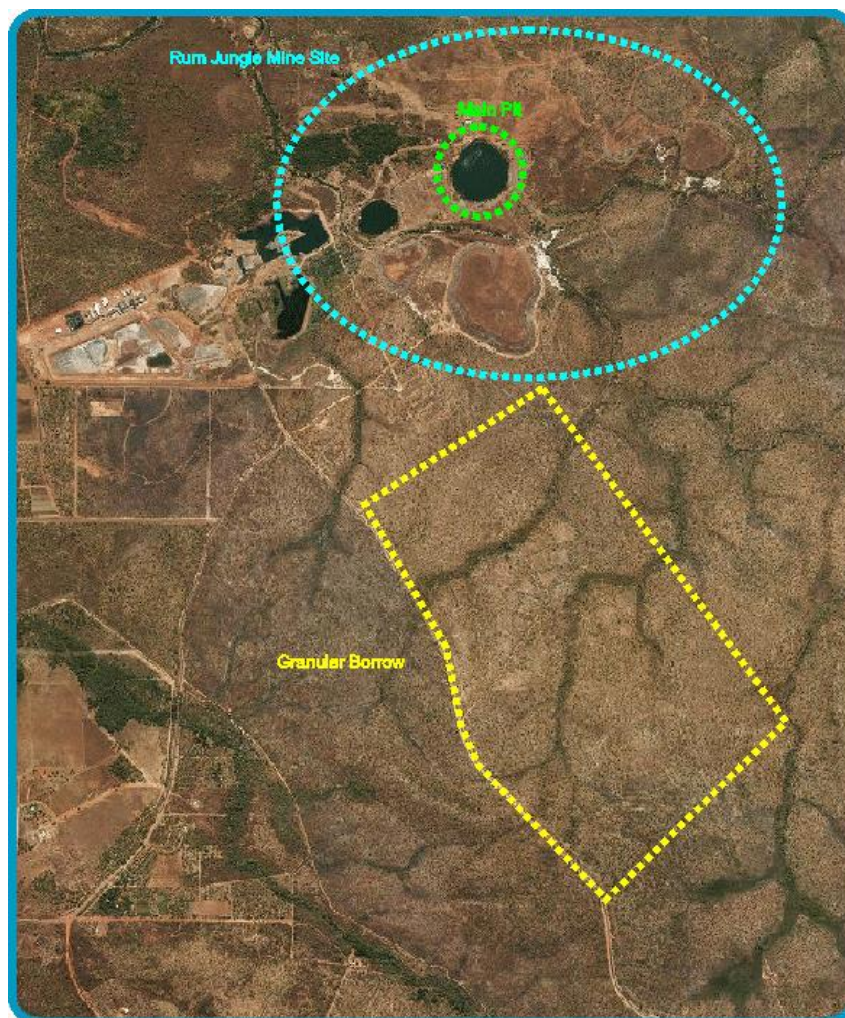
Figure 32 Location of Granular Bridging Layer Borrow

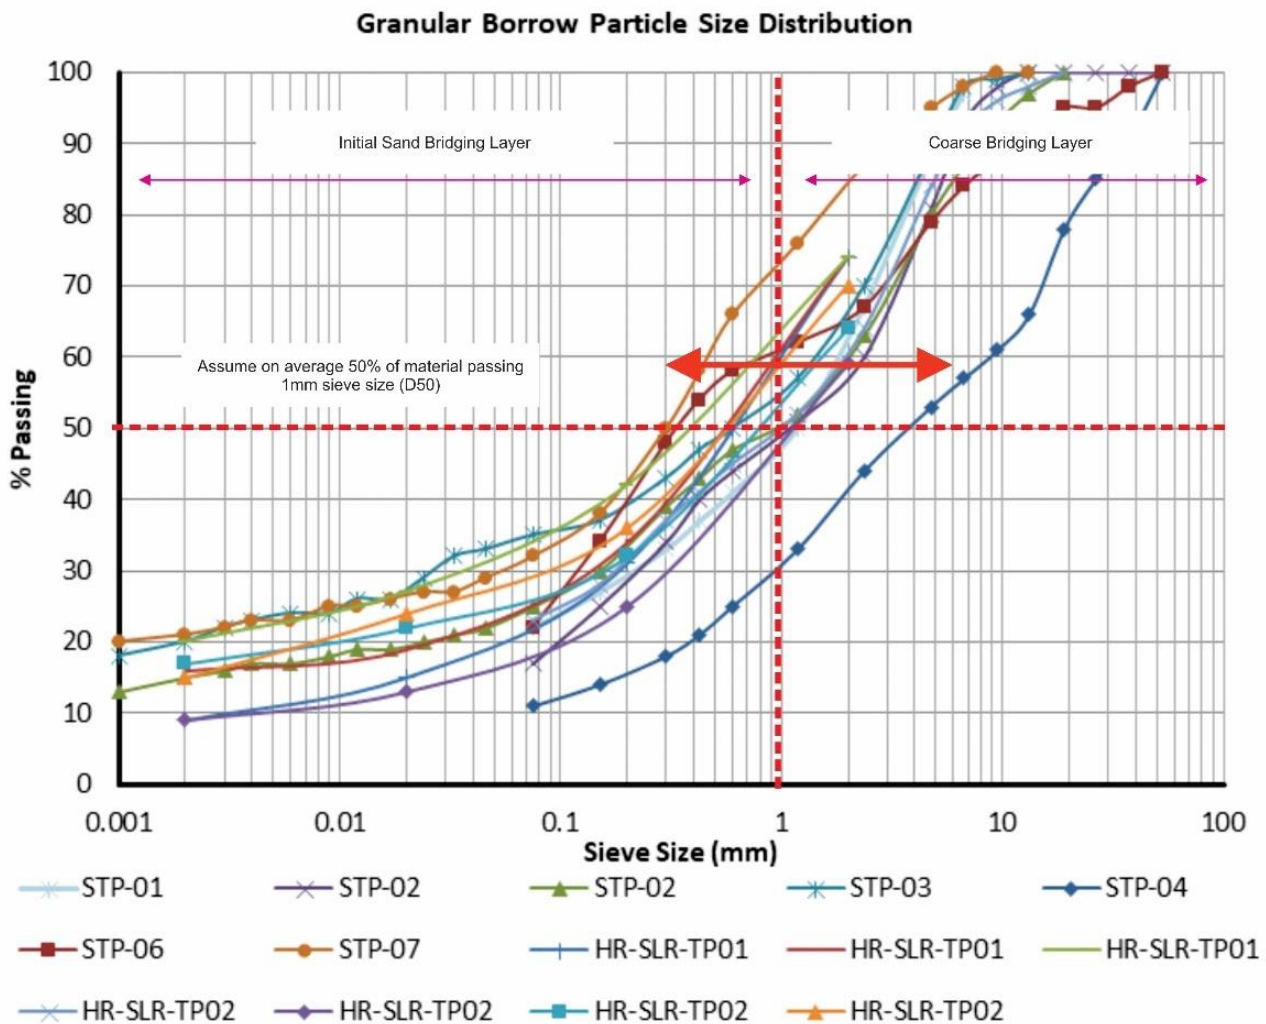
Figure 33 Sand Bedding Layer Grading Summary

The SLR investigation [26] recorded granular residual soils, from clayey SAND to sandy GRAVEL, largely from the weathering of the underlying granite bedrock. Samples of the residual soils underwent Particle Size Distribution (PSD) analysis and shear box testing. The results are provided in the grading plots in **Figure 33** below.

PSD results on average have a D_{50} of about 1 mm particle diameter and the majority of gravel found to be fine and medium grained. This correlates to a sandy GRAVEL or gravelly SAND with up to 23% fines, as observed. Results of shear box testing undertaken on screened samples (1mm minus) indicated a constant volume friction angle of 37° and coarser fraction (3 mm minus) 43°.

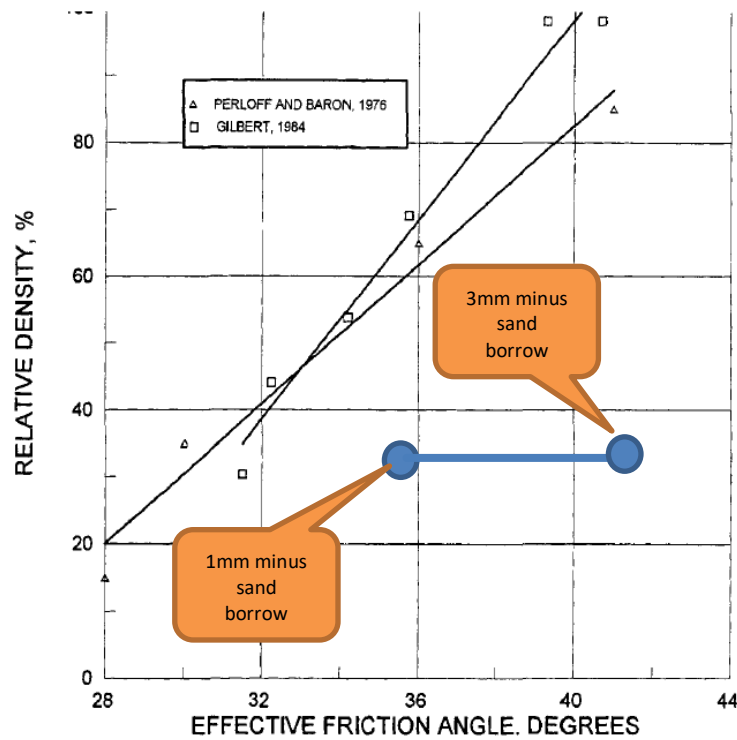
Figure 34 Typical and Measured Friction Angle for Sands

A cautious design value of 30° has been adopted for design, in addition to recognising also that the angle of repose of sub-aqueously placed sand in calm water is likely to be flatter at about 1V : 3H to 4H as follows:

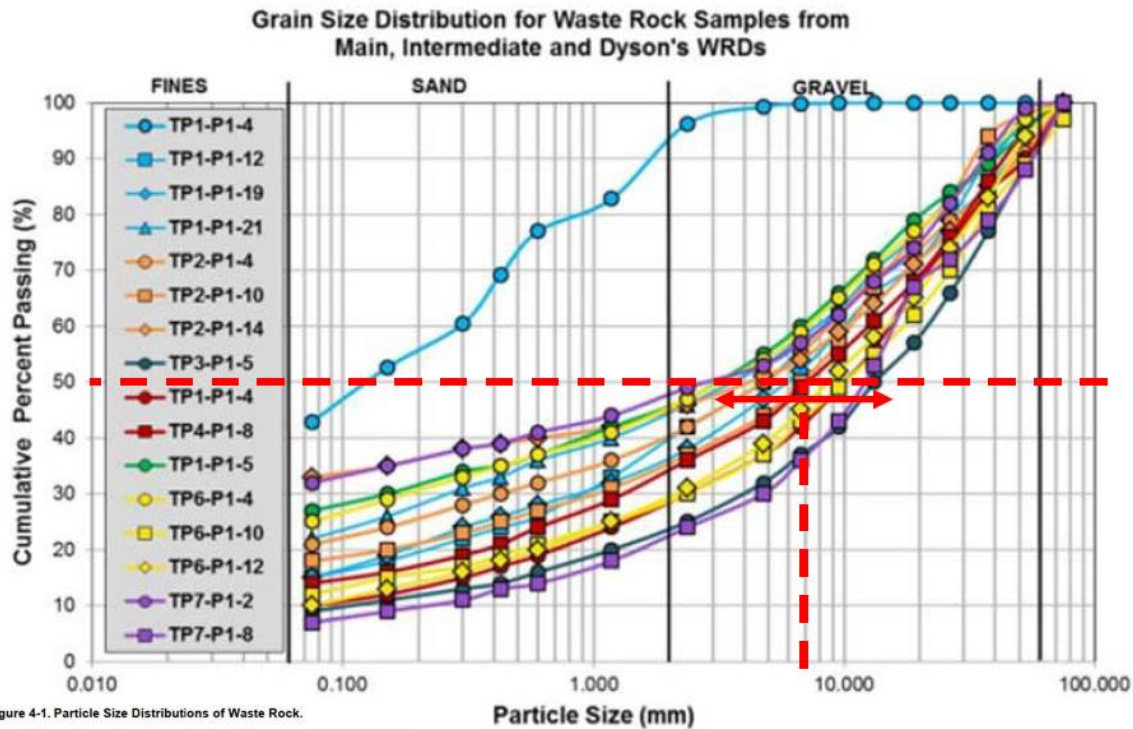
Figure 36 Waste Rock Grading for Sample Particle Size Passing 75mm

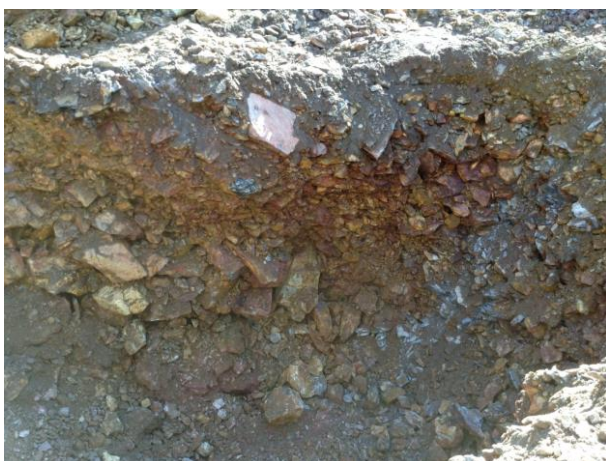
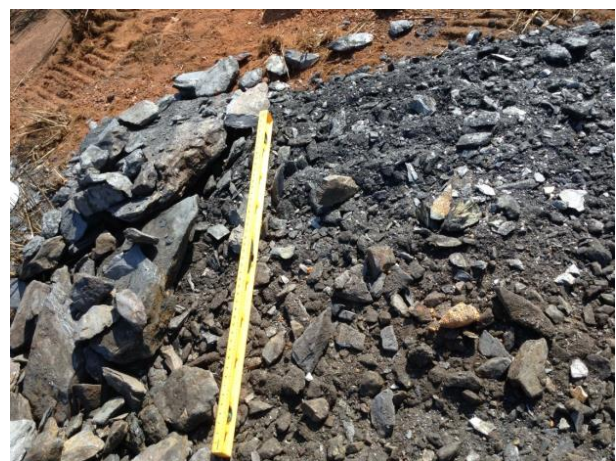
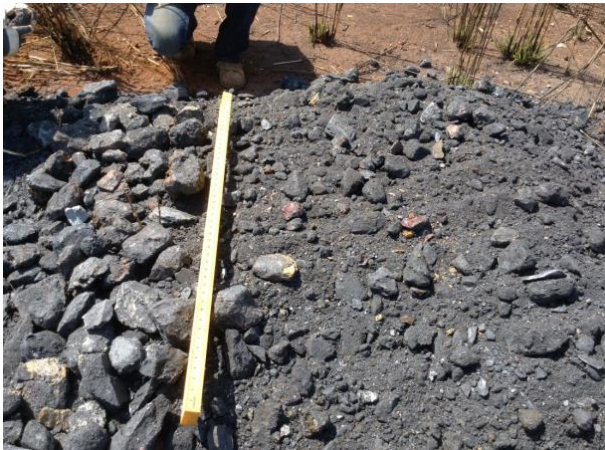
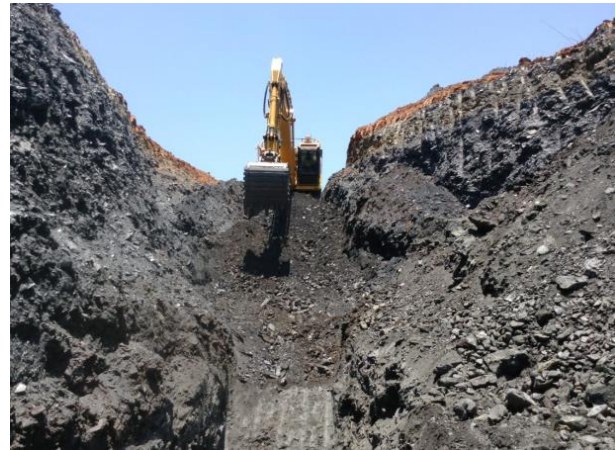
Figure 37 General Waste Rock Sample Photos Extracted from Robertson GeoConsultant Investigation [18]

'Photo A 24: TP1-P1 profile from 15 to 18m'

'Photo A 59: TP4-P1 sample collected from 5 m'

'Photo A 67: TP5-P1 sample collected from 2 m'

'Photo A 104: TP7-P1 on Intermediate WRD facing Main WRD'

Grading tests on waste rock were undertaken following screening to remove oversize (75 mm), the proportion of which varied from about 5 to 90% on samples processed for grading. Typical D₅₀ of screened WR is 6mm i.e. mainly fine-med gravel (**Figure 36**). Review of photographs presented within the Robertson GeoConsultant 2016 *Physical and Geochemical Characteristics of Waste Rock and Contaminated Materials report* [18] (**Figure 37** – additional photographs provided in RGC report) indicate that, visually, up to about 75% by volume may be up to about 150 mm particle size, with an effective upper size of about 500 mm.

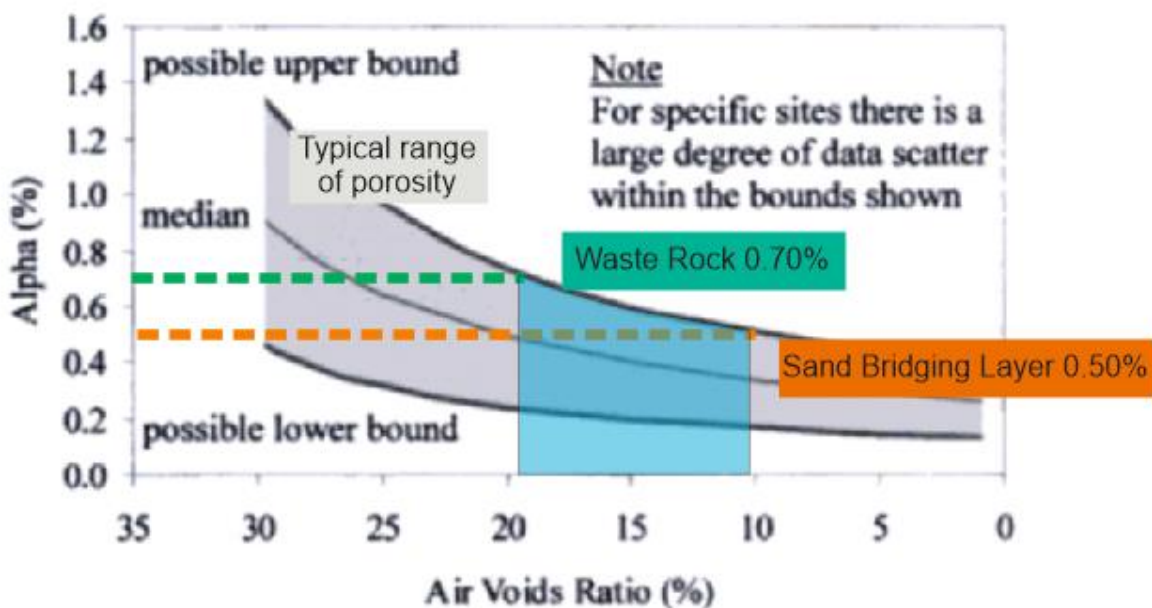
Figure 38 Published and Selected Mine Backfill Creep Rates

Typical creep compression rate parameters (α) published by Goodwin and Holden [43] are shown in **Figure 38** below, alongside the parameters adopted in backfilling design.

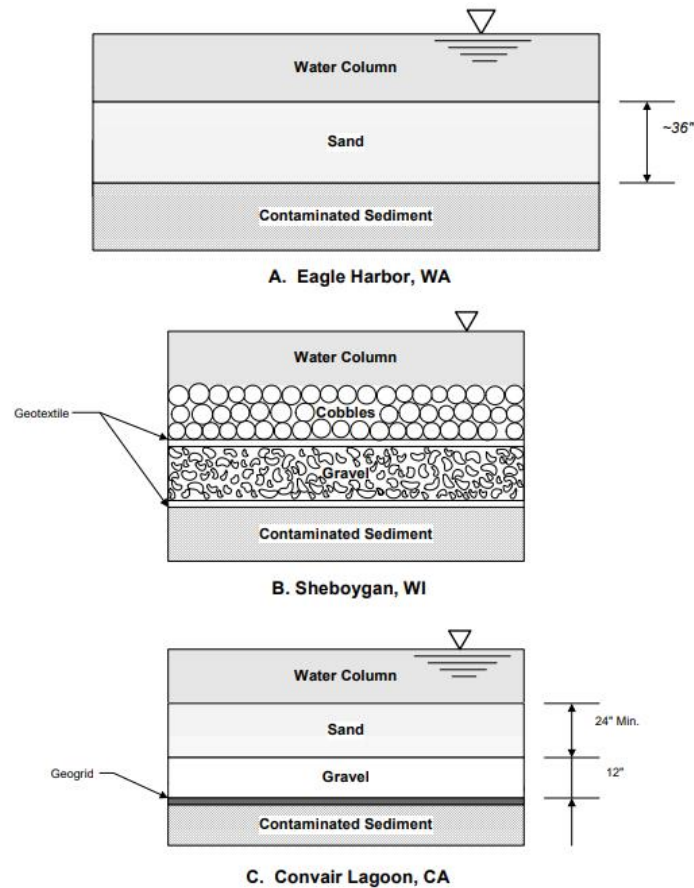
Figure 39 Typical Capping Types (Palermo [44])

Typical capping systems used to remediate contaminated sediments are shown schematically below in **Figure 39**. Option A is the preferred concept design for Main Pit capping design, optionally with a geotextile separation layer at the sand capping layer / in-situ sediment interface.

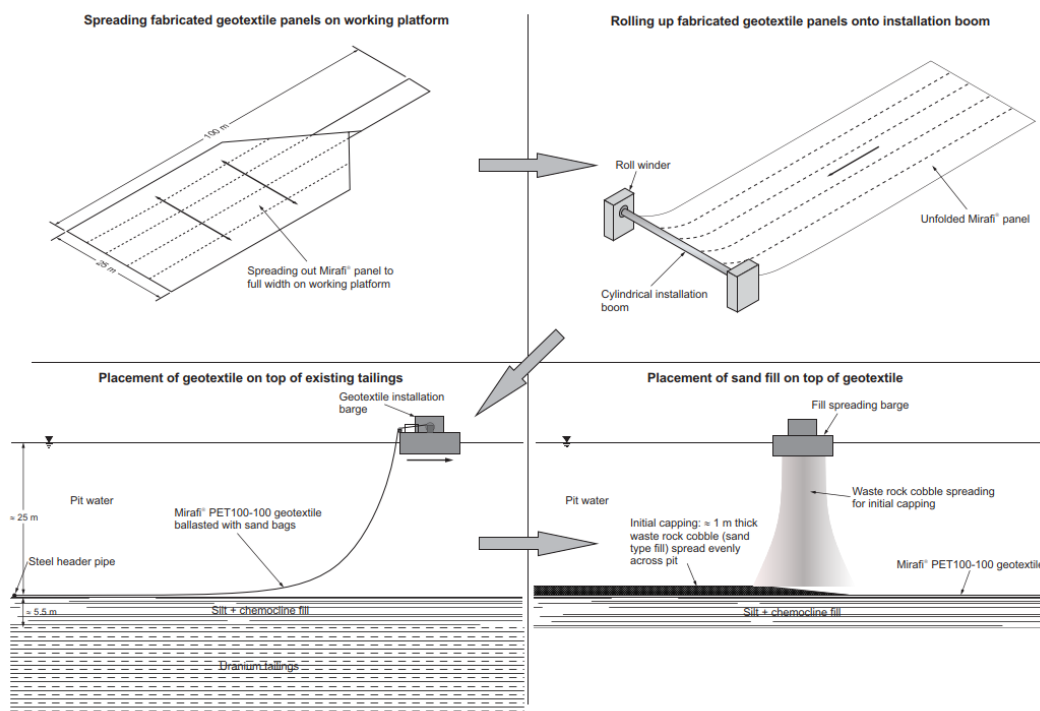
Figure 40 Concept Design of Geotextile Option

Use of a geotextile separation layer would potentially result in the following advantages and disadvantages:

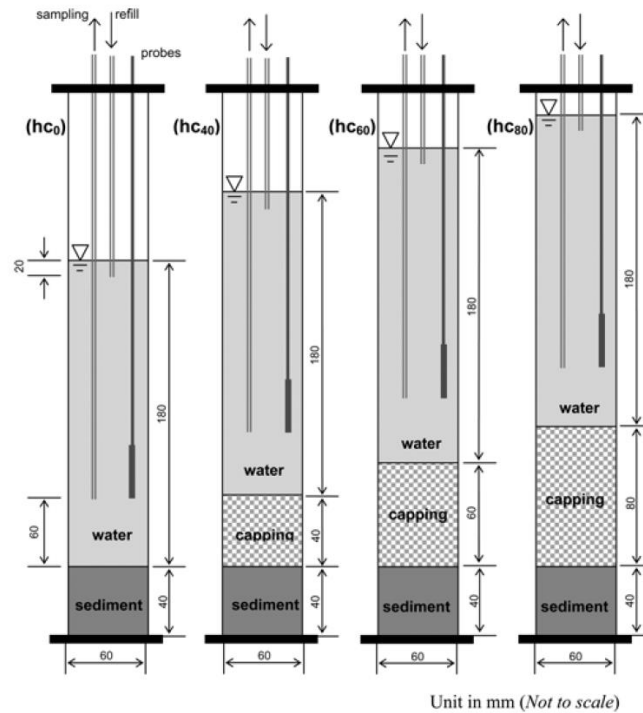
Figure 41 Schematic of bench scale sediment column testing

US EPA [46] also report that Environment Canada has performed tank tests on sediments from Lake Ontario to qualitatively investigate the interaction of capping sand and compressible sediments. The tests were carried out in 3.6 x 3.6 x 3.7 metre observation tanks in which the compressible sediments were placed and allowed to consolidate and sand was placed through the water column onto the sediment surface. In the initial tests, physical layering and consolidation behaviour were observed.

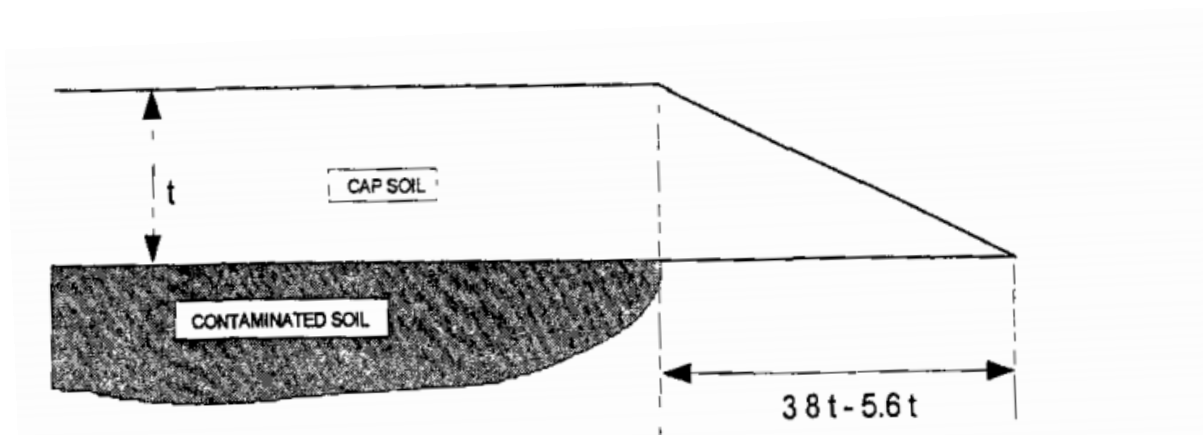
Figure 42 Typical Limiting Fill Slope for Stability

Placement of the initial sand bedding layer particles ($D_{50} \leq 1\text{mm}$) by sub-aqueous discharge would result in raining down of quartz sand particles into the basal chemocline profile consisting of increasingly dense and viscous fluid. It is anticipated that as individual sand grains rain down that they would penetrate and displace lighter fractions of chemocline before coming to rest once the frictional resistance of the receiving body exceeds the gravitational force exerted on each grain. As subsequent capping layer material is rained down, a degree of mechanical interlock is likely to form between sand grains and the displaced chemocline will occupy pore space of subsequently placed material.

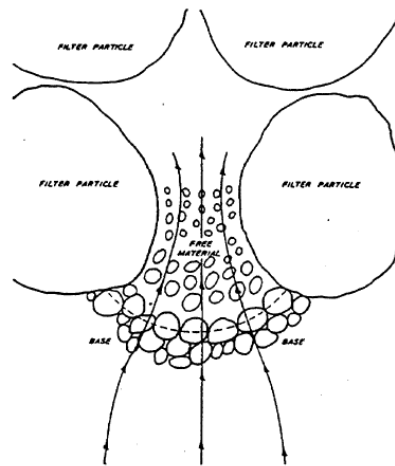
Figure 43 Granular Filter at Capping/Tailings Interface (Image: USACE [53])

Granular filter design rules governing the selection of grading to prevent piping or migration of soils under hydraulic gradients have been developed and published by empirical experimentation. The process is shown schematically below in **Figure 43**.

Filter design rules published by Unites States Army Corps of Engineers [53] are tabulated below and fall into two groupings comprising uniform and graded filters. As the Rum Jungle sand borrow material is relatively well graded, the graded filter rule is considered to be appropriate, however the uniform filter rule is also shown for completeness.

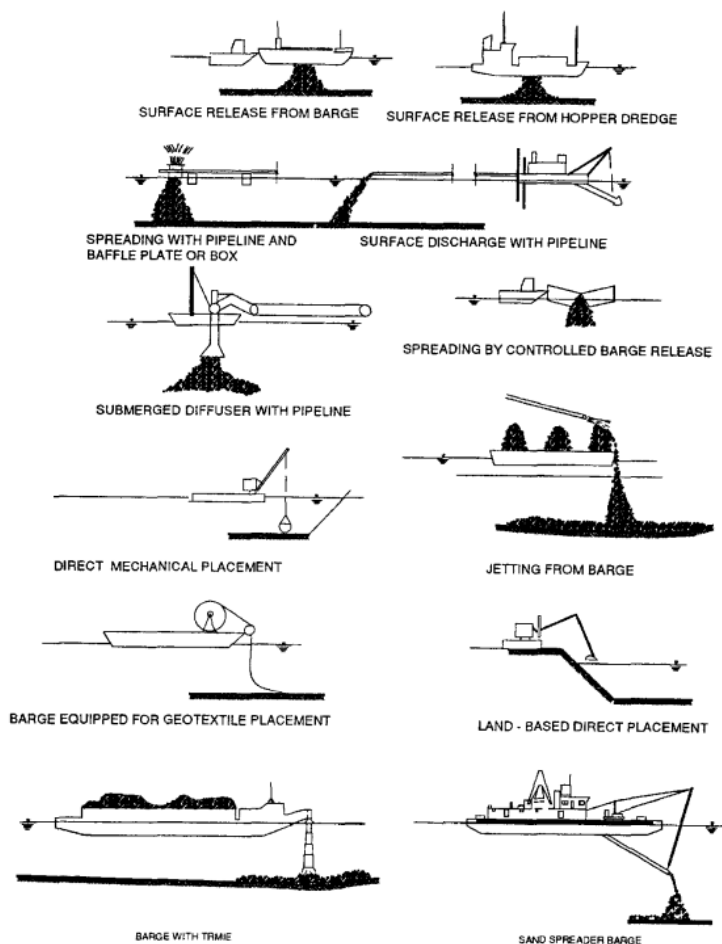
Figure 44 Examples of Typical Capping Layer Placement Methods (Image: US EPA [46])

Examples of typical capping layer placement methods are shown in **Figure 44** and **Figure 45** below (from US EPA 2005 [46]).

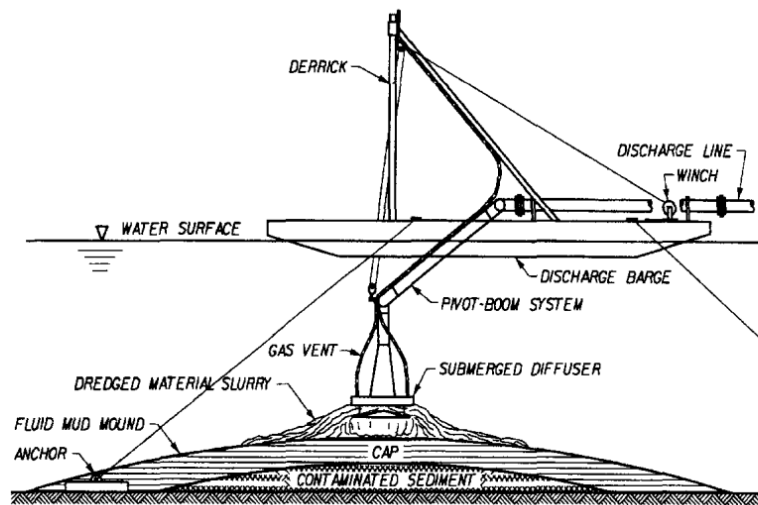
Figure 45 Example of Spreader Pontoon with Diffuser

Granular cap materials can also be entrained in a water slurry and carried to the contaminated site wet, where they can be discharged by pipe into the water column at the water surface or at depth. These hydraulic methods offer the potential for a more precise placement, although the energy required for slurry transport could require dissipation using an underwater diffuser to prevent resuspension of contaminated sediment (**Figure 45**). Placement of the optional geotextile layer would require special equipment.

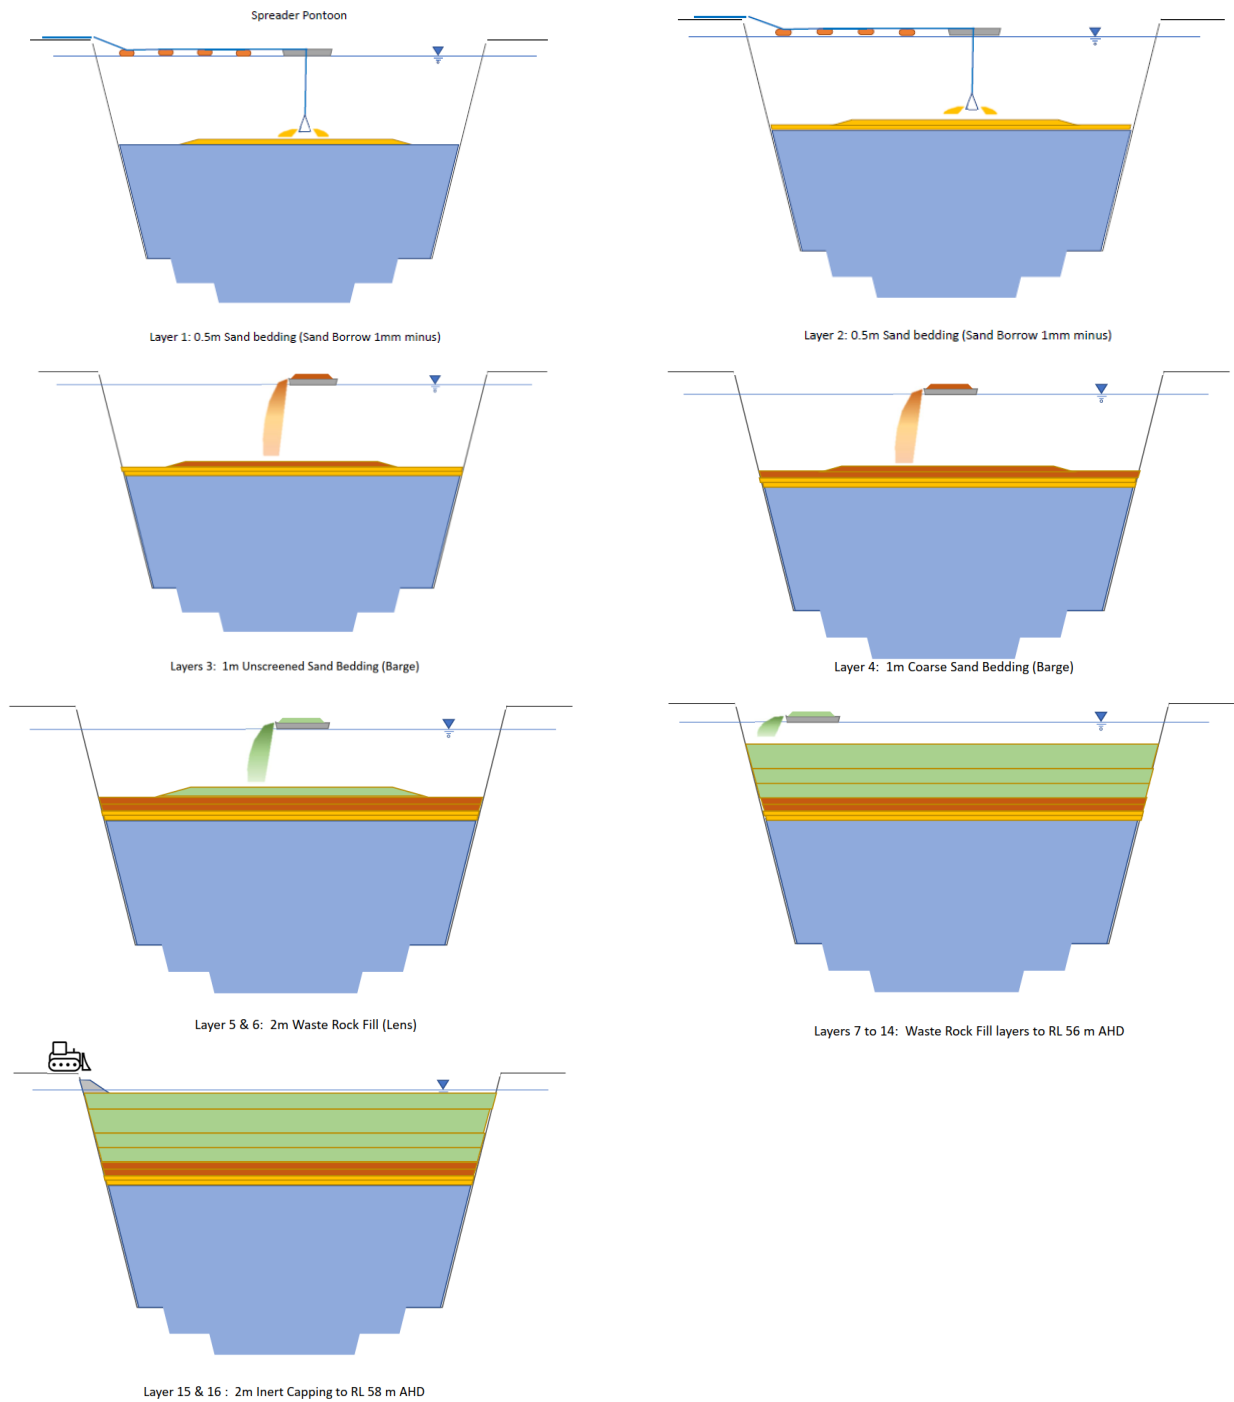
Figure 46 Schematic Backfill Sequence

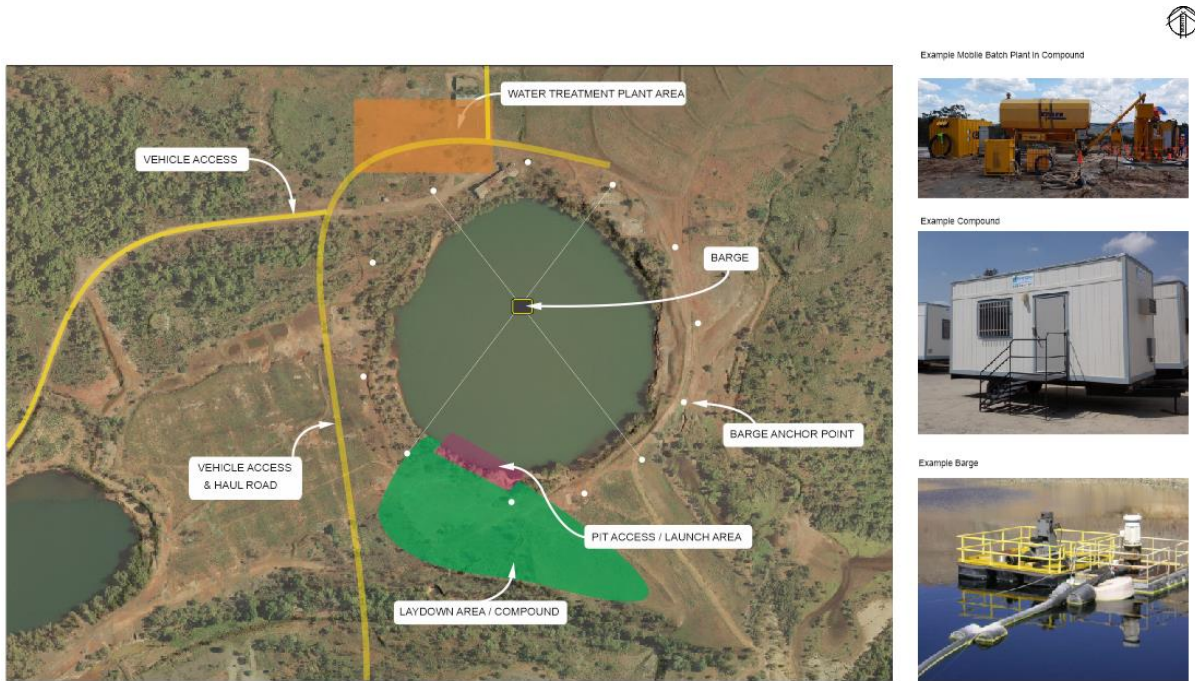
Figure 47 Anticipated Layout of Typical Backfilling Operations

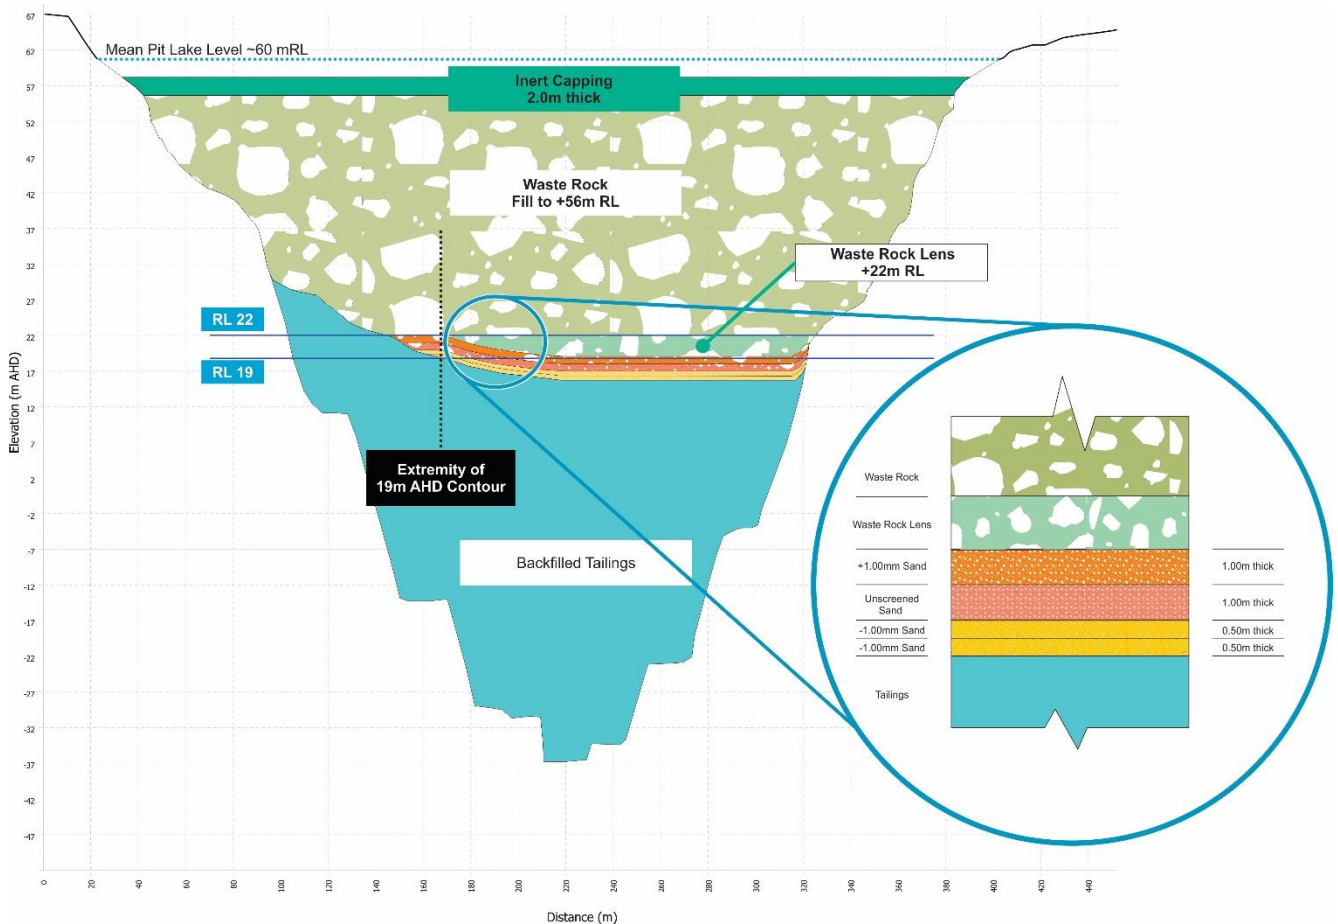
Figure 48 Proposed Layering of Fill Materials
