SLR Consulting Australia (2020) *Rum Jungle Rehabilitation – Stage 2A Detailed Design – Main Pit Backfill Strategy, Geotechnical Considerations*. Report to the Department of Mines and Energy, Northern Territory. PART A.

RUM JUNGLE REHABILITATION - STAGE 2A DETAILED DESIGN

**Main Pit Backfill Strategy
Geotechnical Considerations
Issued for Client and External Peer Review**

SLR Ref: 680.10421.90030-R03
Version No: -v2.0
June 2020

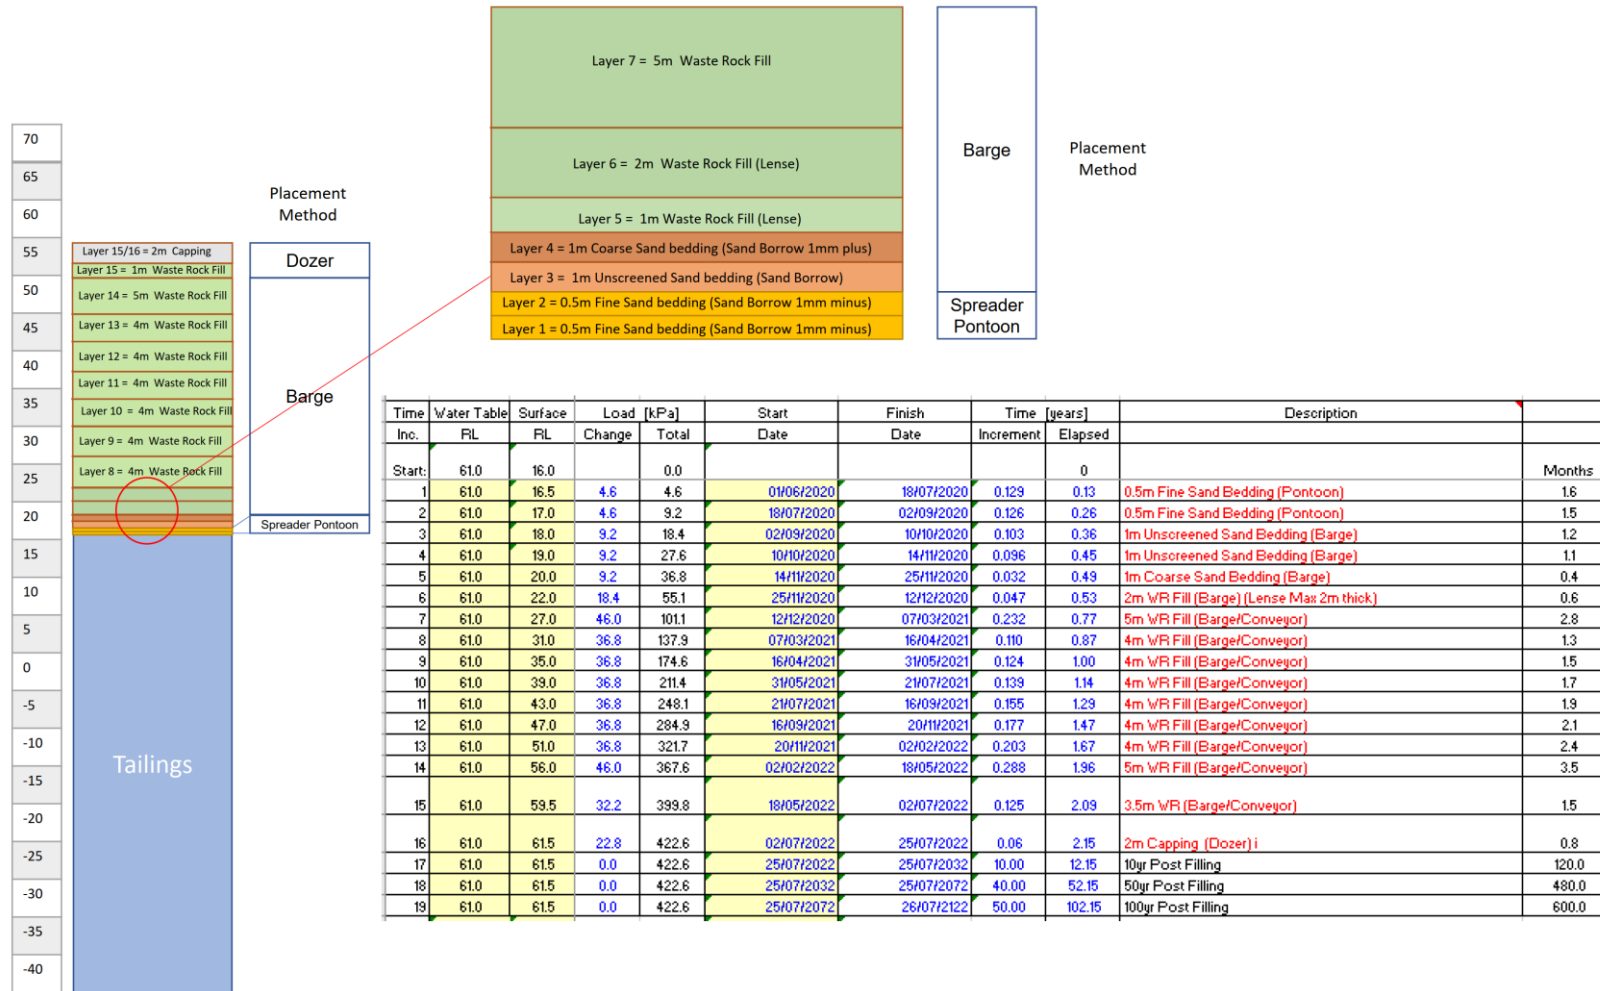
Figure 49 Backfilling Strategy and Indicative Program

Based on the constraints and adopted methodology above, it is possible to estimate the volume and the estimated placement timeframes for individual backfill layers and the pit backfilling as a whole, as shown in **Figure 49**.

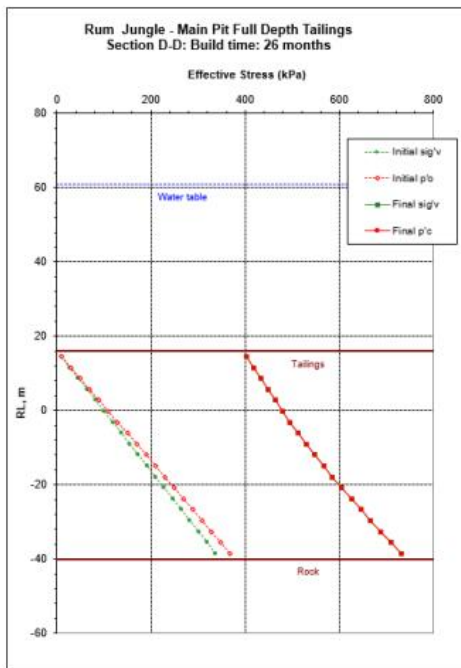
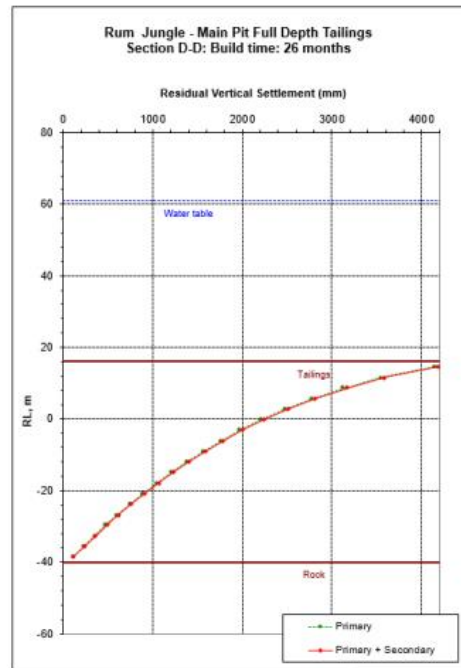
Figure 50 Settlement Input Summary

INPUT PROFILE:				Total Unit Weight [not buoyant] below WT above WT (kN/m ³) (kN/m ³)	Layer Drainage Code* B	Normally Consolidated			Cc/Cr [ratio of NC to OC slopes]	Initial Stress Conditions (below initial surface RL for loading)			Maximum Past Pressure			
Layer No.	Description	Depth to Top	RL Top			Thickness (m)	Cc	Cv		C α	Sig' v Layer Top (kPa)	Over-consolidation Factor (ratio)	Offset (kPa)	Layer Top (kPa)	Bottom (kPa)	Not less than (kPa)
1	Tailings	0.00	16.00	56.00	2	1	0.13	10.00	0.450%	6.00	0.00	1.09	0.5	0.50	377.28	0.50
2	Rock	56.00	-40.00		0						346.64			0.00		
3

Settlement has been estimated using general one-dimensional consolidation theory for cohesive tailings (primary and secondary consolidation) and estimating creep within granular backfill according to the log-time relationship described in Section Settlement Design Methodology **Section 9.5.3**.

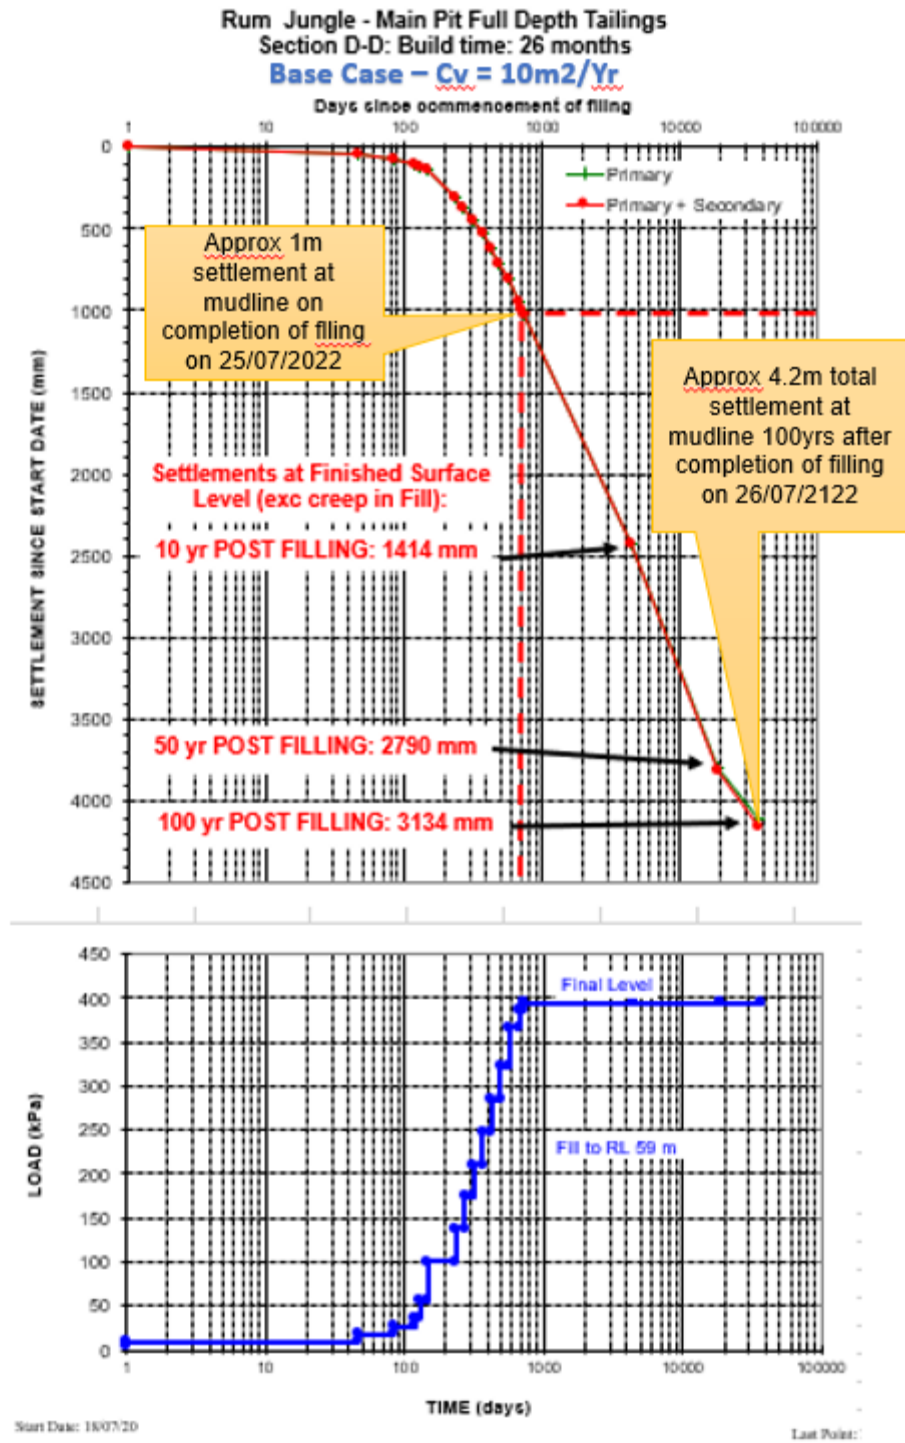
Figure 51 Settlement of Tailings

Above settlements are at mud-line and excludes post-construction creep settlement within fill

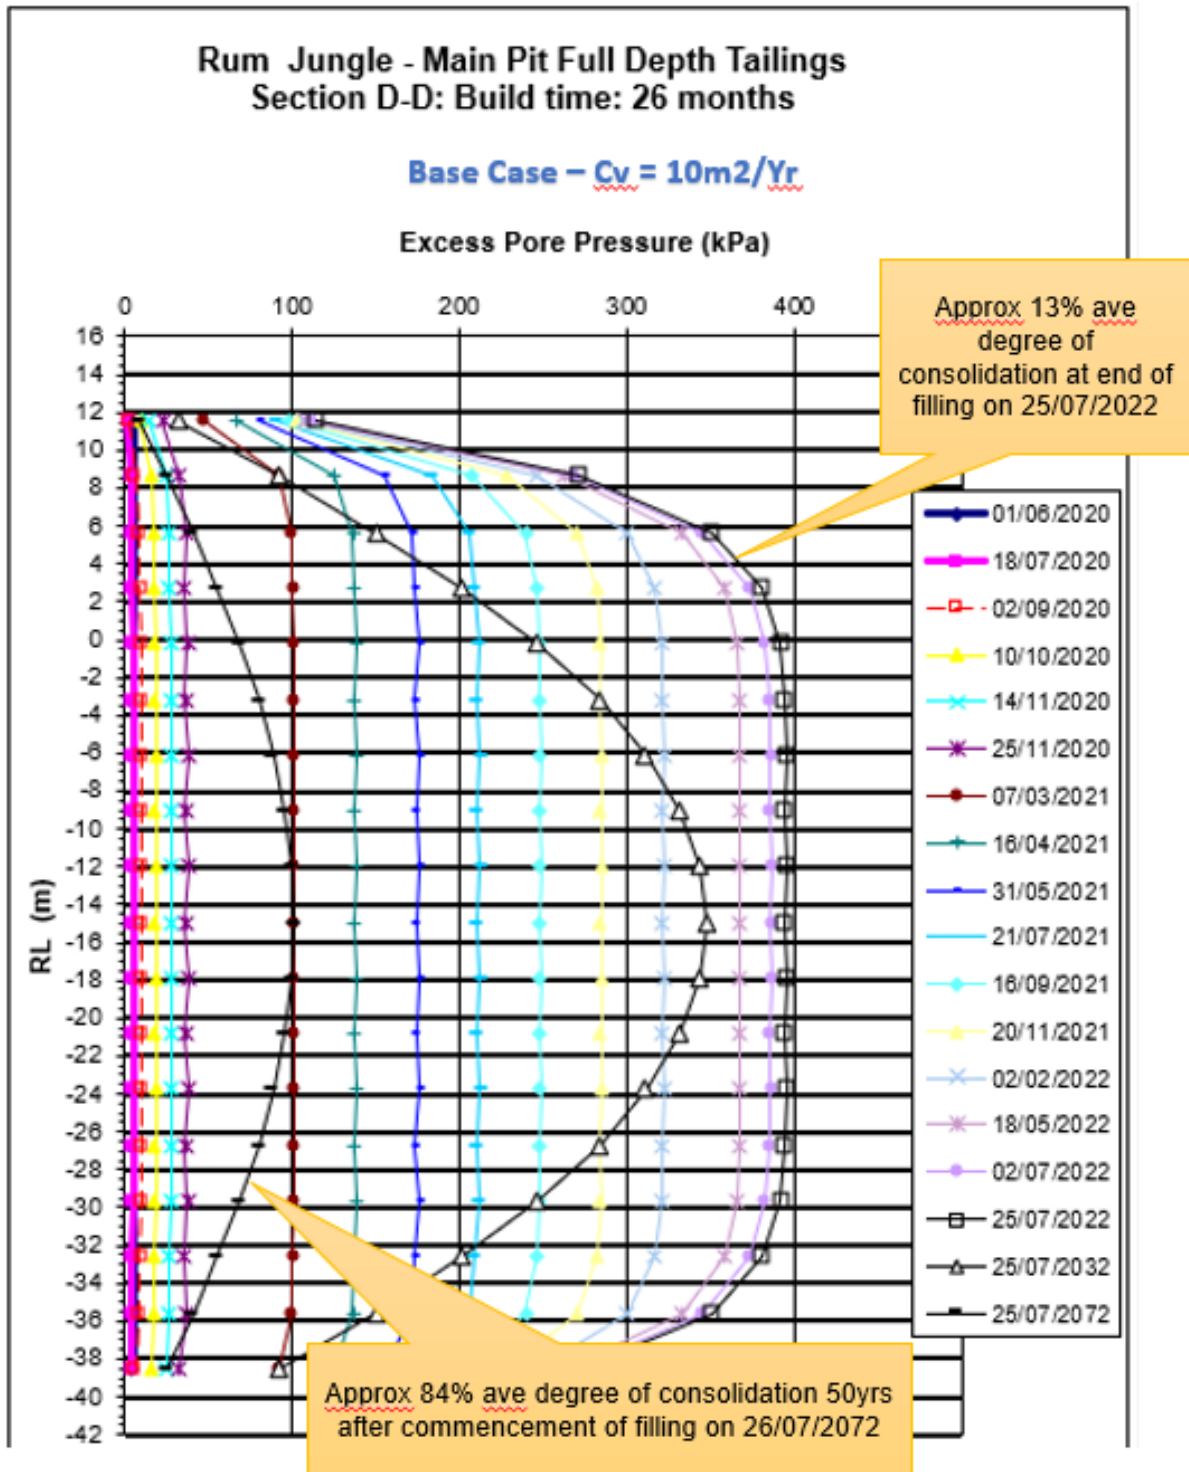
Figure 52 Excess Pore Pressure in Tailings

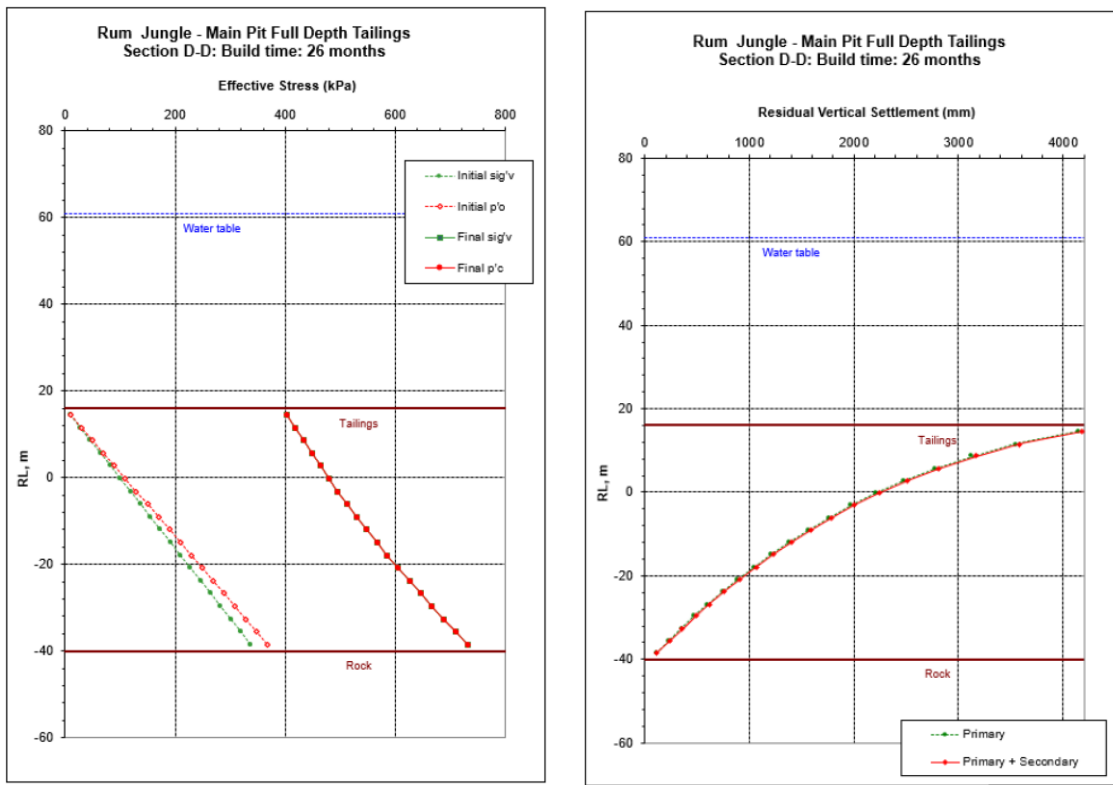
Figure 53 Stress and Settlement in Tailings Layer

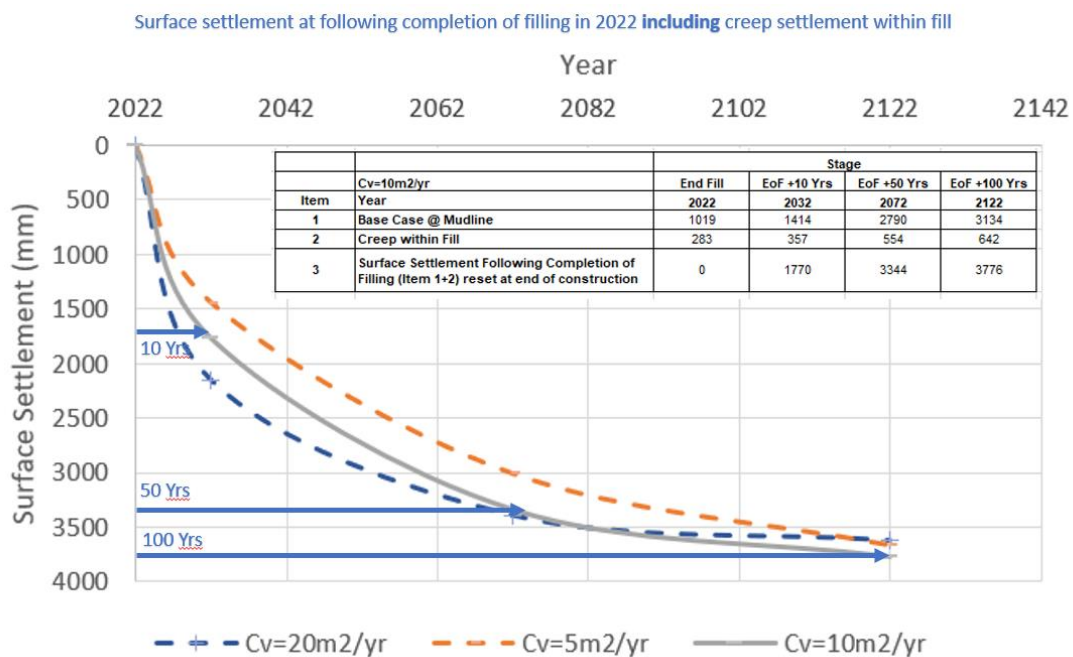
Settlement summary showing Cv sensitivity analysis.

Figure 54 Settlement Summary

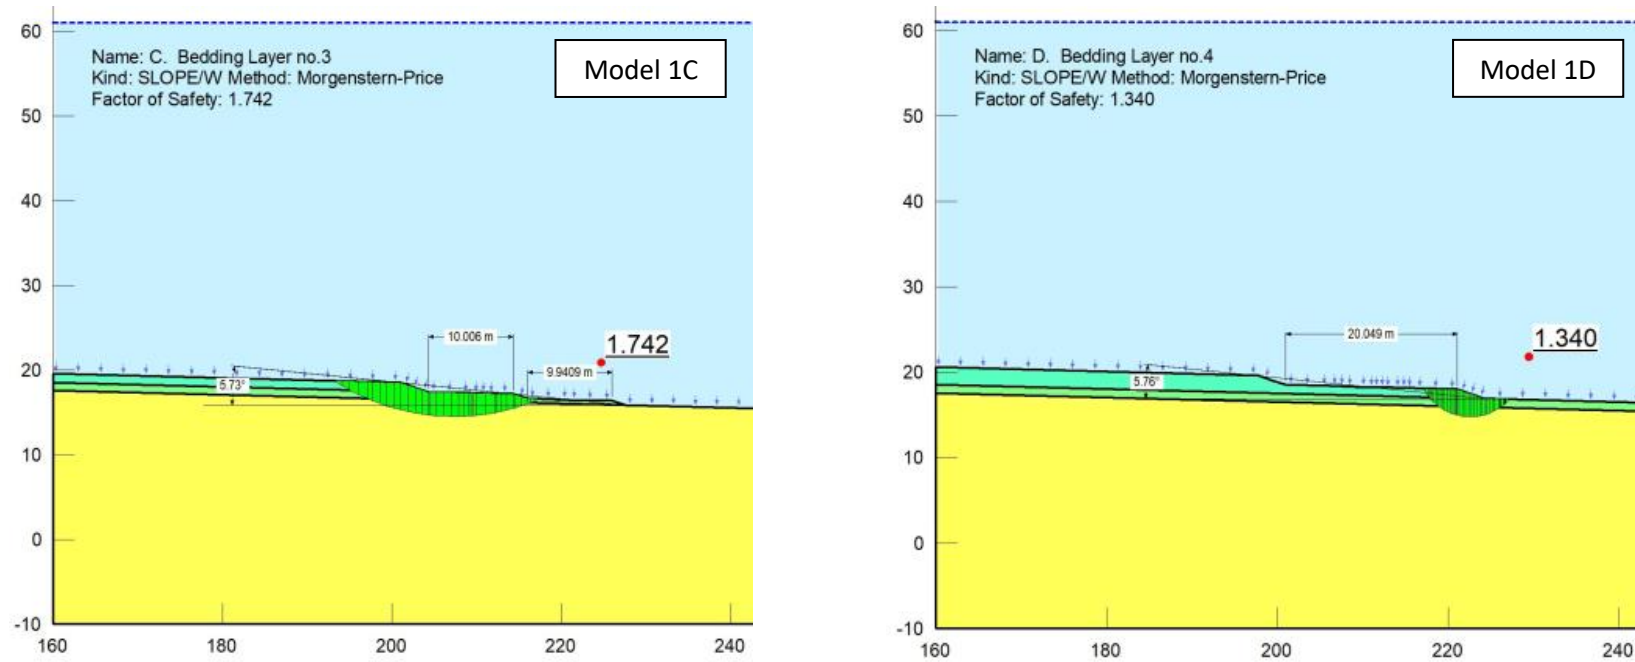
Figure 55 Models 1C and 1D

Color	Name	Model	Unit Weight (kN/m³)	C-Top of Layer (kPa)	C-Rate of Change ((kN/m²)/m)	C-Maximum (kPa)	Cohesion' (kPa)	Phi' (°)
Green	Bedding Layer	Mohr-Coulomb	18				0	30
Light Green	Intermediate Bedding Layer	Mohr-Coulomb	19				0	34
Yellow	Tailings and Slimes	S=f(depth)	16	0.5	1.5	0

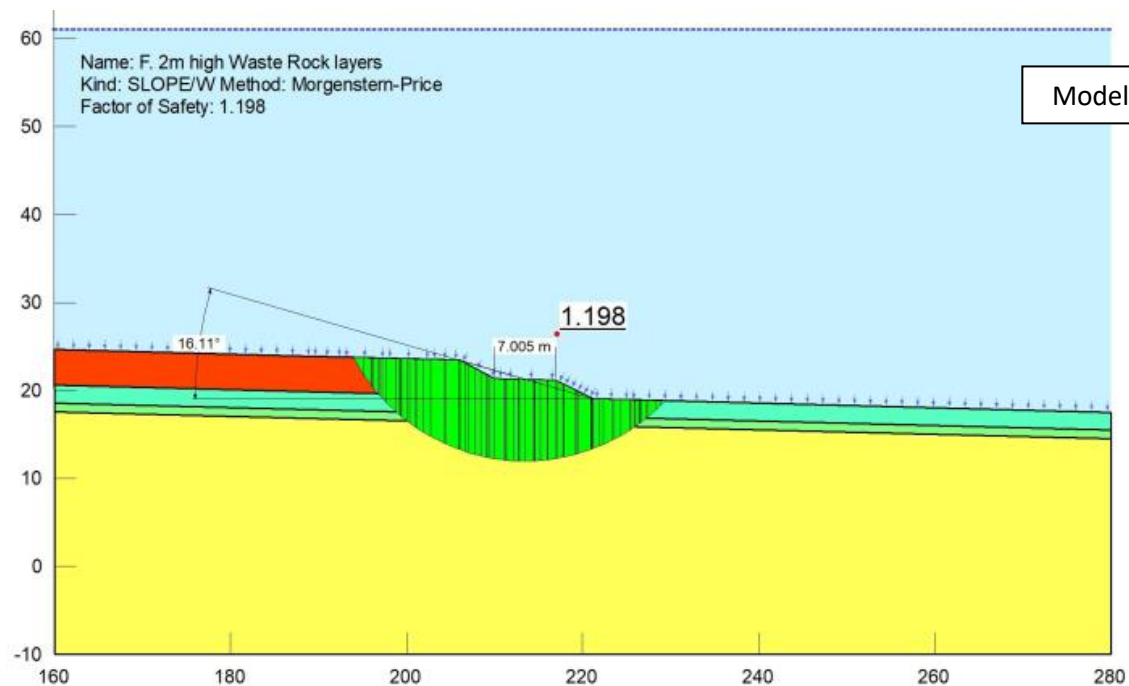
Figure 56 Models 1F

Color	Name	Model	Unit Weight (kN/m ³)	C-Top of Layer (kPa)	C-Rate of Change ((kN/m ²)/m)	C-Maximum (kPa)	Cohesion' (kPa)	Phi' (°)	Phi-B (°)	Piezometric Line
Green	Bedding Layer	Mohr-Coulomb	18				0	30	0	1
Light Green	Intermediate Bedding Layer	Mohr-Coulomb	19				0	34	0	1
Yellow	Tailings and Slimes	S=f(depth)	16	0.5	1.5	0				1
Red	Waste Rock	Mohr-Coulomb	19				0	32	0	1

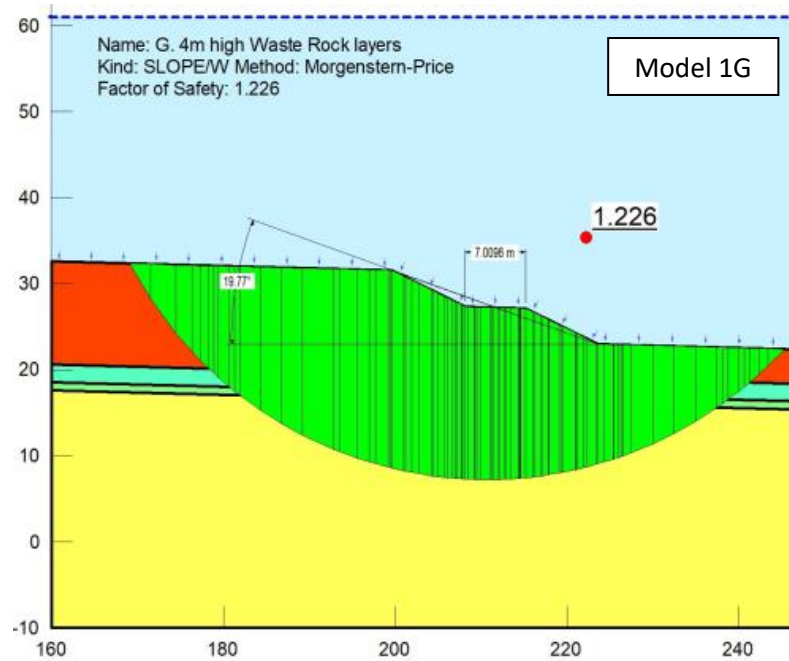
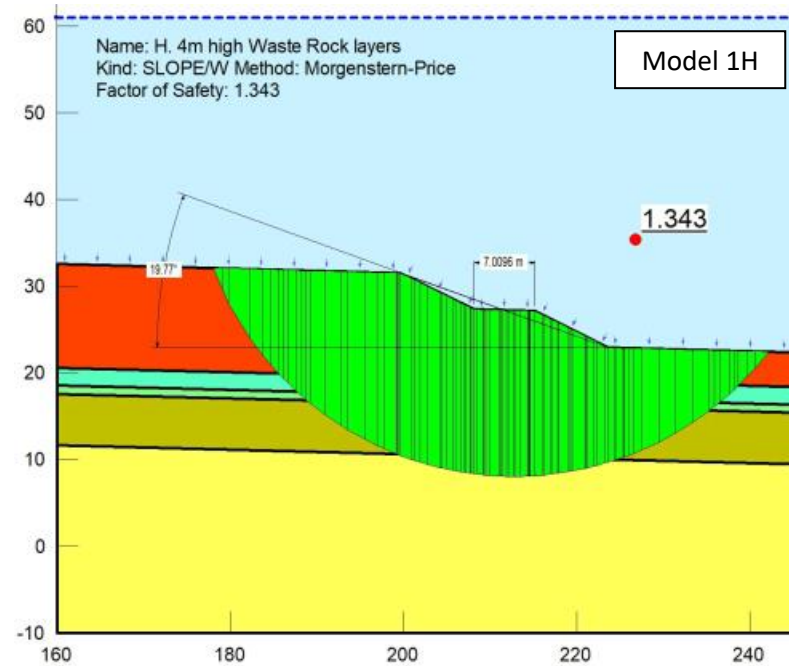
Figure 57 Models 1G and 1H without geotextile

Color	Name	Model	Unit Weight (kN/m ³)	C-Top of Layer (kPa)	C-Rate of Change ((kN/m ³)/m)	C-Maximum (kPa)	Cohesion' (kPa)	Phi' (°)	Phi-B (°)	Piezometric Line
Green	Bedding Layer	Mohr-Coulomb	18				0	30	0	1
Cyan	Intermediate Bedding Layer	Mohr-Coulomb	19				0	34	0	1
Yellow	Tailings and Slimes	S=f(depth)	16	0.5	1.5	0				1
Red	Waste Rock	Mohr-Coulomb	19				0	32	0	1

A strength gain in the upper 6.0 m of tailings was applied at this stage of backfilling, analysed as Model 1H. A FOS of 1.343 was recorded showing a slight increase from Model 1G, showing the same deep rotational failure mode. Model 1G and 1H are presented in **Figure 57**.

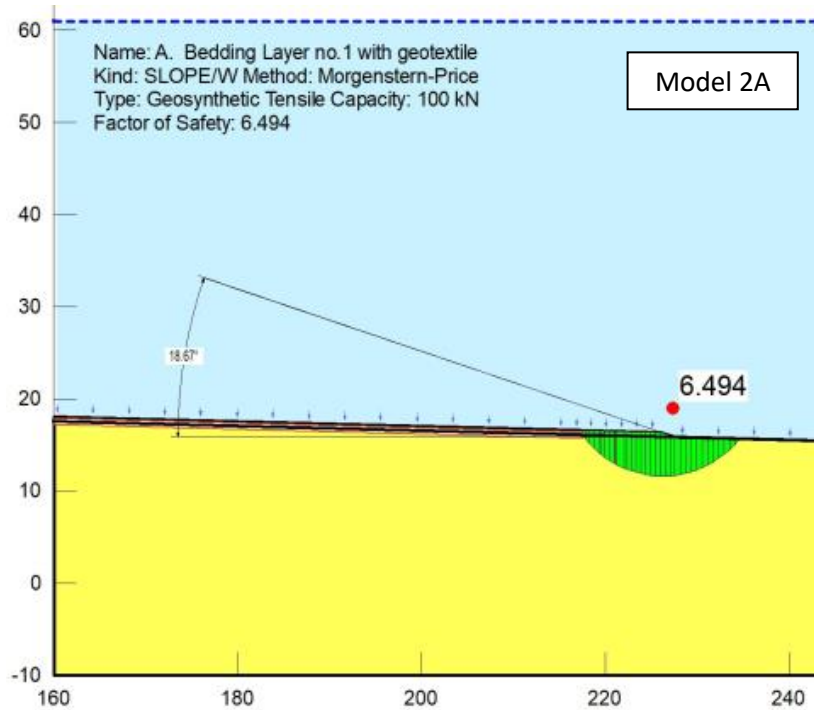
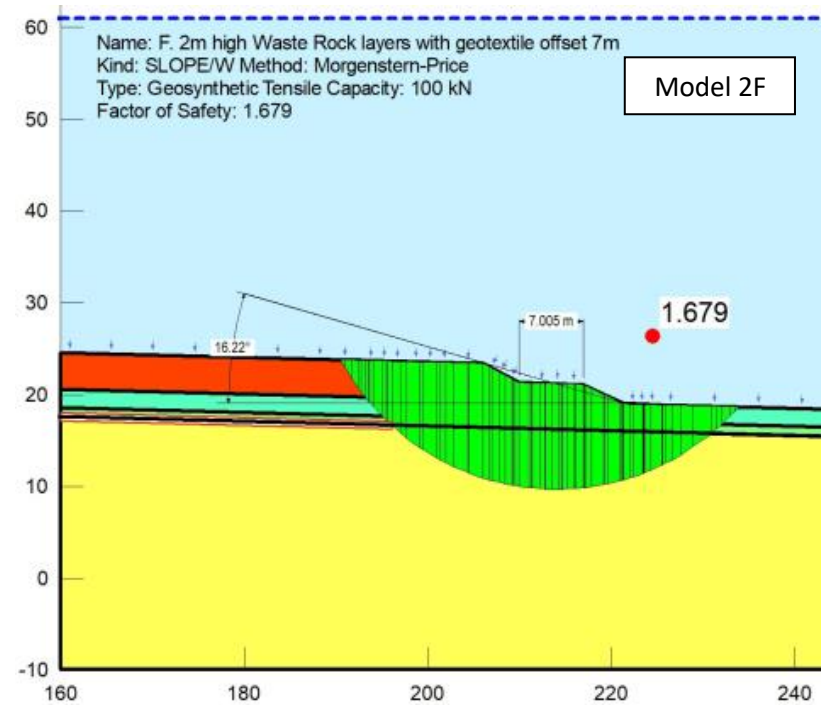
Figure 58 Models 1G and 1H with geotextile

Color	Name	Model	Unit Weight (kN/m ³)	C-Top of Layer (kPa)	C-Rate of Change ((kN/m ²)/m)	C-Maximum (kPa)	Cohesion' (kPa)	Phi' (°)	Phi-B (°)	Piezometric Line
Green	Bedding Layer	Mohr-Coulomb	18				0	30	0	1
Yellow	Tailings and Slimes	S=f(depth)	16	0.5	1.5	0				1

Color	Name	Model	Unit Weight (kN/m ³)	C-Top of Layer (kPa)	C-Rate of Change ((kN/m ²)/m)	C-Maximum (kPa)	Cohesion' (kPa)	Phi' (°)	Phi-B (°)	Piezometric Line
Green	Bedding Layer	Mohr-Coulomb	18				0	30	0	1
Cyan	Intermediate Bedding Layer	Mohr-Coulomb	19				0	34	0	1
Yellow	Tailings and Slimes	S=f(depth)	16	0.5	1.5	0				1
Red	Waste Rock	Mohr-Coulomb	19				0	32	0	1

Figure 58 shows Model 2A, the maximum FOS recorded, and Model 2F, exhibiting the last significant increase in FOS due to the presence of the geotextile liner.

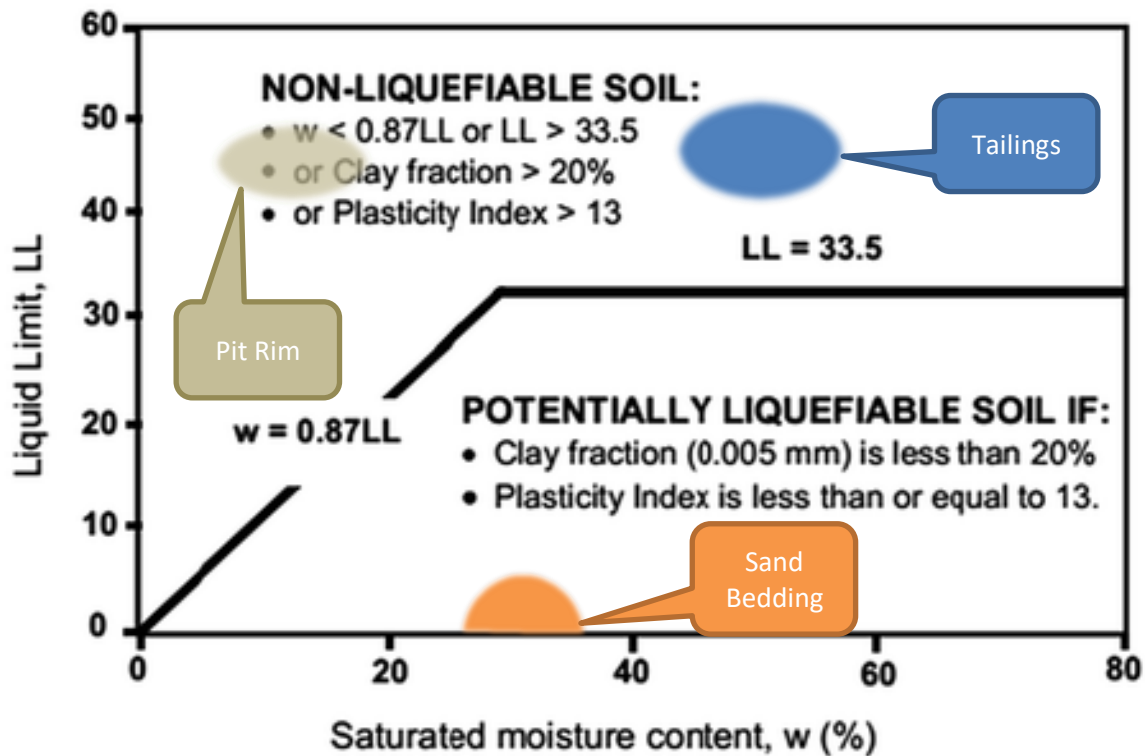
Figure 59 Liquefaction Screening Based on Material Classification

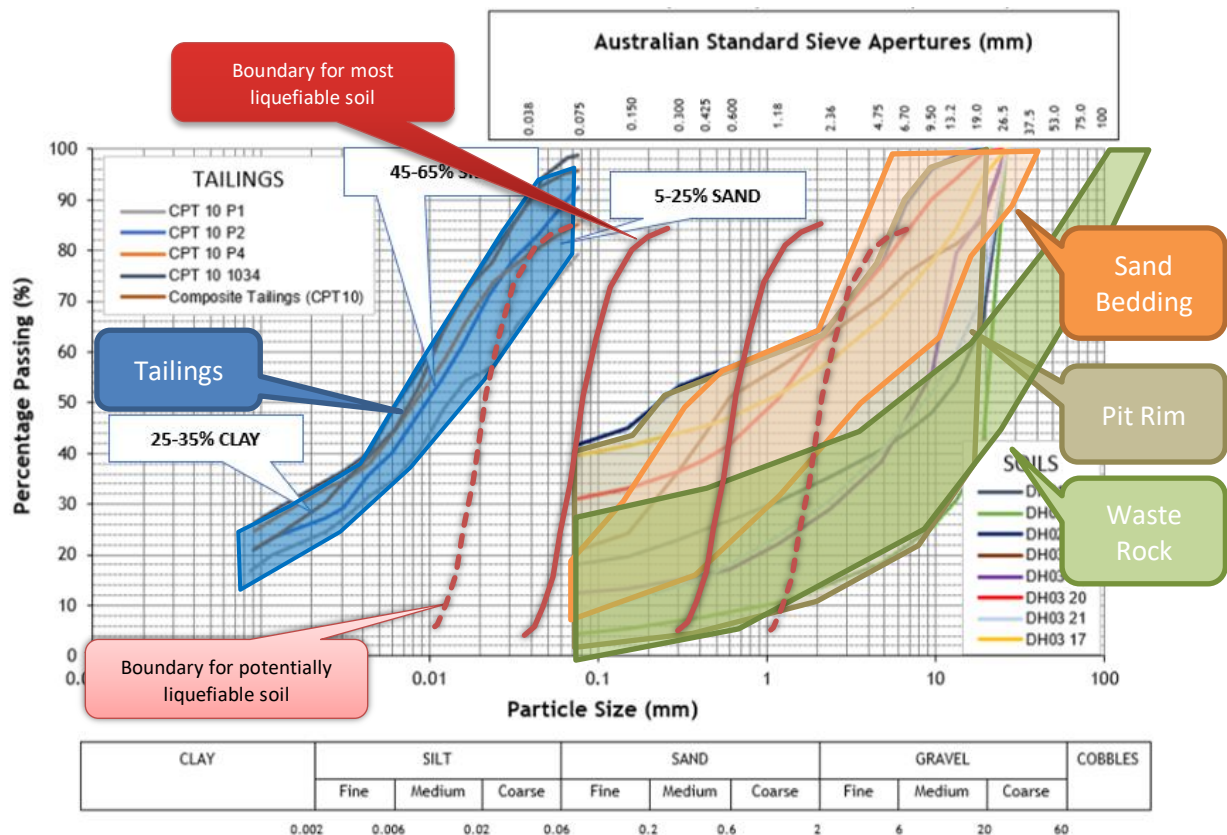
Figure 60 Liquefaction screening based on grading (after Tsuchida 1970 [55])

An alternative screening method based on grading of soil materials published by Tsuchida [55] was also used to examine liquefaction potential as shown in **Figure 60** below.

The screening process shown above indicates the following:

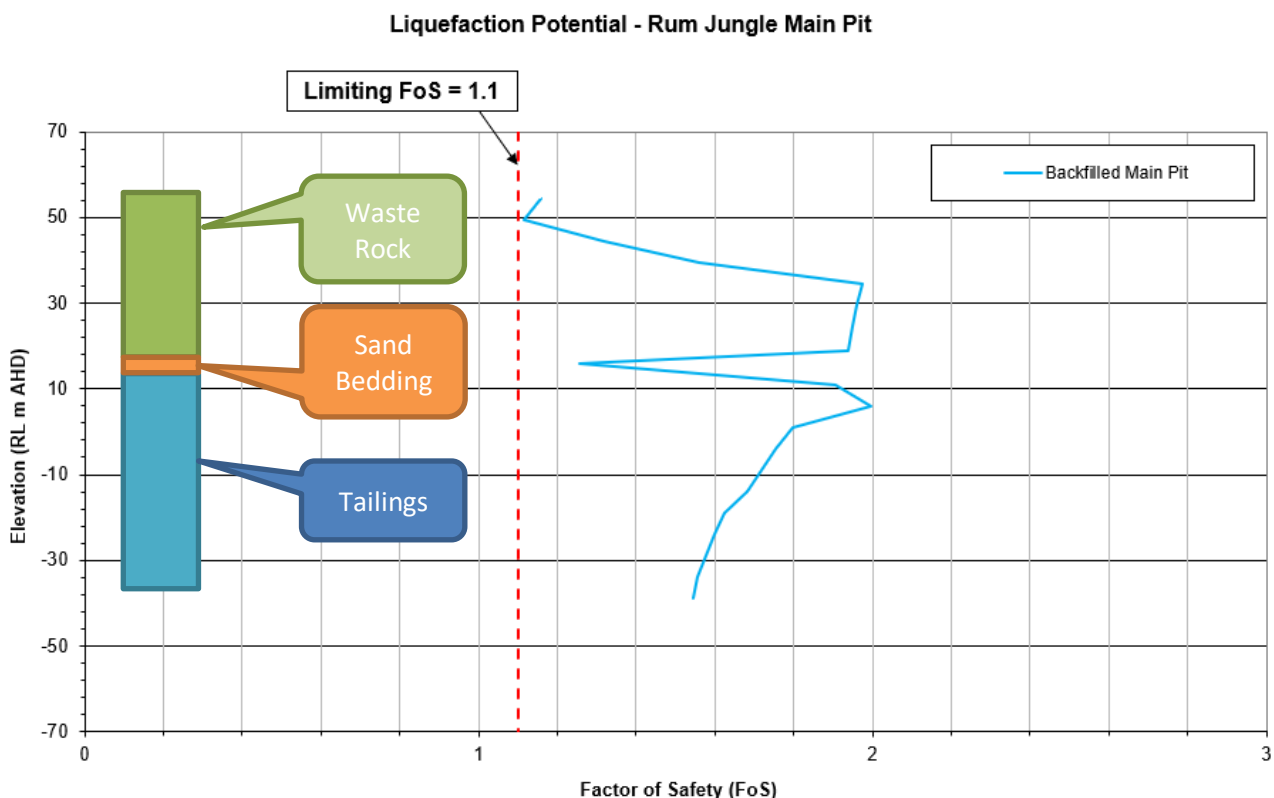
Figure 61 Liquefaction FoS Assessment (after Kramer 1995 [56])

It is noted, whilst a peak ground acceleration of 0.08g has been used for assessment, there could be argument to consider longer return period intervals for peak ground acceleration. For larger peak acceleration, it may give rise to discrete layered liquefaction with potential for localised sand boils and small-scale settlements at the surface. Evaluated in consideration of possible project long-term consequences; with no planned
