SLR Consulting Australia (2020) *Rum Jungle Rehabilitation – Stage 2A Detailed Design – Main Pit Backfill Strategy, Geotechnical Considerations*. Report to the Department of Mines and Energy, Northern Territory. PART A.

RUM JUNGLE REHABILITATION - STAGE 2A DETAILED DESIGN

**Main Pit Backfill Strategy
Geotechnical Considerations
Issued for Client and External Peer Review**

SLR Ref: 680.10421.90030-R03
Version No: -v2.0
June 2020

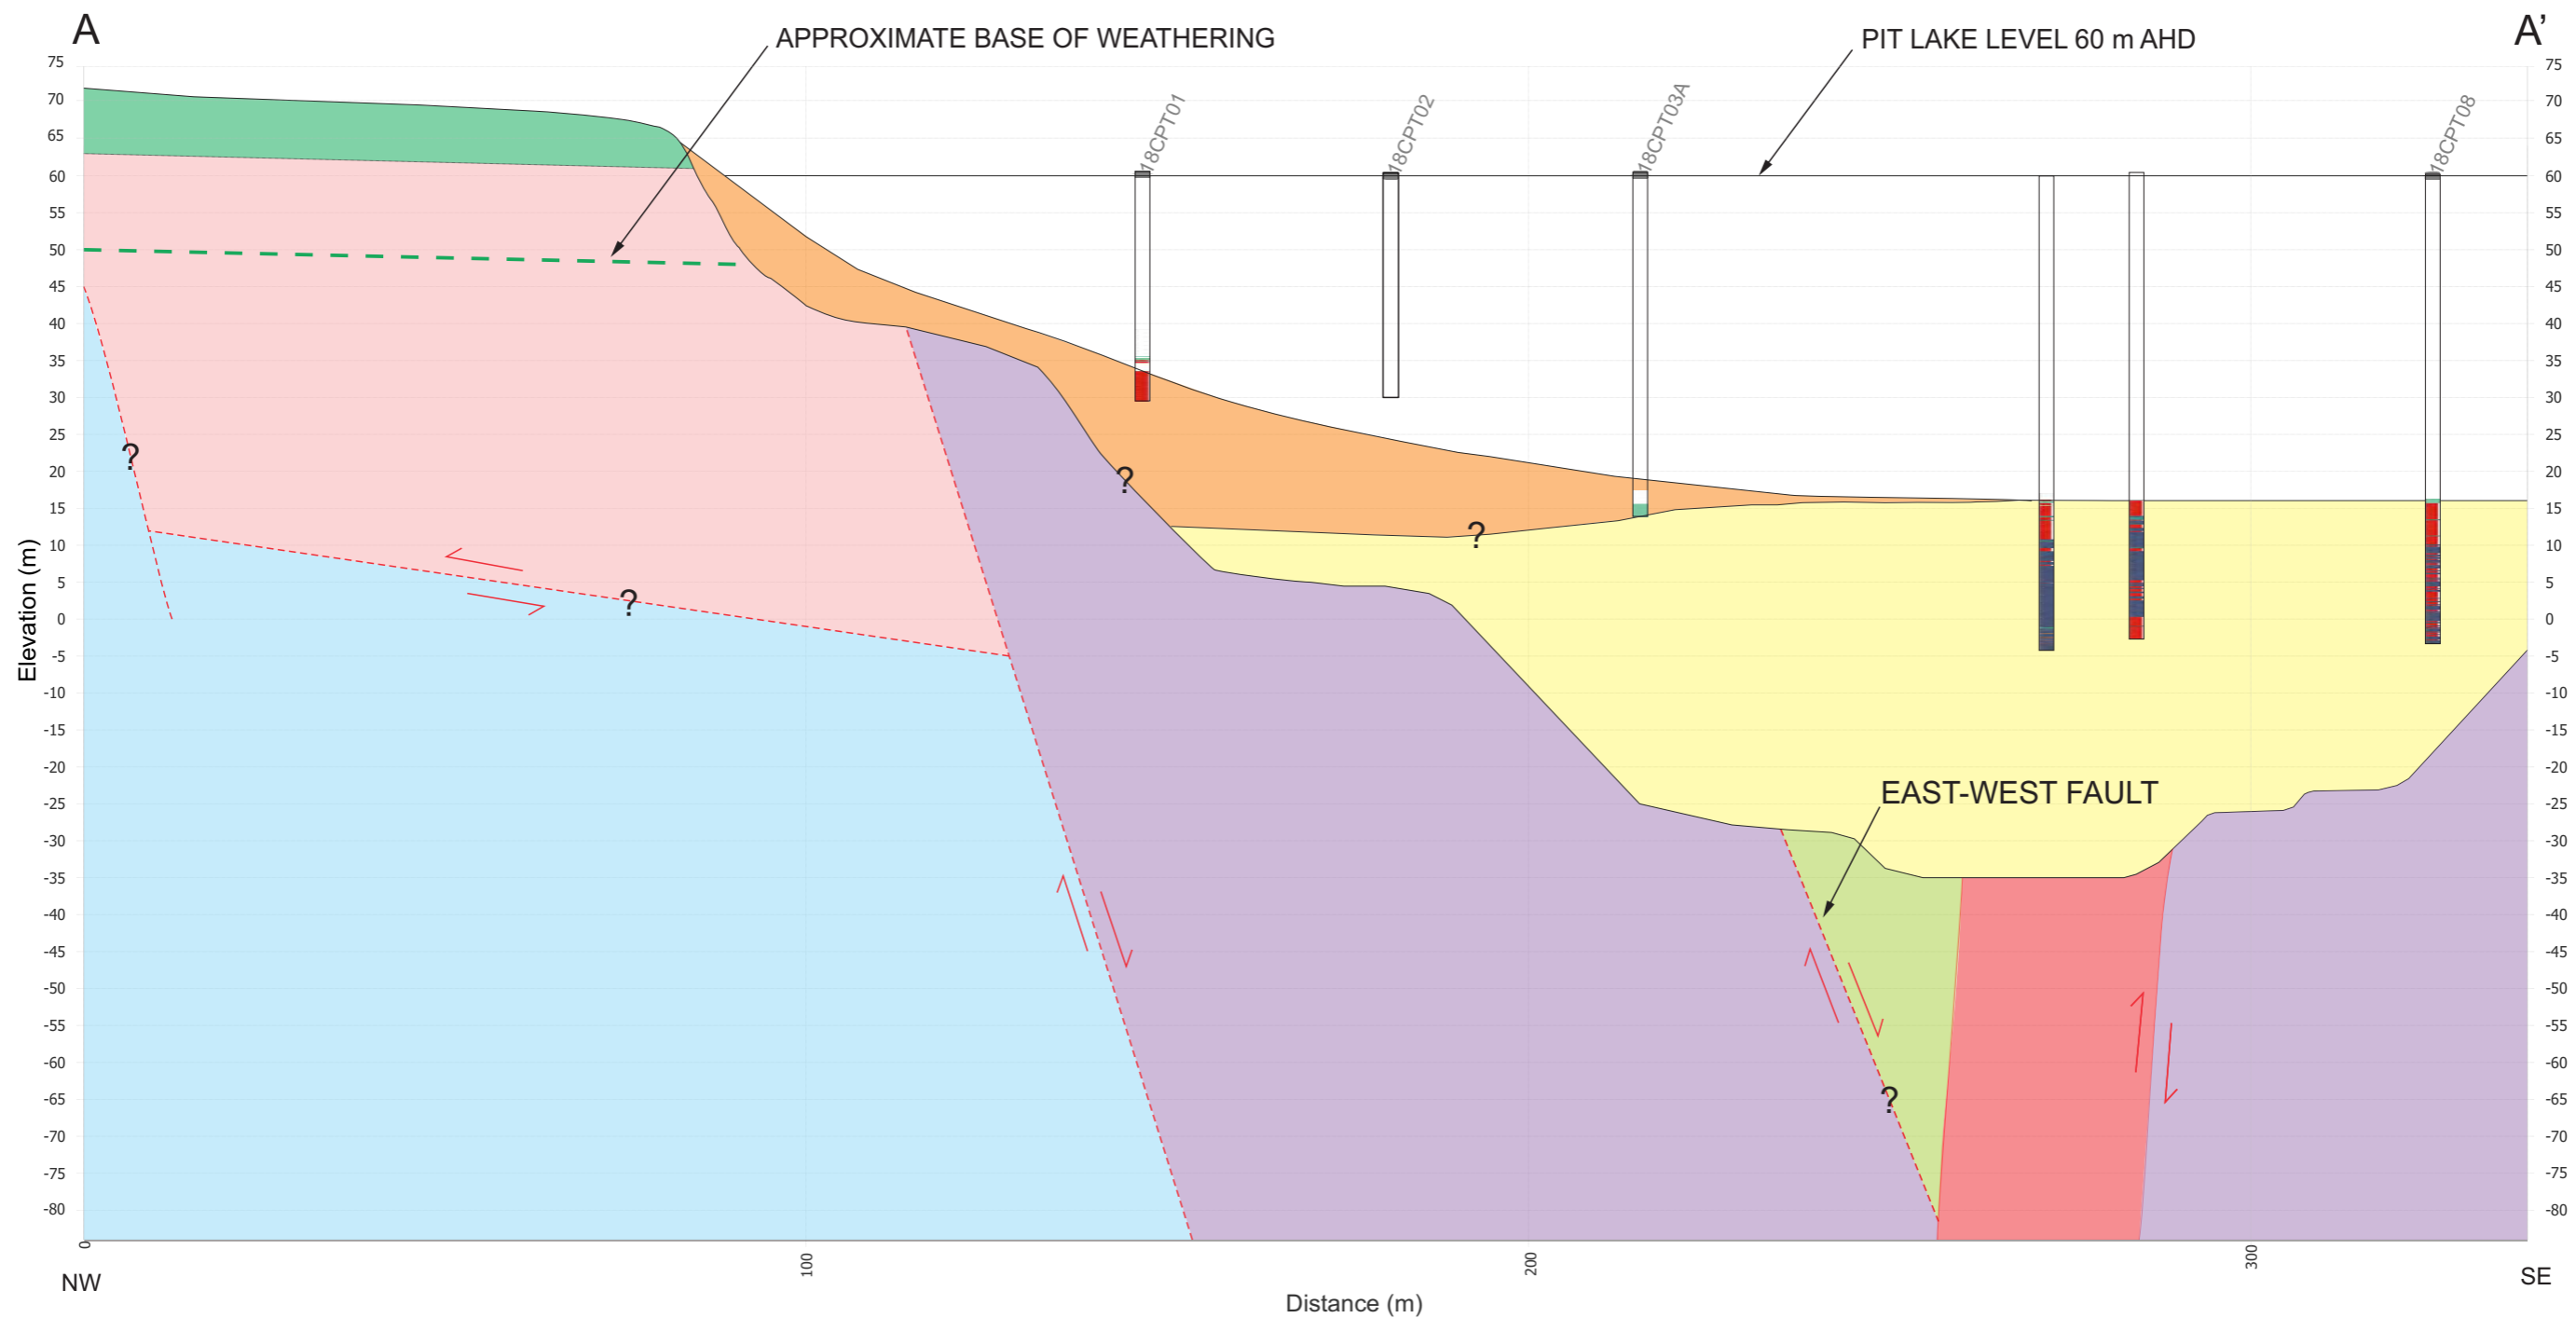
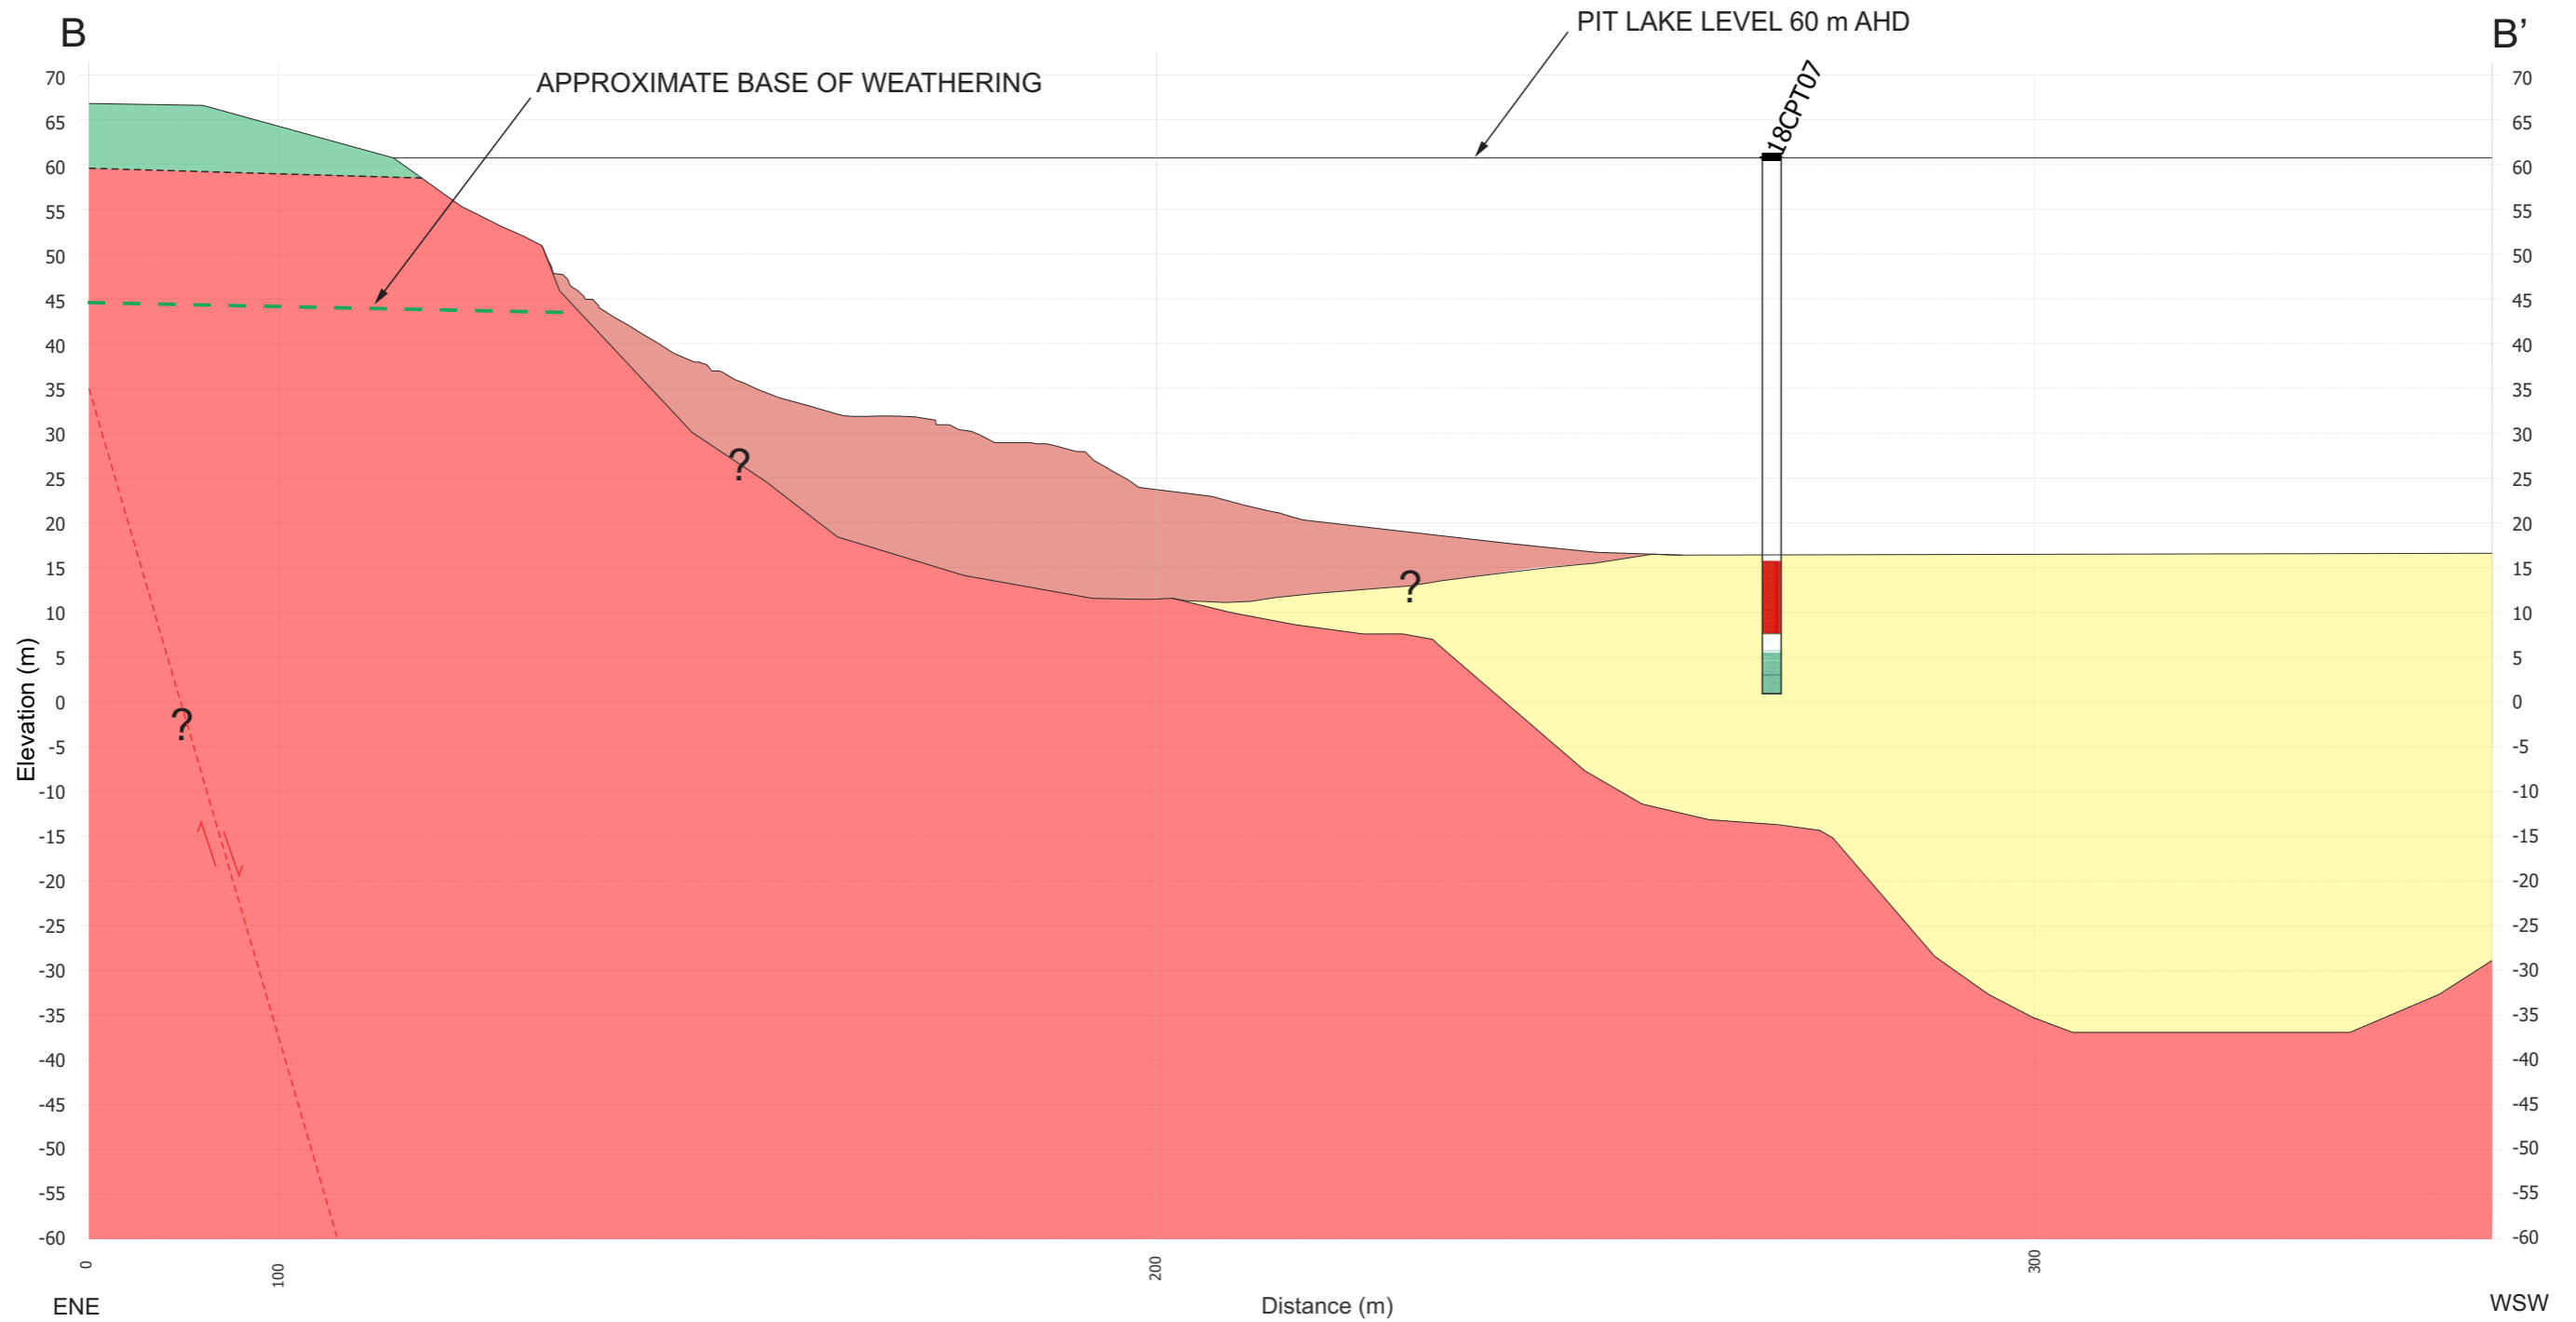
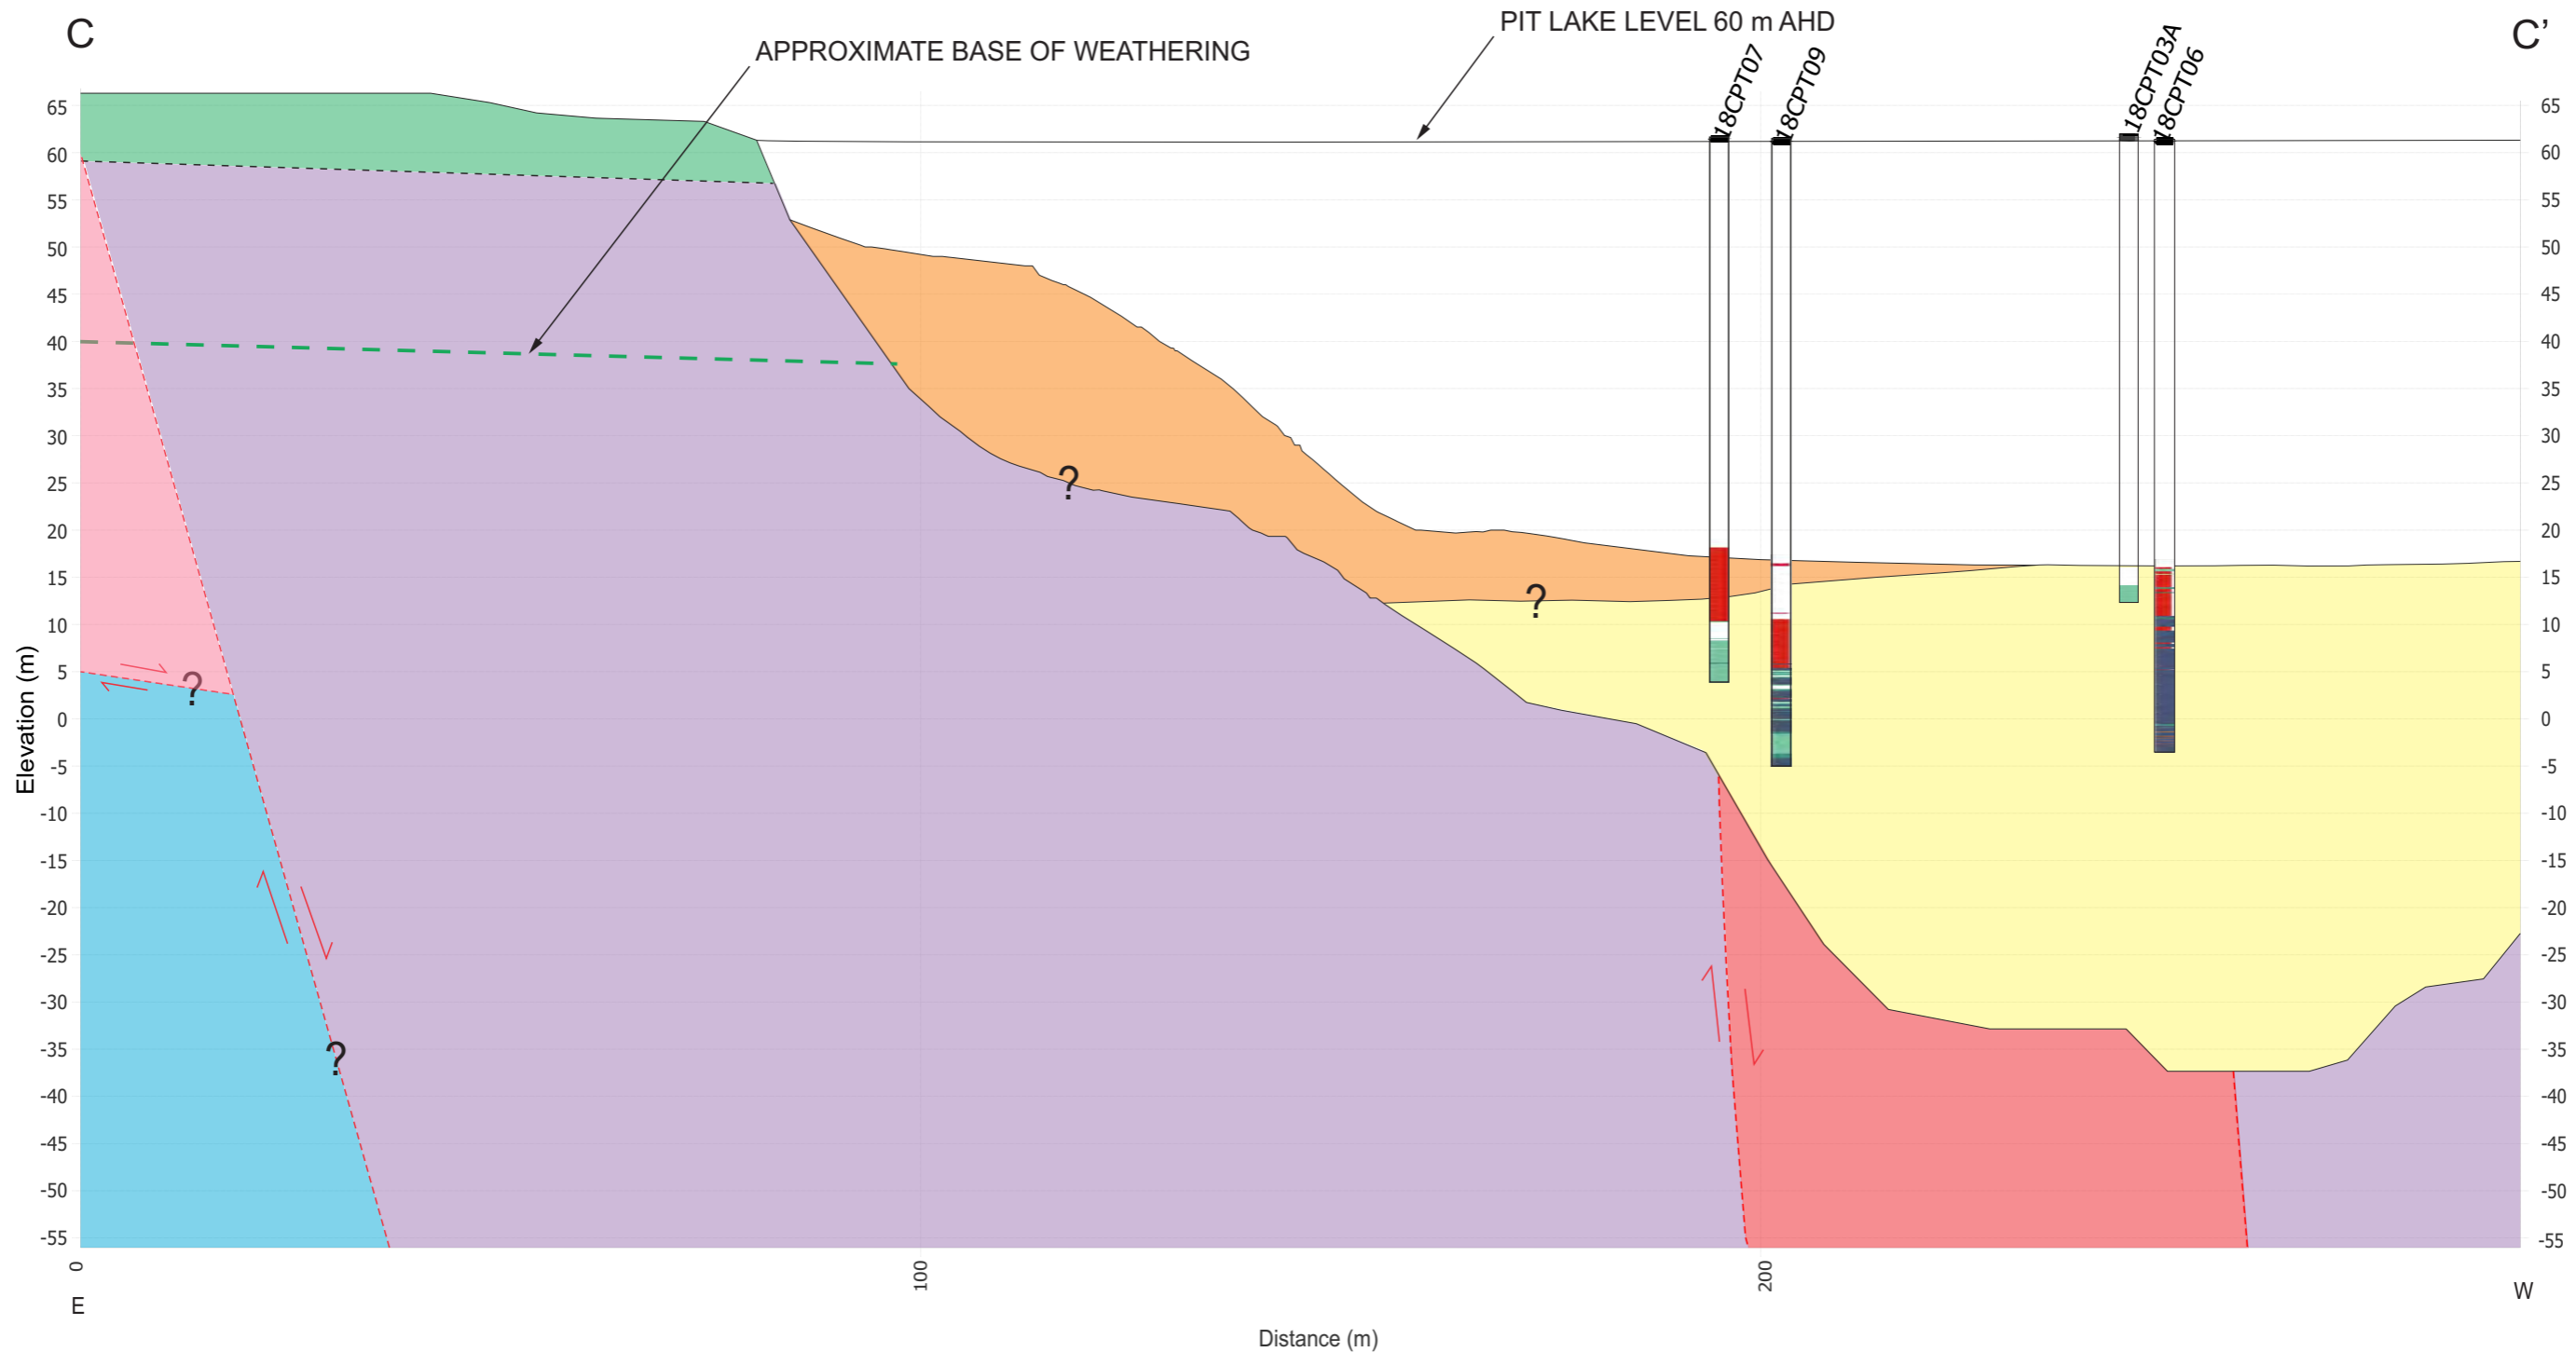
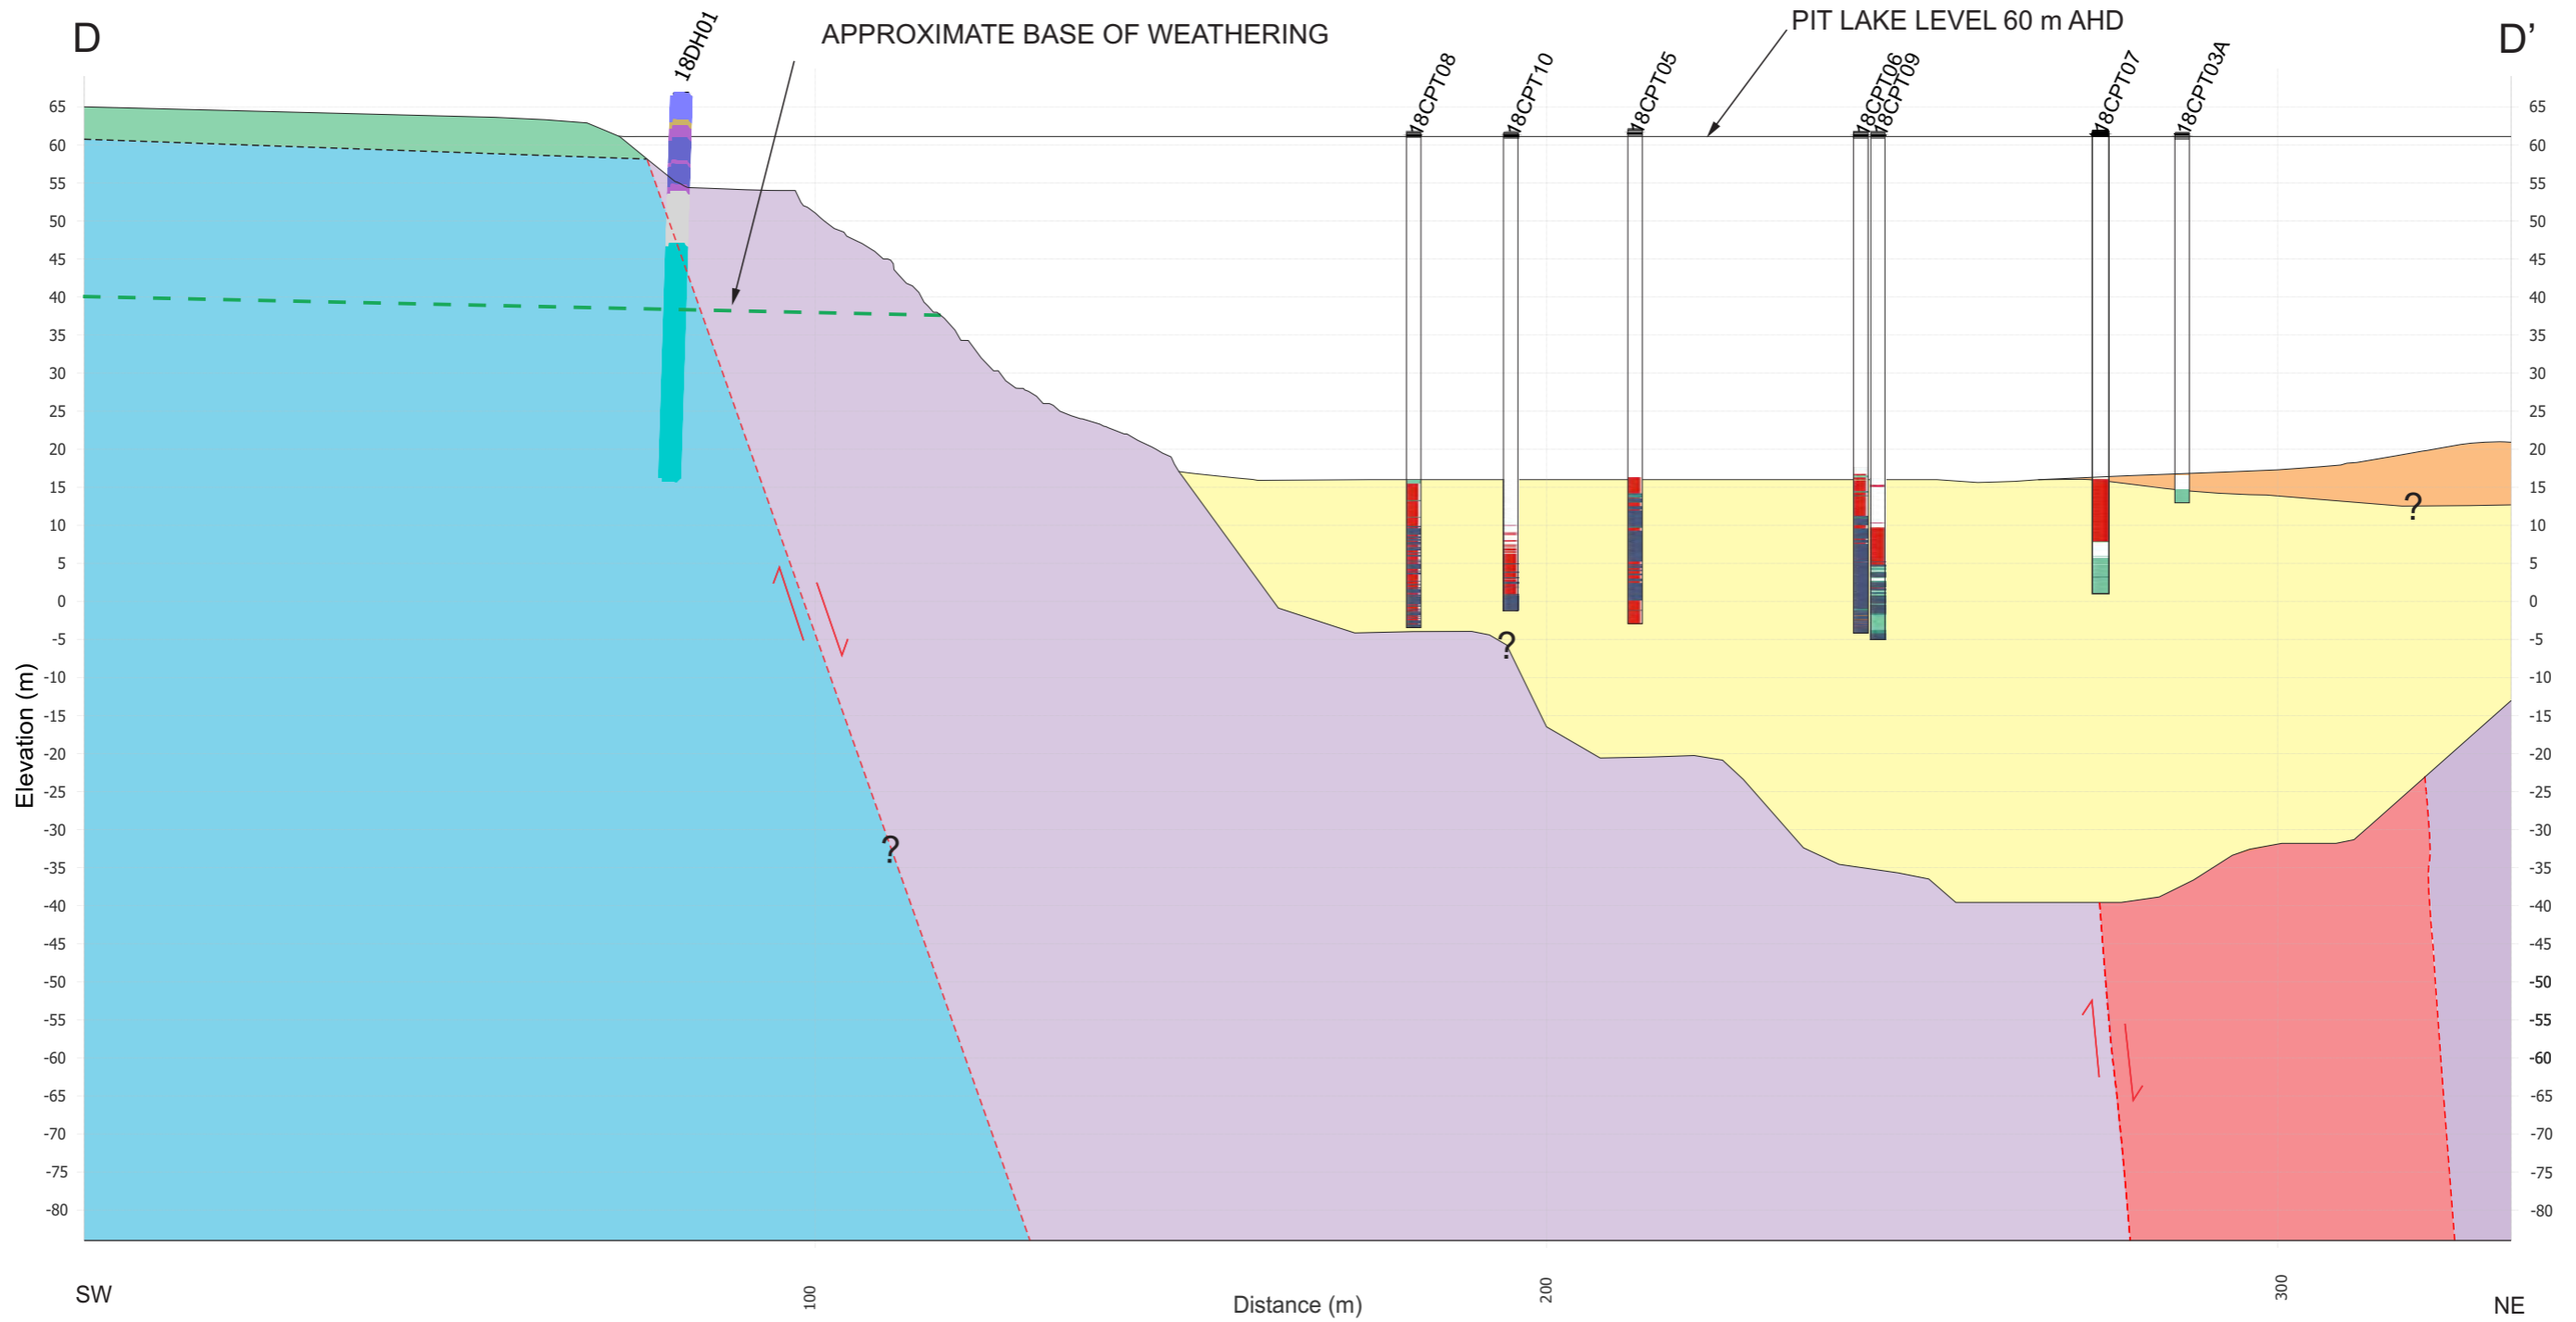
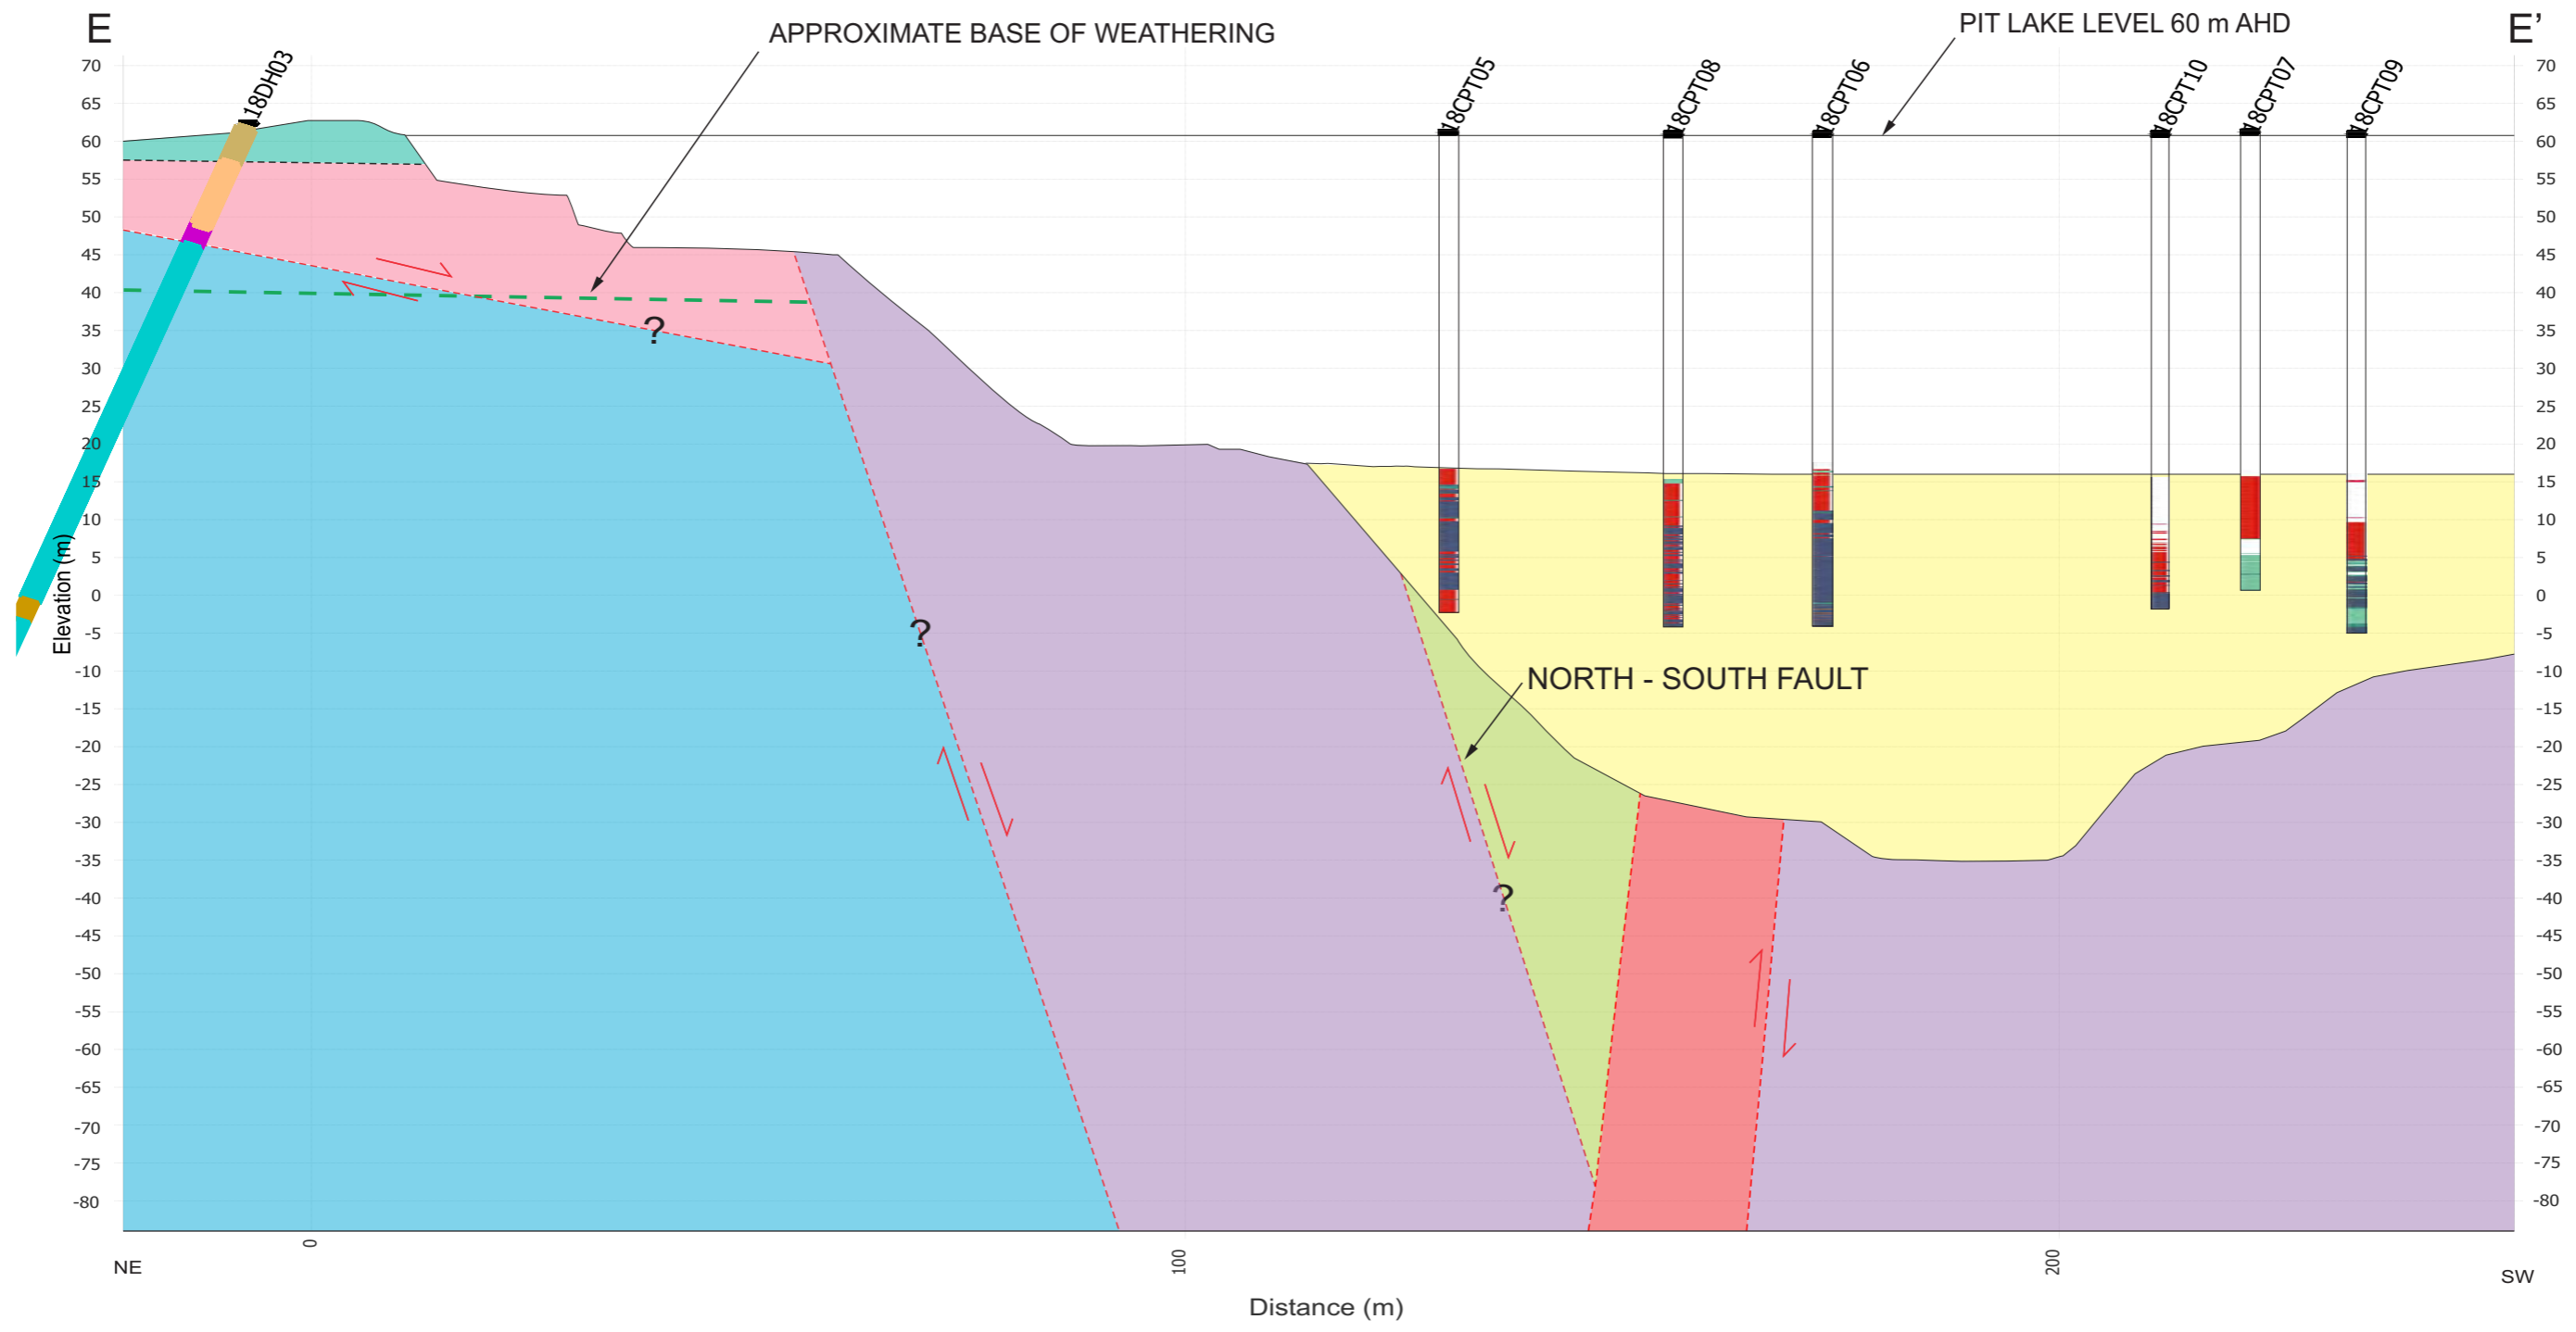
Geotechnical Main Pit Sections

COOMALIE DOLOSTONE
DOLOMITE, QUARTZITE

- MAIN SHEAR ZONE
DEFORMED, SHEARED BRECCIATED WHITES FORMATION
- SAPROLITE / LATERITE
SANDY GRAVELLY CLAY
- UNCONTROLLED FILL
TAILINGS

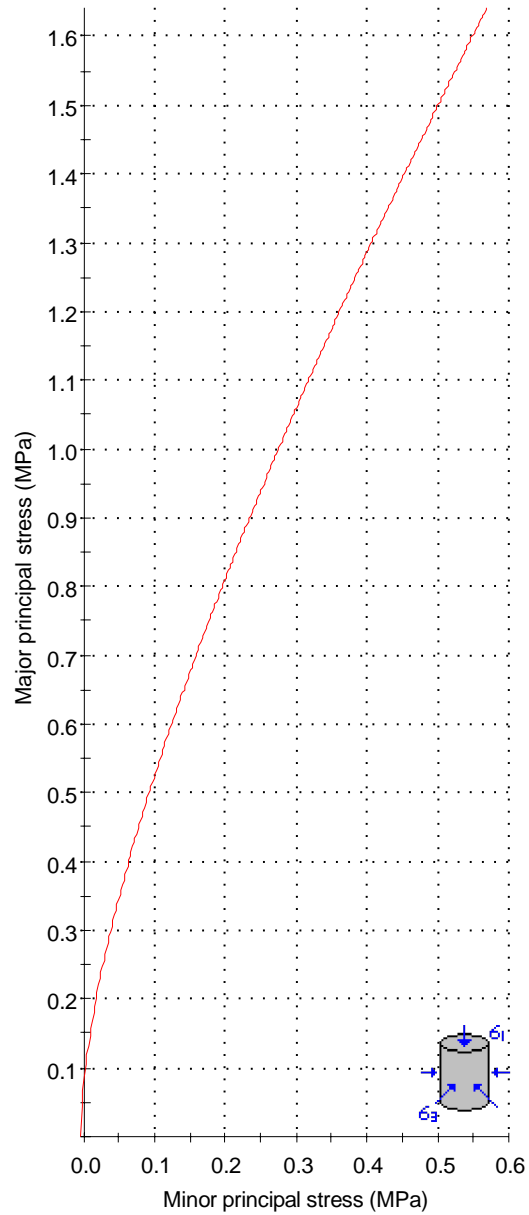
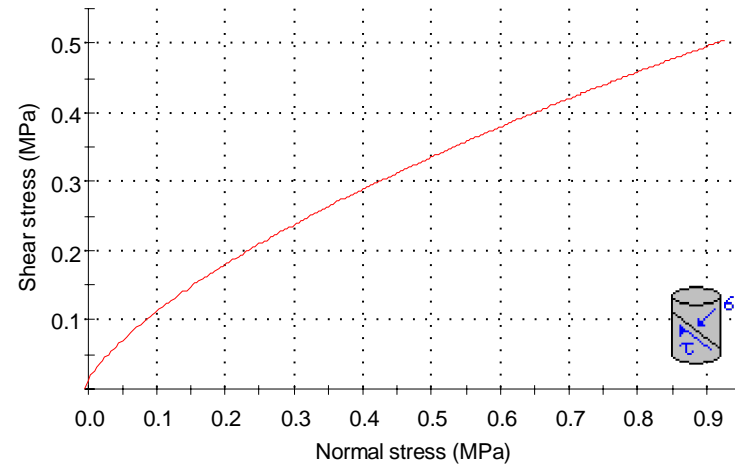
Whites Fm Shale

intact uniaxial comp. strength (σ_{ci}) = 25 MPa
GSI = 20 m_i = 6 Disturbance factor (D) = 0.5
intact modulus (E_i) = 5000 MPa
modulus ratio (MR) = 200

tensile strength = -0.004 MPa
uniaxial compressive strength = 0.076 MPa
global strength = 0.915 MPa
deformation modulus = 149.31 MPa

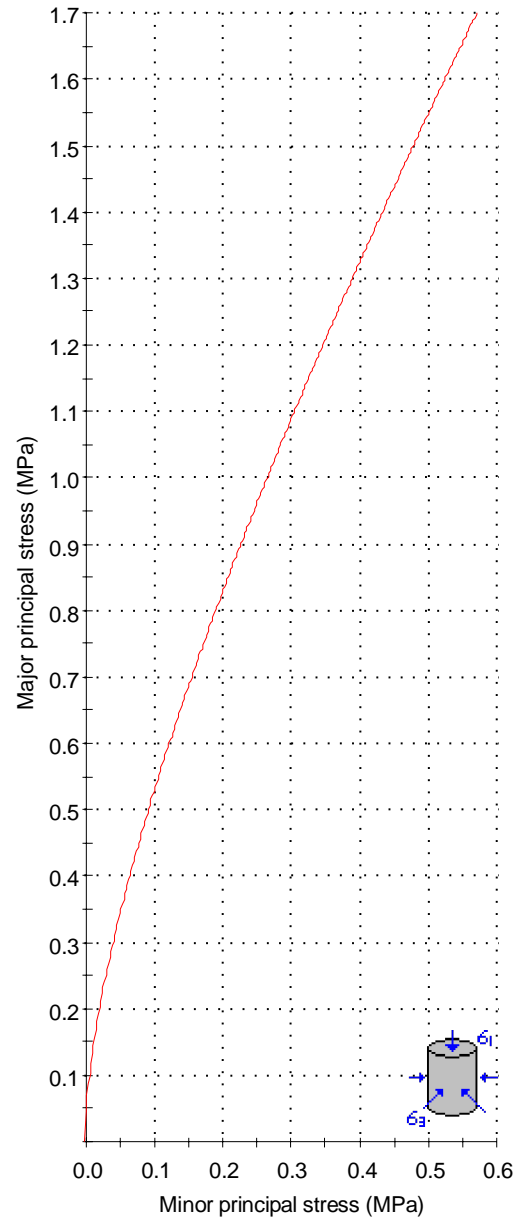
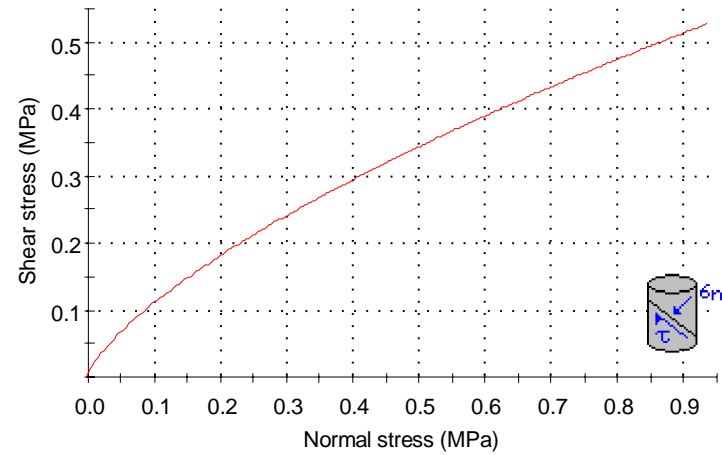
Whites Fm Schist

intact uniaxial comp. strength (σ_{ci}) = 25 MPa
GSI = 15 m_i = 10 Disturbance factor (D) = 0.5
intact modulus (E_i) = 16875 MPa
modulus ratio (MR) = 675

tensile strength = -0.002 MPa
uniaxial compressive strength = 0.043 MPa
global strength = 0.948 MPa
deformation modulus = 443.64 MPa

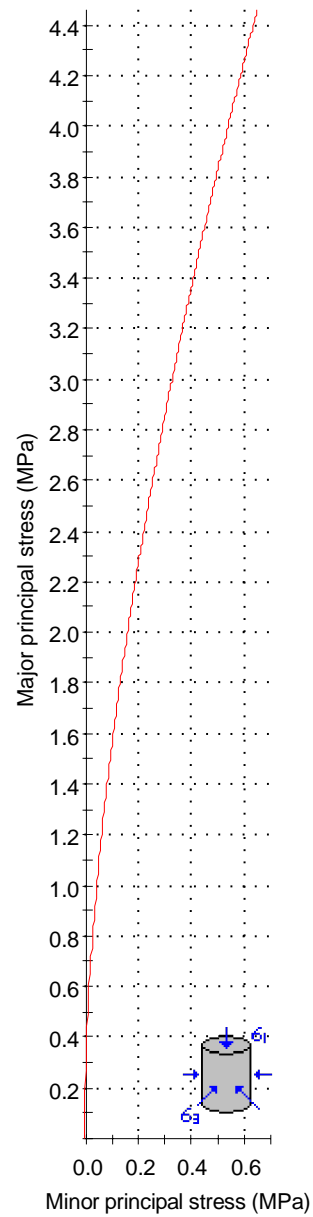
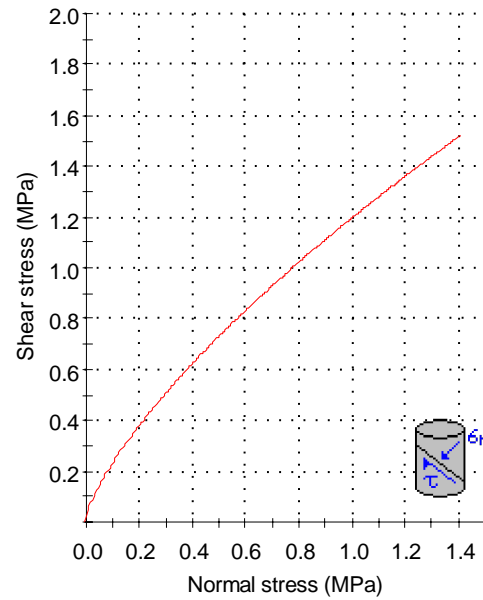
Whites Fm Meta Sandstone

intact uniaxial comp. strength (σ_{ci}) = 40 MPa
GSI = 30 m_i = 19 Disturbance factor (D) = 0.5
intact modulus (E_i) = 10000 MPa
modulus ratio (MR) = 250

tensile strength = -0.005 MPa
uniaxial compressive strength = 0.305 MPa
global strength = 3.945 MPa
deformation modulus = 440.09 MPa

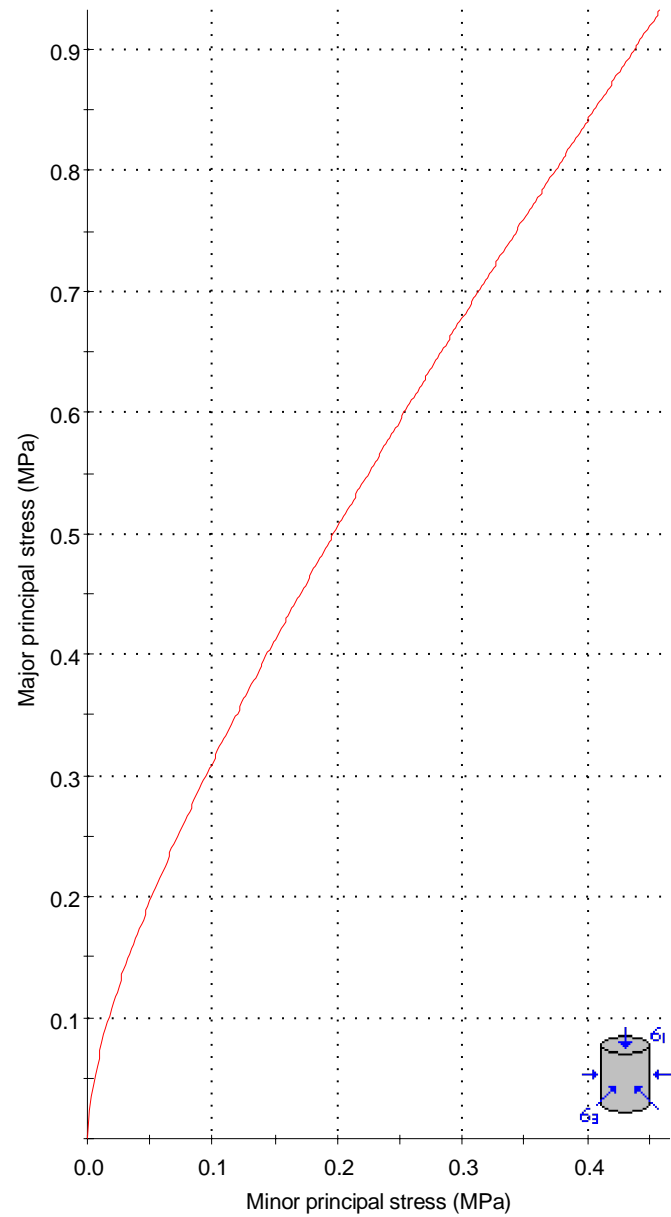
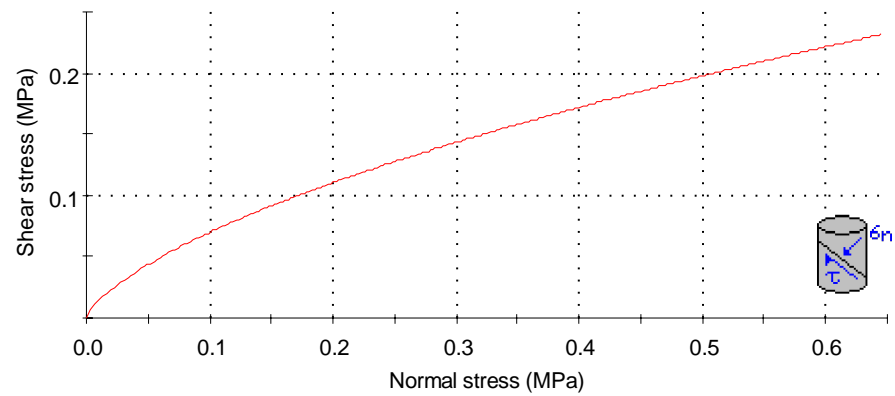
HW Quartz Breccia

intact uniaxial comp. strength (σ_{ci}) = 1 MPa
GSI = 25 m_i = 19 Disturbance factor (D) = 0.5
intact modulus (E_i) = 500 MPa
modulus ratio (MR) = 500

tensile strength = -8.5e-5 MPa
uniaxial compressive strength = 0.005 MPa
global strength = 0.083 MPa
deformation modulus = 17.71 MPa
